ATTACHMENT A

AGREEMENT FOR CONSULTING AND RELATED SERVICES

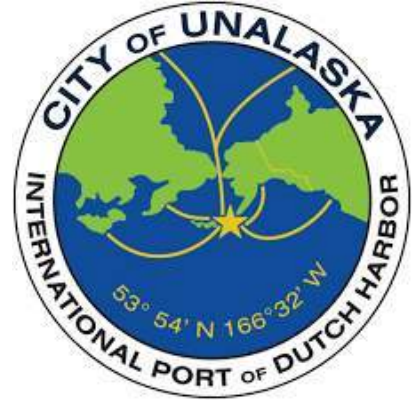
**CITY OF UNALASKA
CITYWIDE ROOF ASSESSMENT PROJECT**

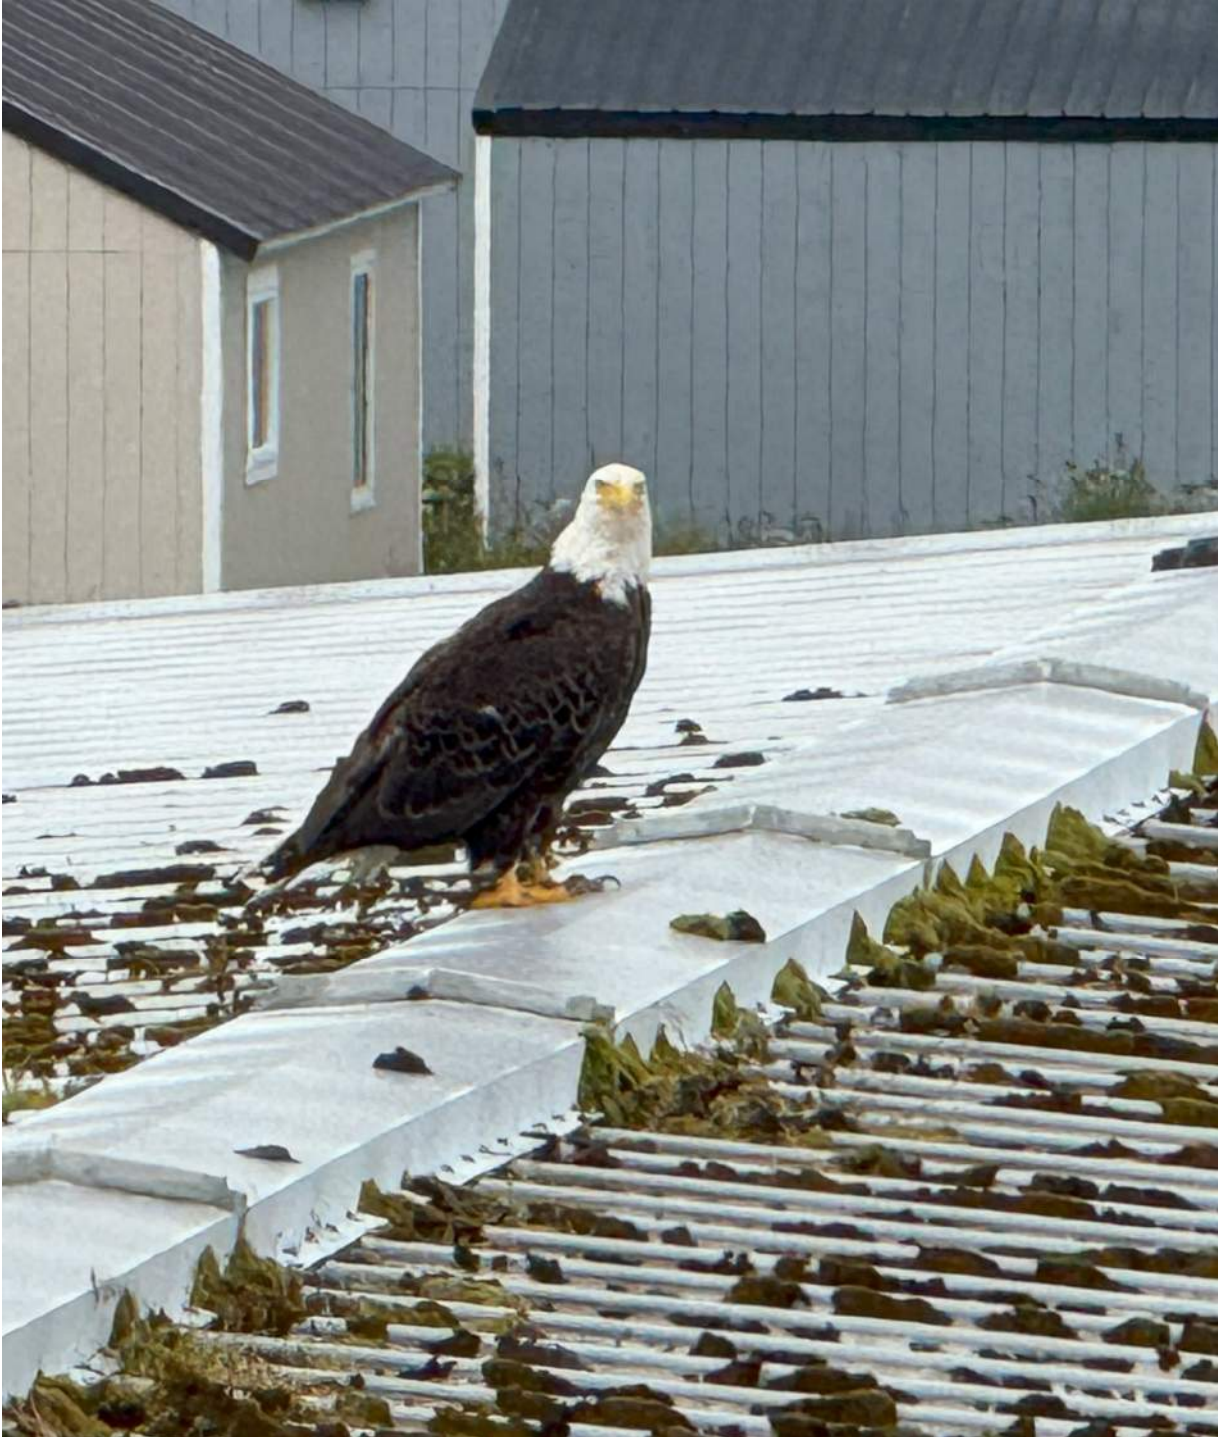
Photo: Site visit was accompanied by drop-in roof consultant.

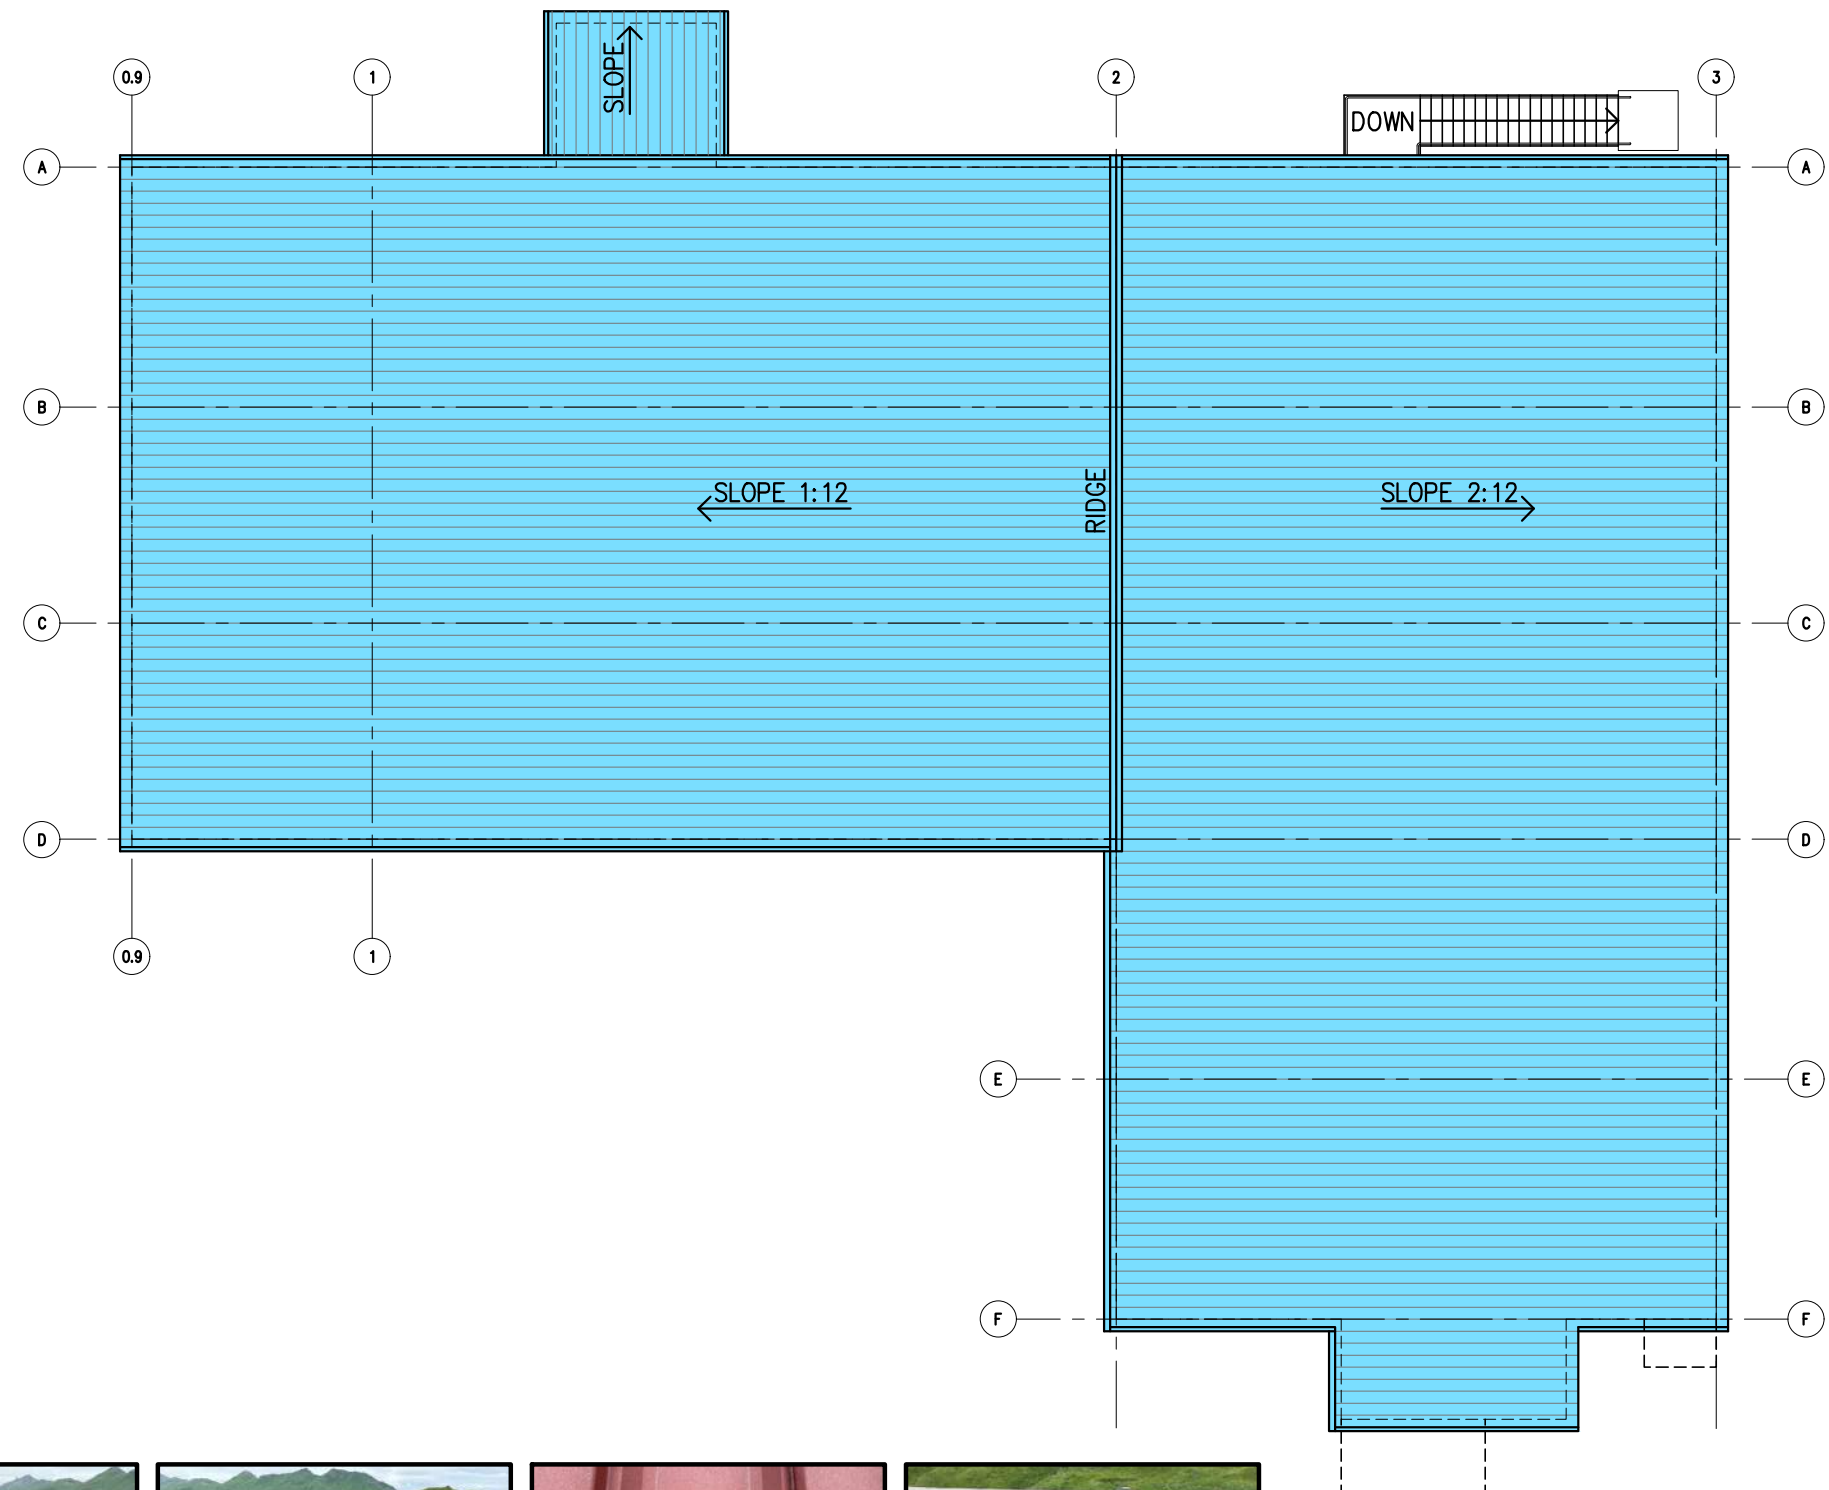
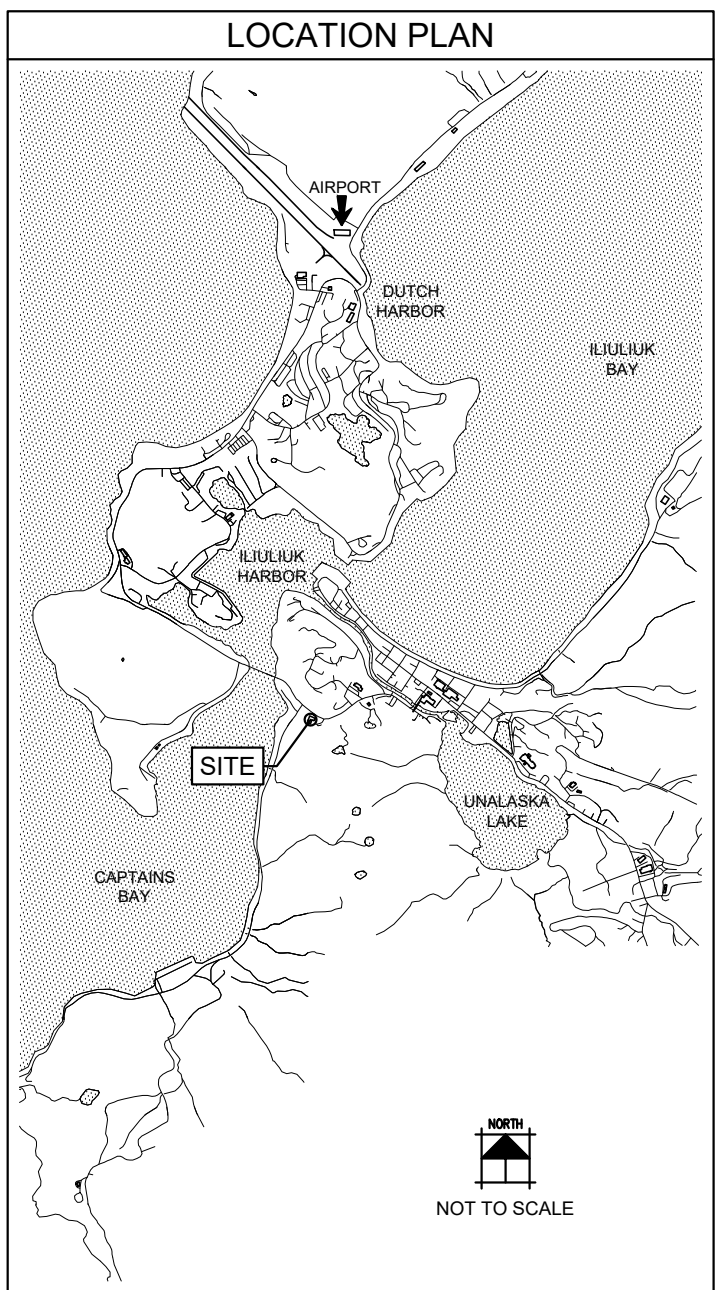
September 25, 2025 - 10:42 AM - BECKY - O:\GOVERNMENT\UNALASKA\3_DRAWINGS\00_AR SHEETS - REPORT\AR-1_DEPT OF PUBLIC SAFETY.DWG

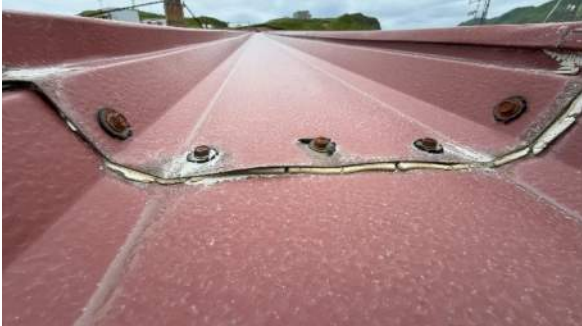
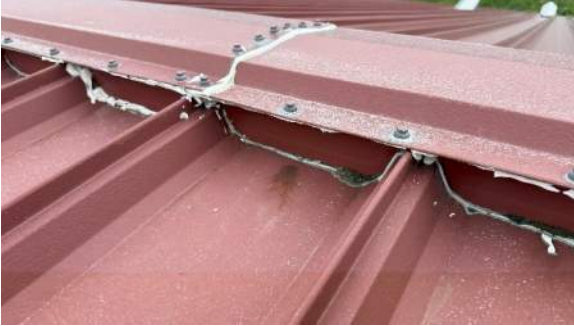
<p><i>Photo #8: Sealant joints peeling away or just not in the correct spot</i></p>
<p><i>Photo #7: Sealant around edge flashings and transitions cracked</i></p>

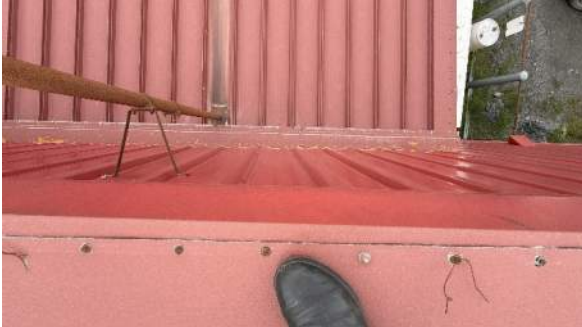
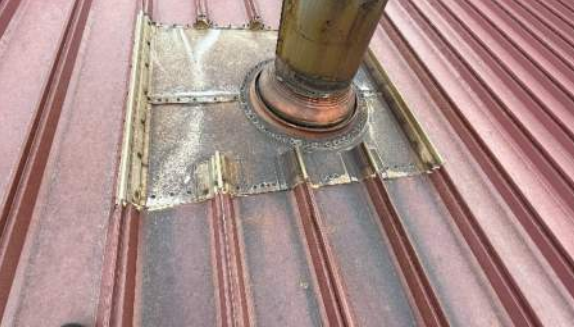
<p><i>Photo #10: Misc. Photo</i></p>
<p><i>Photo #9: Vent pipe rusting and leaching onto roof panels</i></p>

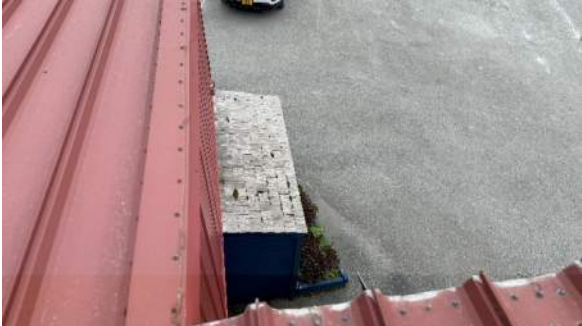
<p><i>Photo #11: Misc. Photo</i></p>

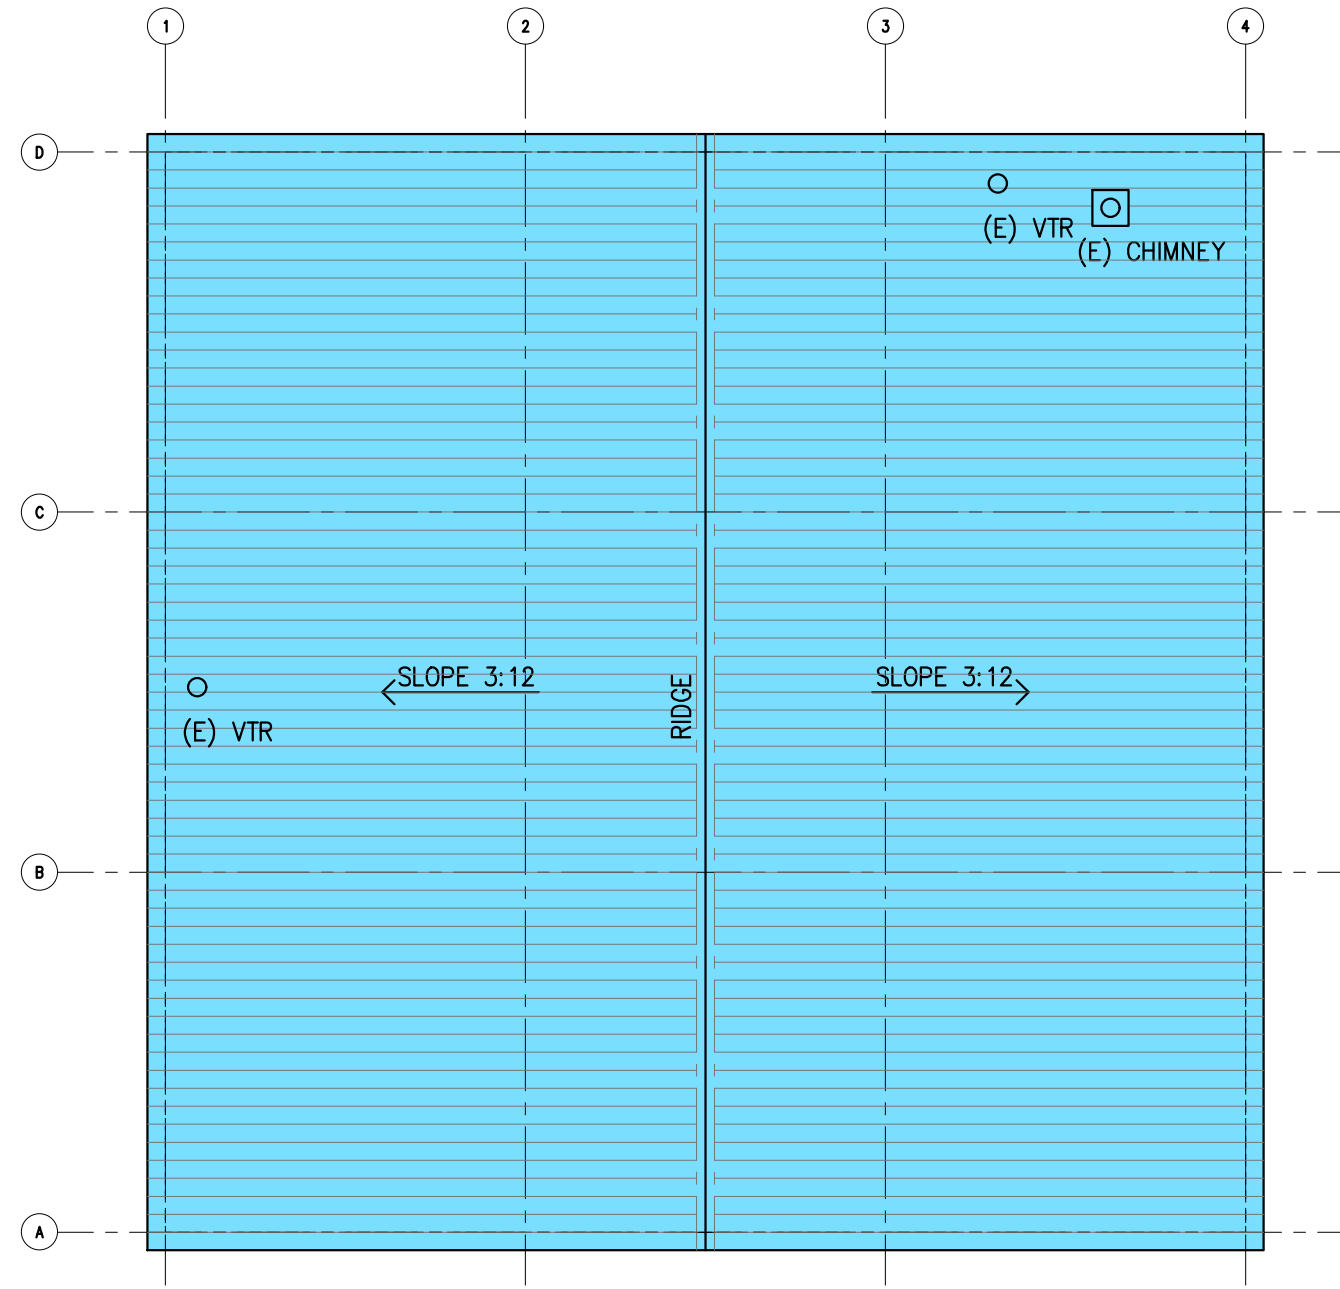
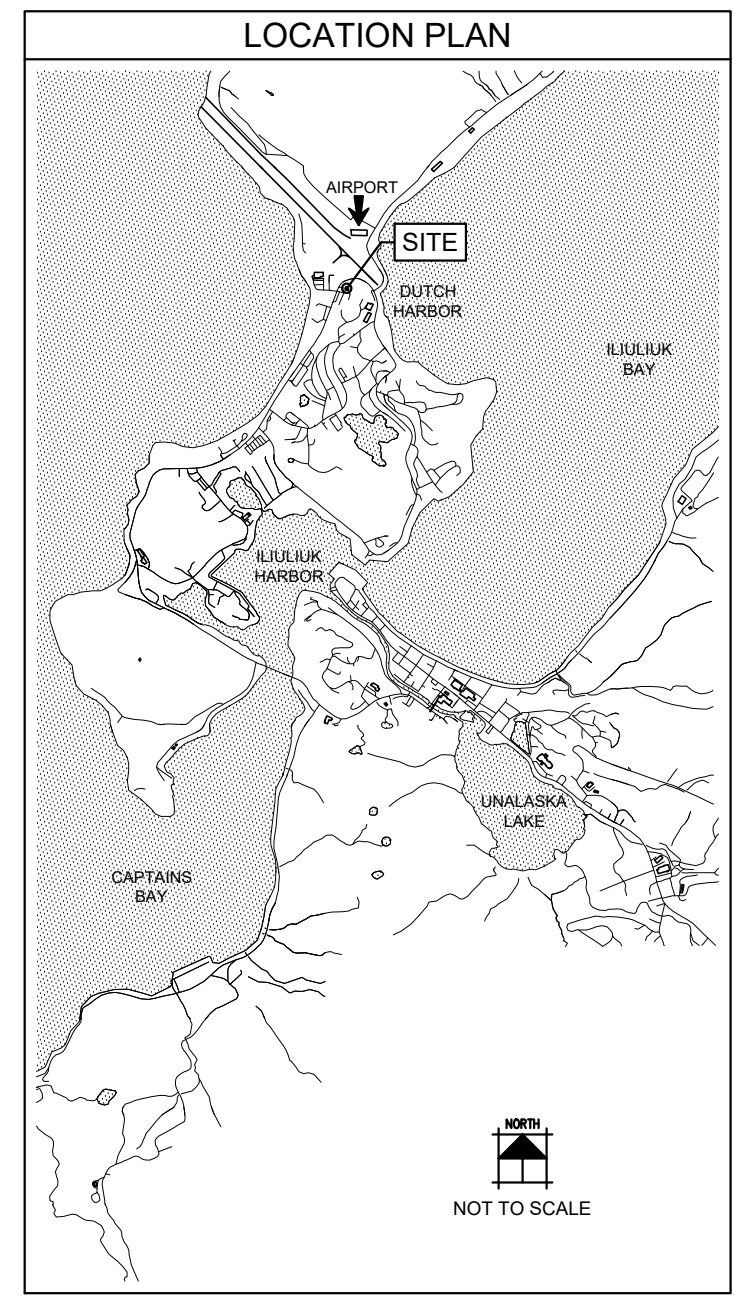
LEGEND	
	METAL ROOF Area: 3,900 SF

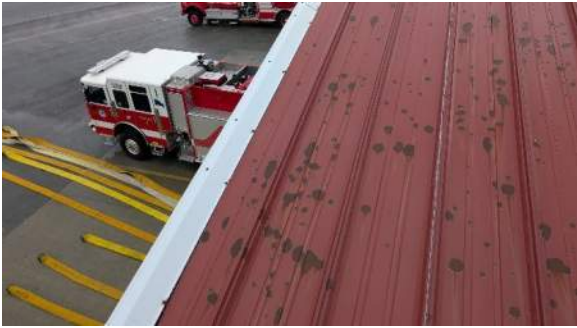
Photo #1: Large rust spots covering entire corrugated metal roof

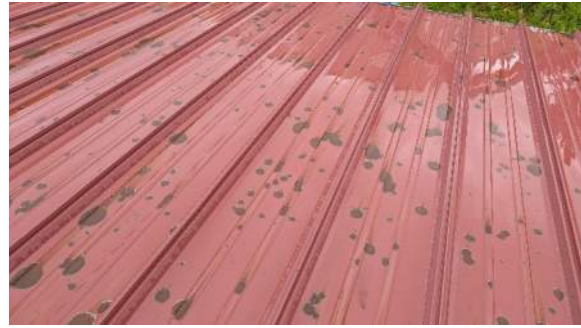
Photo #2: Large rust spots covering entire corrugated metal roof, continued

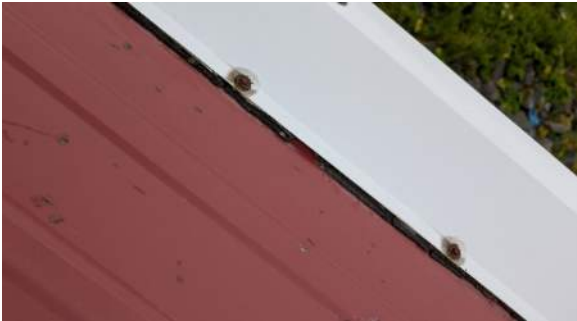
Photo #3: Exposed fasteners at panel laps

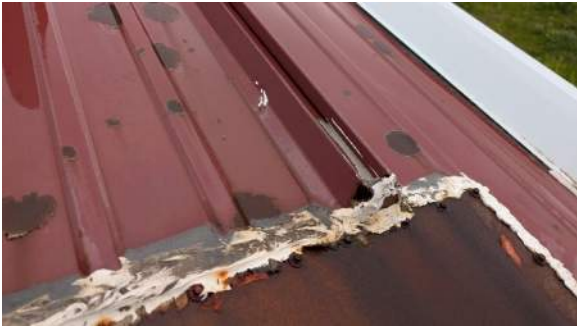
Photo #5: Rusted chimney hood and base, sealant starting to pull away

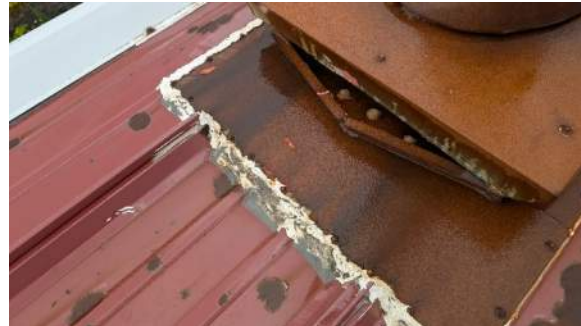
Photo #6: Rusted chimney hood and base, sealant starting to pull away, continued

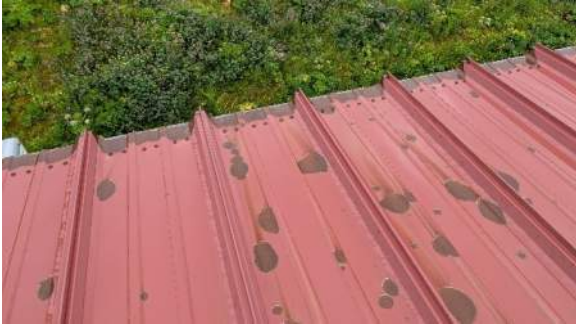
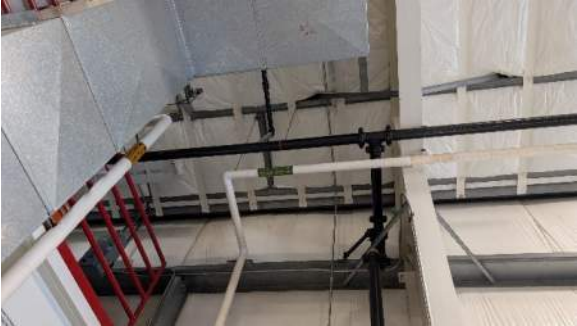
<p><i>Photo #7: Corrugated metal roof edge rusted back to first row of fasteners, both sides entire distance</i></p> <p><i>Photo #8: Observed roof leaking inside the building. South side, back of the building by structural framing. It was raining at the time of observation</i></p>

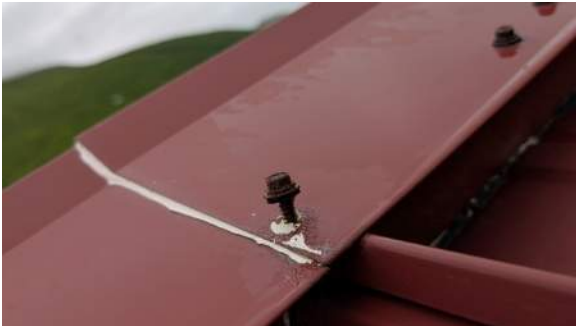
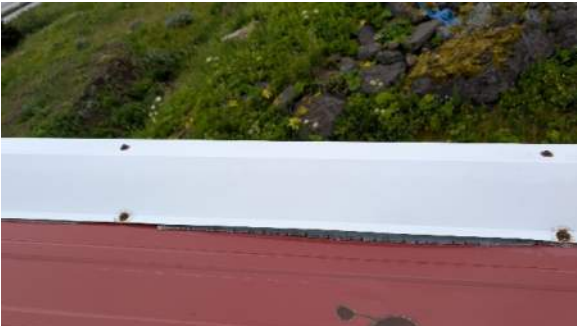
<p><i>Photo #9: Some gasketed hex head fasteners are backed out or not sealing properly</i></p> <p><i>Photo #10: Sealant along edge flashing is deteriorating and pulling away from surface</i></p>

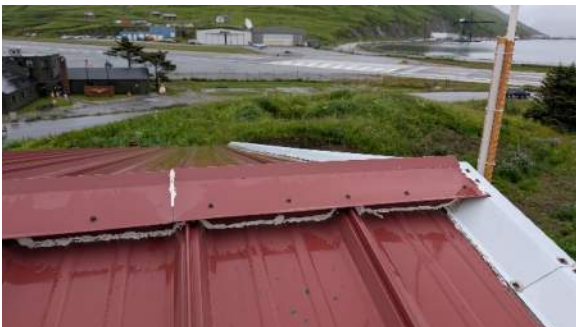
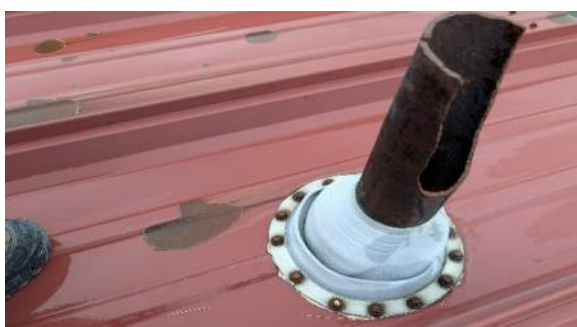
<p><i>Photo #11: Non-industry standard coping/flashing termination</i></p> <p><i>Photo #12: Broken soil vent pipe & incorrect termination of flashing</i></p>

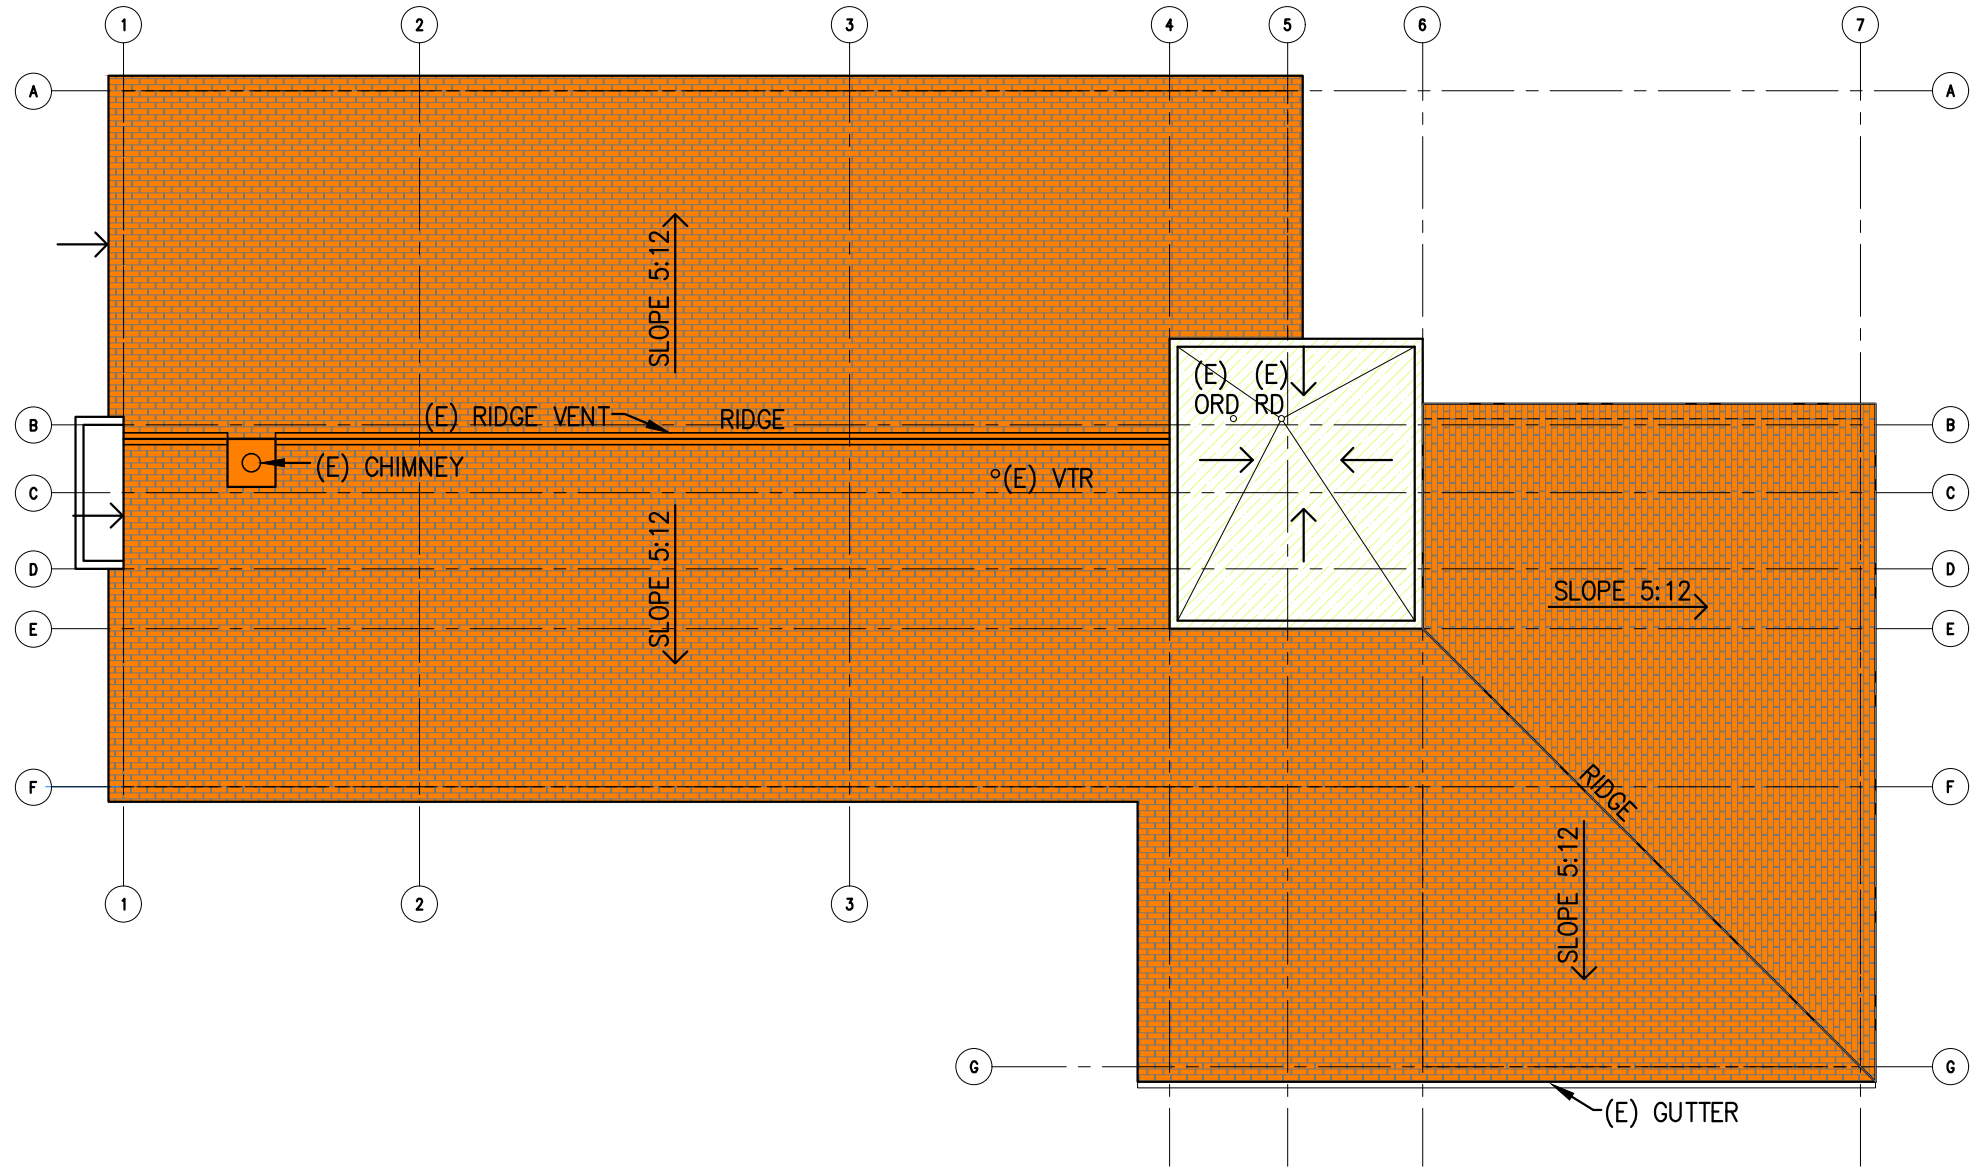
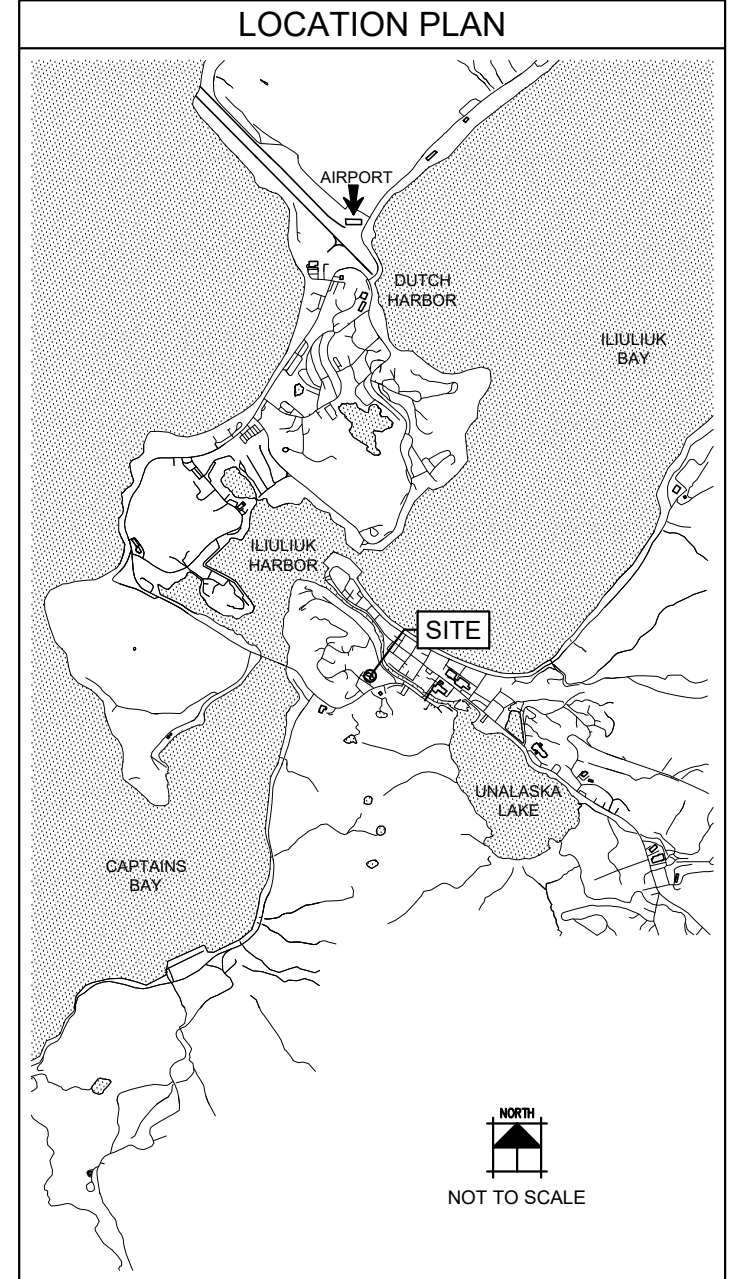
LEGEND	
	CEDAR SHINGLE Area: 8,700 SF
	EPDM ROOF Area: 600 SF

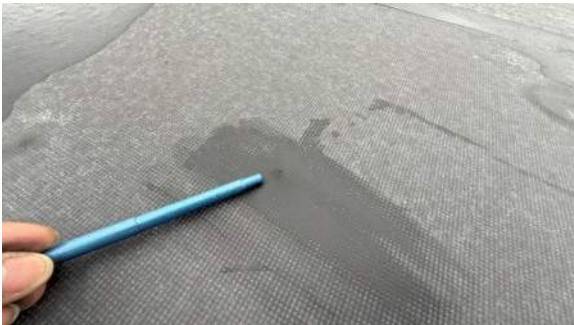
Photo #3: Protruding object under the membrane roof. High wear point, potential puncture hazard

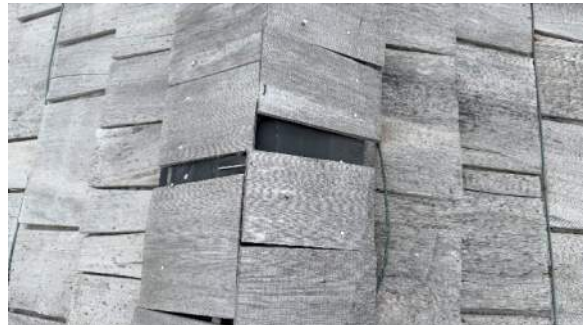
Photo #4: Cedar shakes at ridge broken or missing

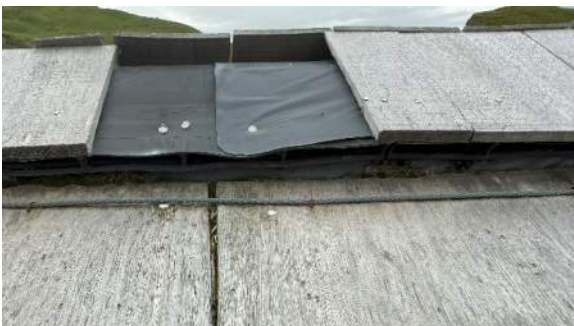
Photo #5: Cedar shakes on roof missing

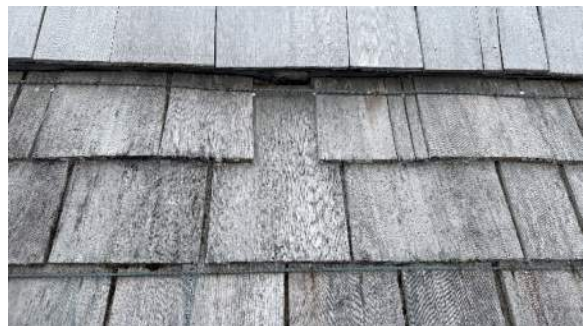
Photo #6: Cedar shakes on roof missing, continued

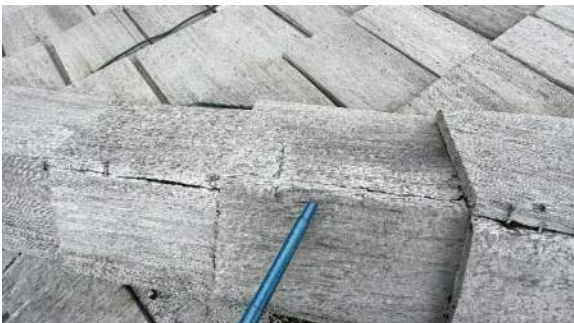
Photo #7: Cedar shakes on roof damaged

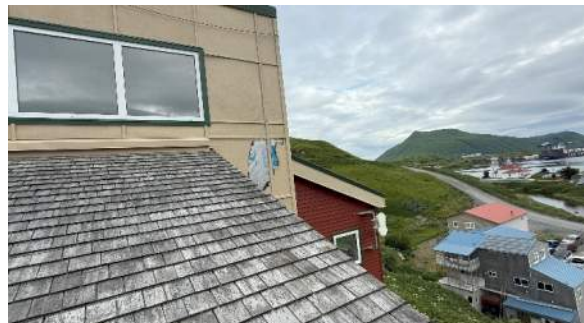
Photo #8: Section of exterior wall torn off

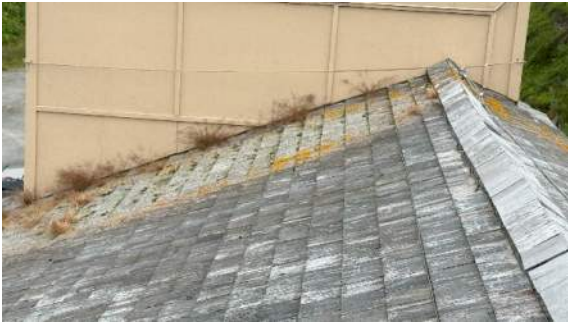
Photo #11: Lichen stains at shingle field

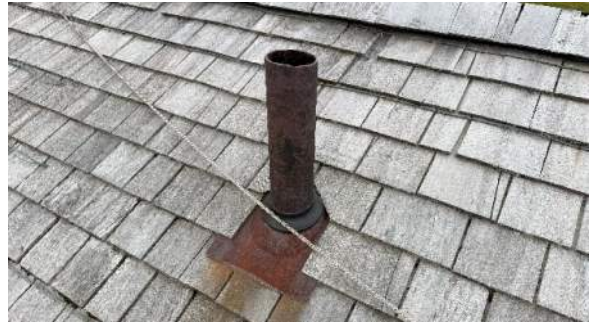
Photo #12: Deteriorated pipe flashing

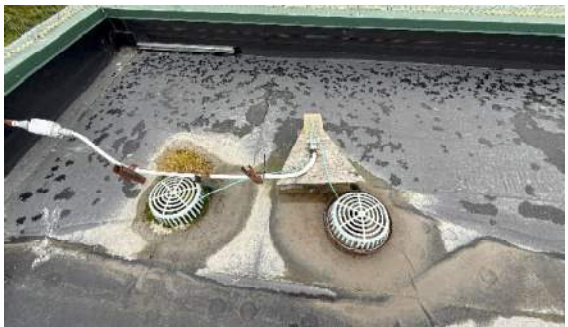
Photo #13: Hazardous conduit location

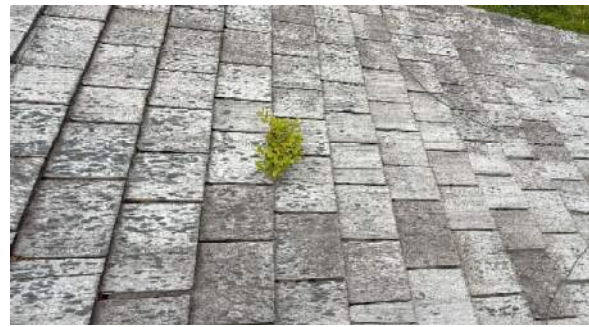
Photo #14: Grass and vegetation growing on cedar and membrane roofing, continued

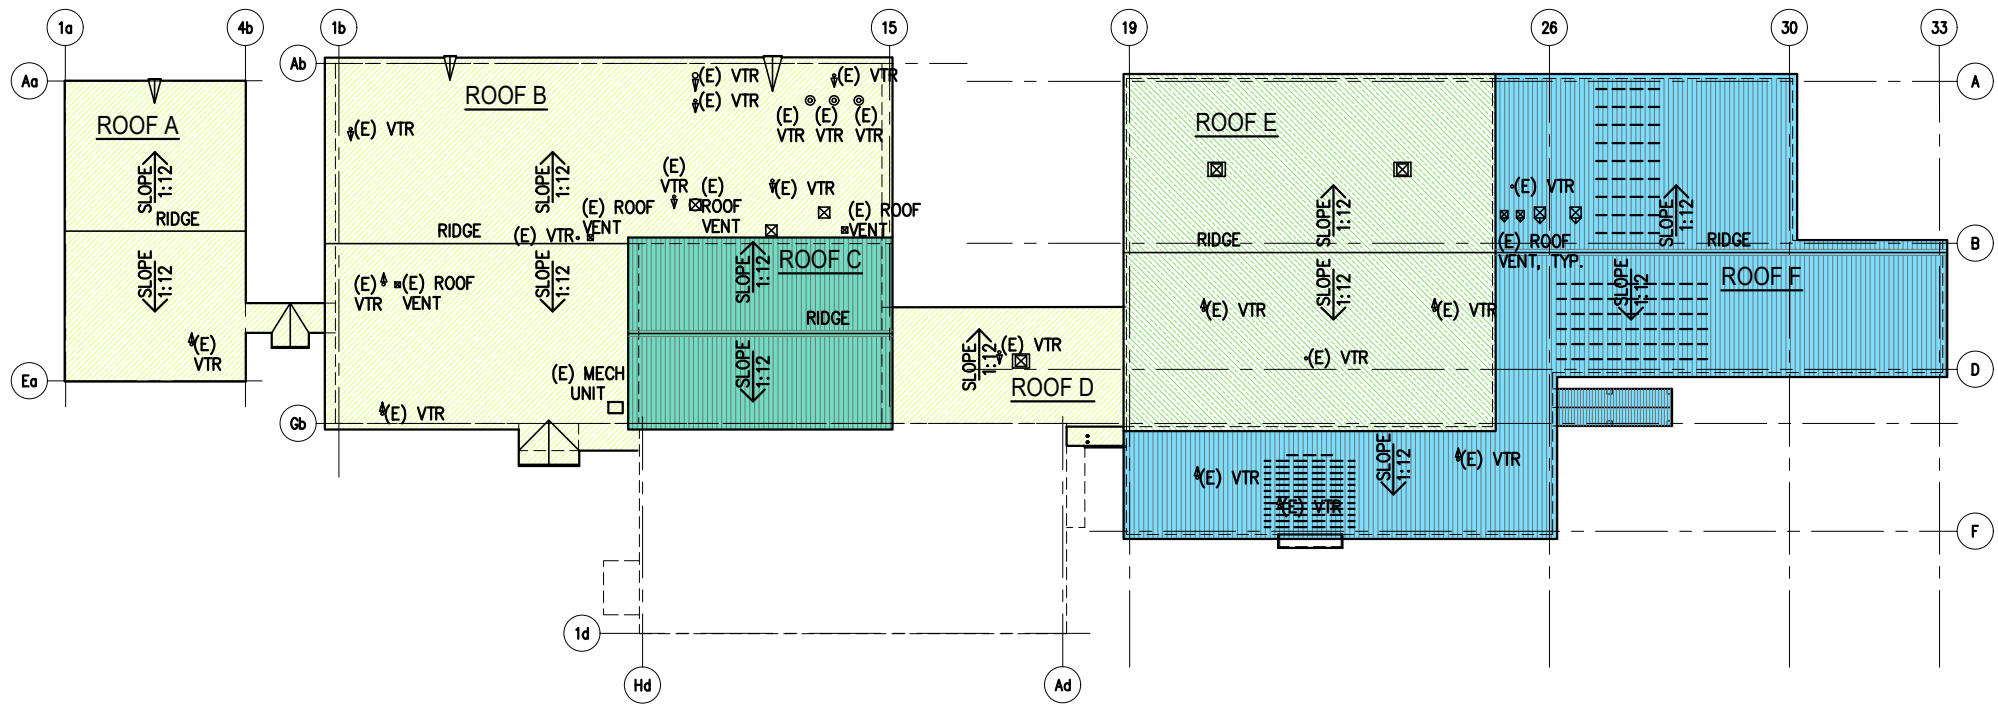
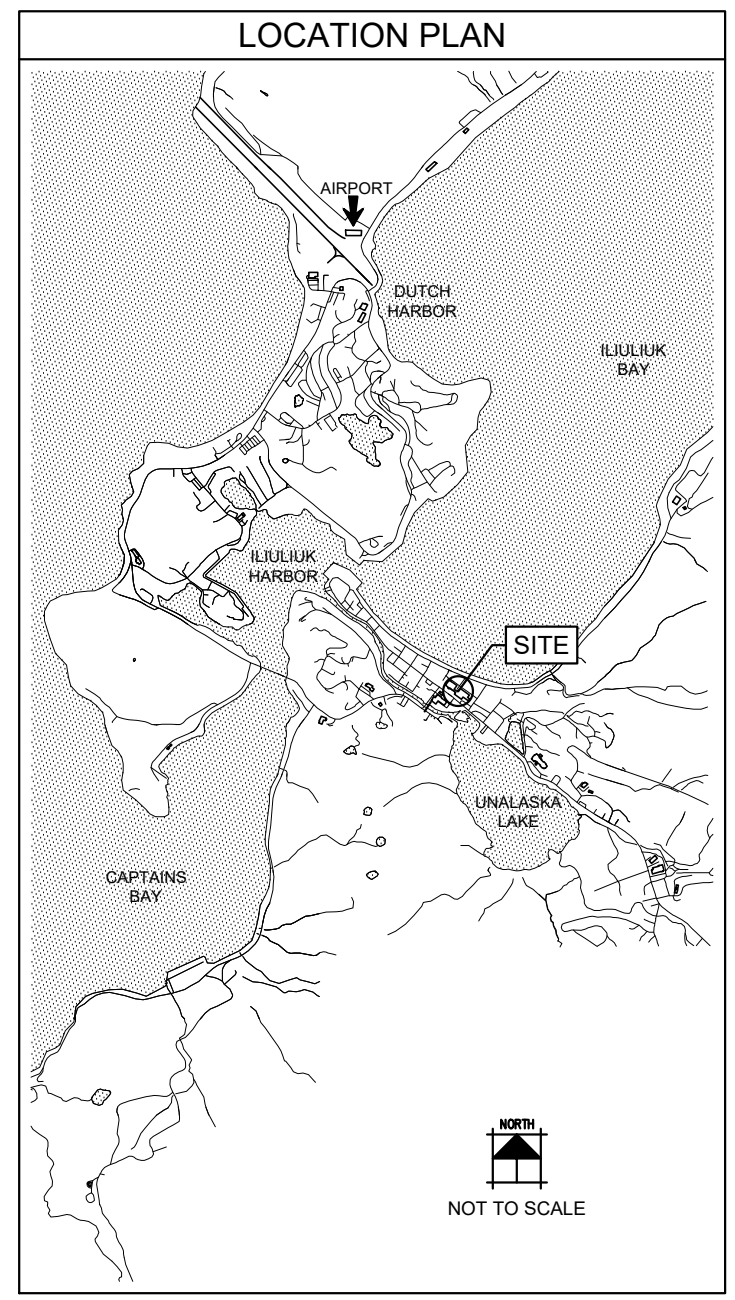
LEGEND	
	METAL ROOF C Area: 5,700 SF
	METAL ROOF F Area: 18,500 SF
	EPDM ROOF Area: 28,000 SF
	THERMOPLASTIC Area: 14,800 SF

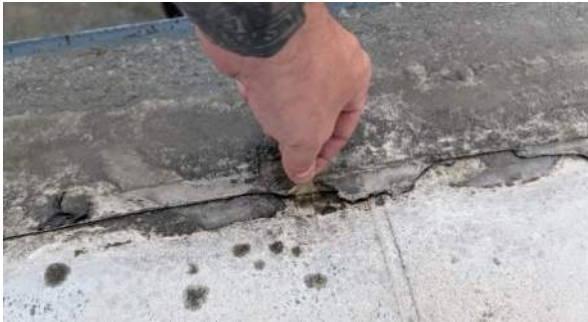
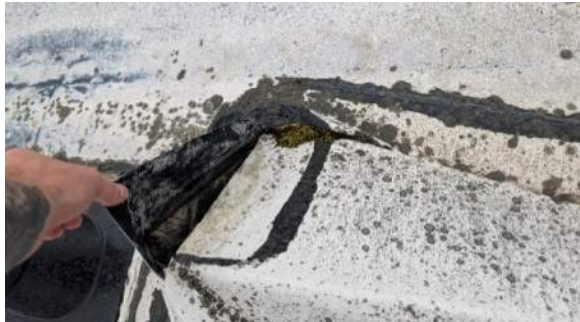
<p><i>Photo #19: Sealant is failing and has failed around roof penetrations, vents, and snow triangles, continued</i></p> <p><i>Photo #20: Sealant is failing and has failed around roof penetrations, vents, and snow triangles, continued</i></p>

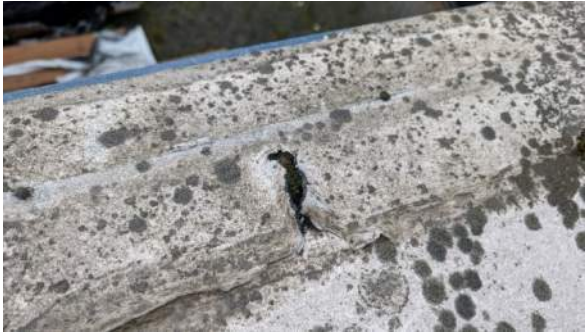
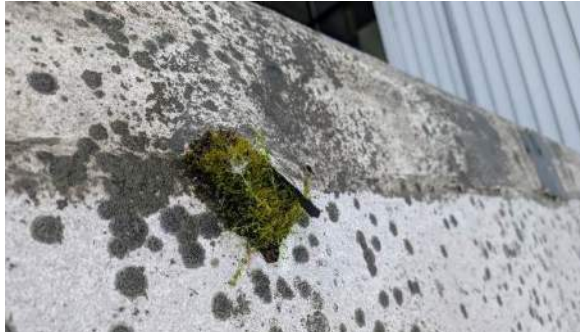
<p><i>Photo #21: Sealant is failing and has failed around roof penetrations, vents, and snow triangles, continued</i></p> <p><i>Photo #22: Sealant is failing and has failed around roof penetrations, vents, and snow triangles, continued</i></p>

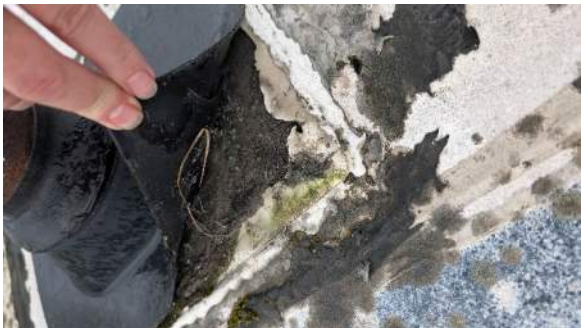
<p><i>Photo #23: Sealant is failing and has failed around roof penetrations, vents, and snow triangles, continued</i></p> <p><i>Photo #24: Holes in snow triangles</i></p>

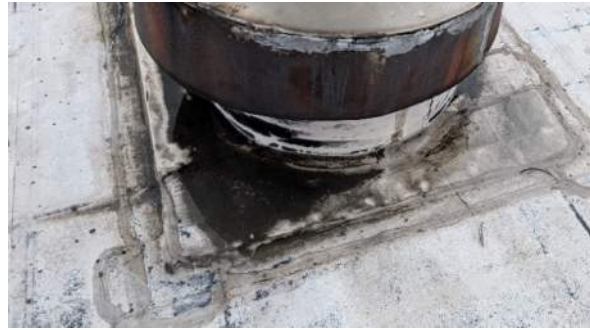
Photo #25: Sealant is failing and has failed around roof penetrations, vents, and snow triangles, continued

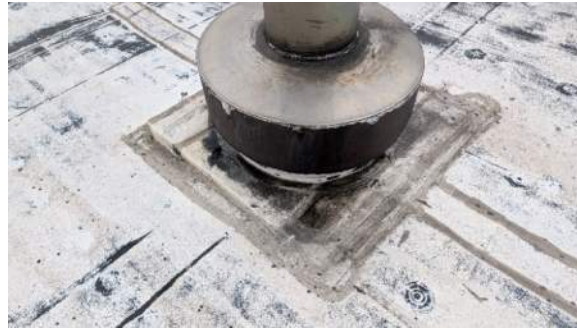
Photo #26: Sealant is failing and has failed around roof penetrations, vents, and snow triangles, continued

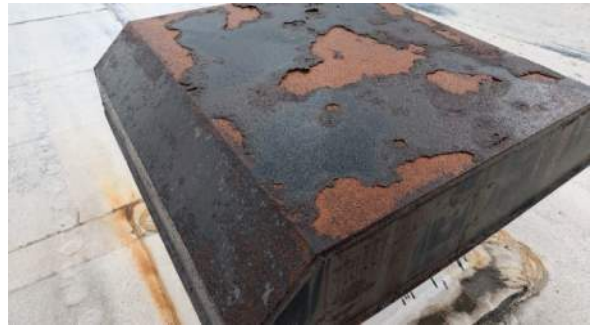
Photo #27: Exhaust hood is rusted

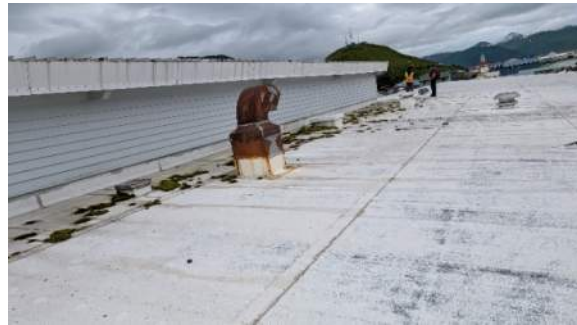
Photo #28: Exhaust hood is rusted, continued

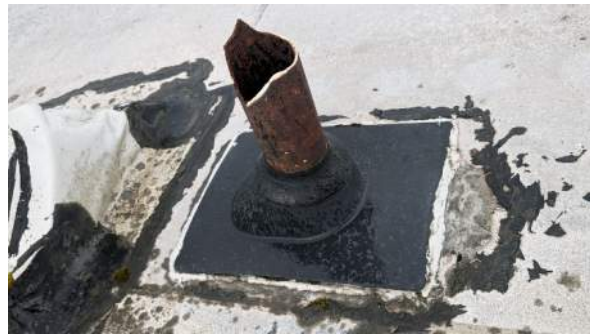
Photo #29: Boot at vent through roof sealant has failed and is pulling away. Steel pipe is also broken

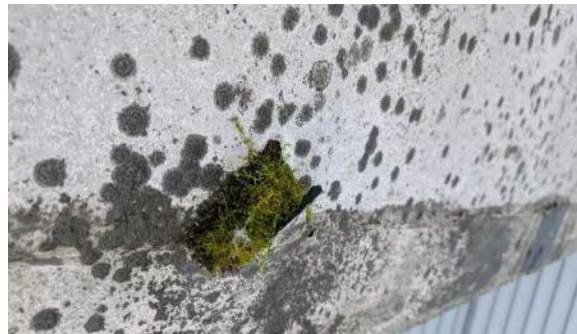
Photo #30: Moss and grass grow in the holes in the roof membrane

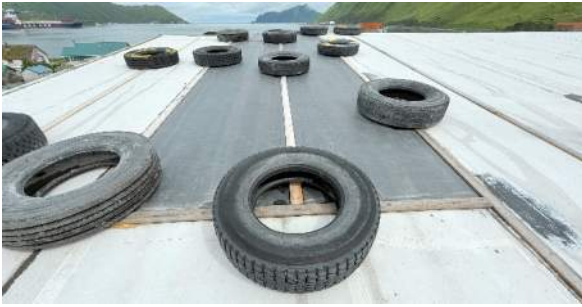
Photo #31: Area of Repair Weighted Down with Tires and Battens Surface Fastened

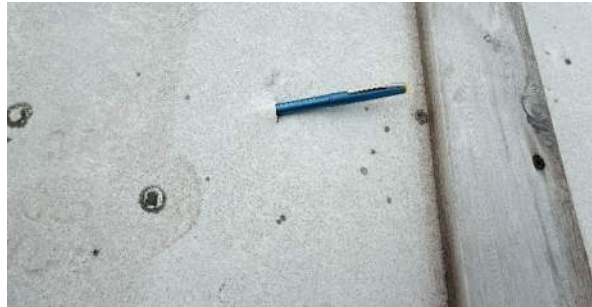
Photo #32: Holes in membrane

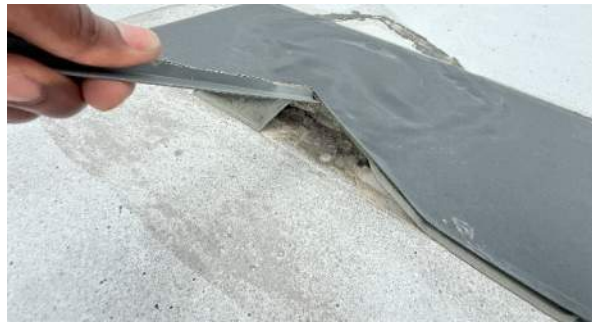
Photo #36: Roof patch has failed

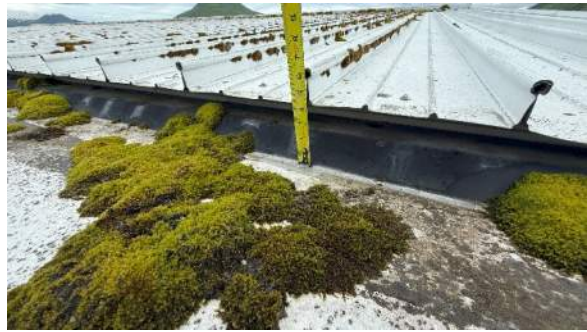
Photo #40: Degraded gasket

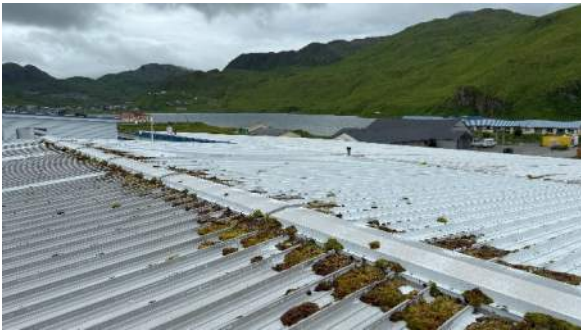
Photo #41: Moss at roof ridge

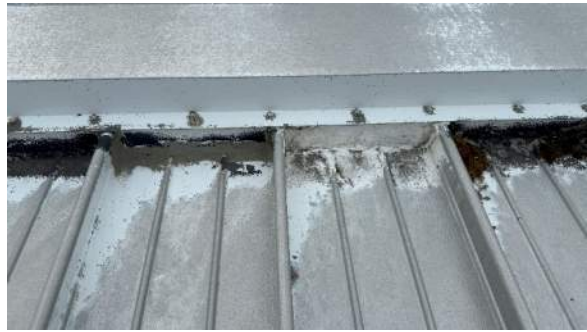
Photo #42: Previous repairs at roof closures

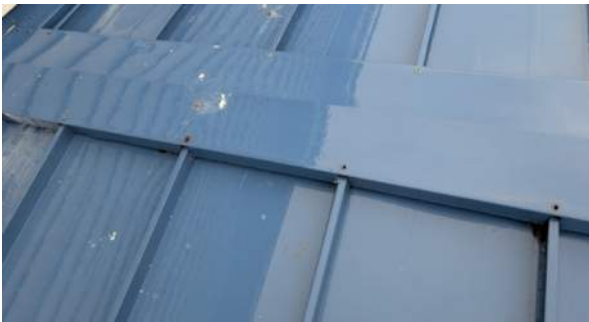
Photo #45: Missing fasteners on ridge flashing
