ATTACHMENT A

AGREEMENT FOR CONSULTING AND RELATED SERVICES

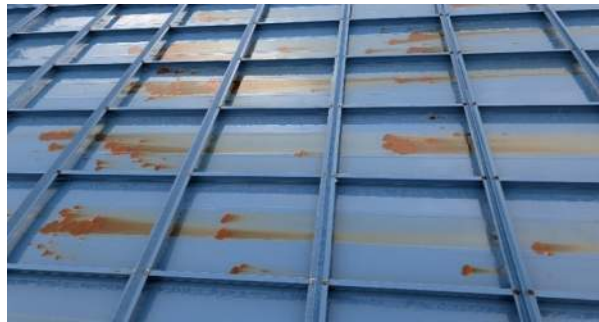
Photo #46: Rust spots all over metal roofing

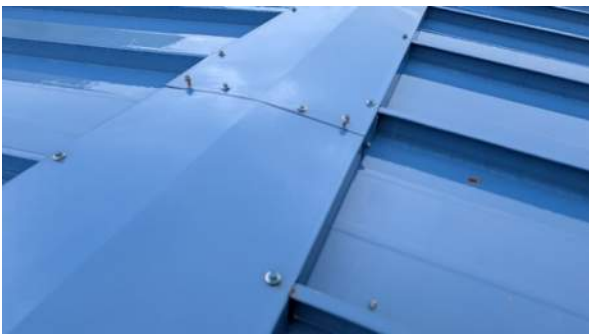
Photo #47: Areas on roof where screws are missing, backed out or have been torn out

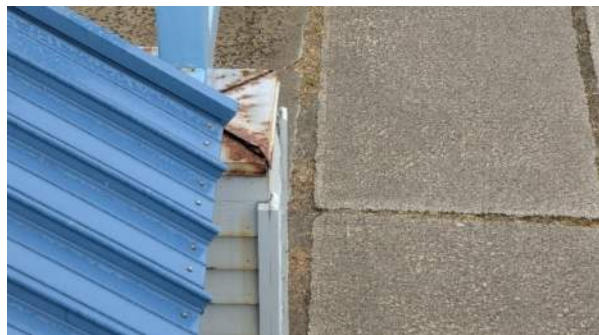
Photo #48: Coping on plinth near back door is rusting out

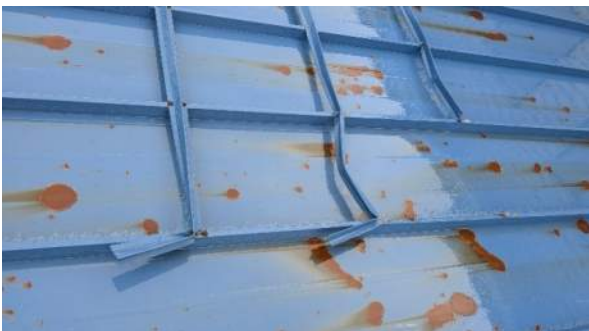
Photo #49: Snow guard bent or broken

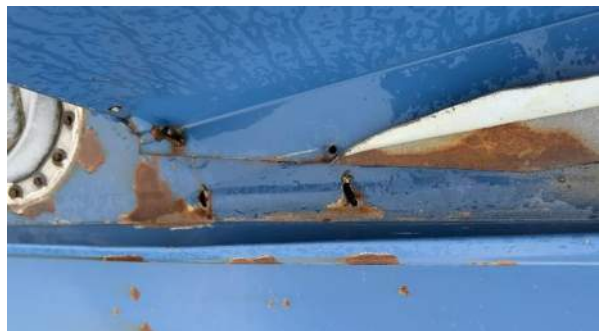
Photo #50: Fasteners torn out of metal roofing

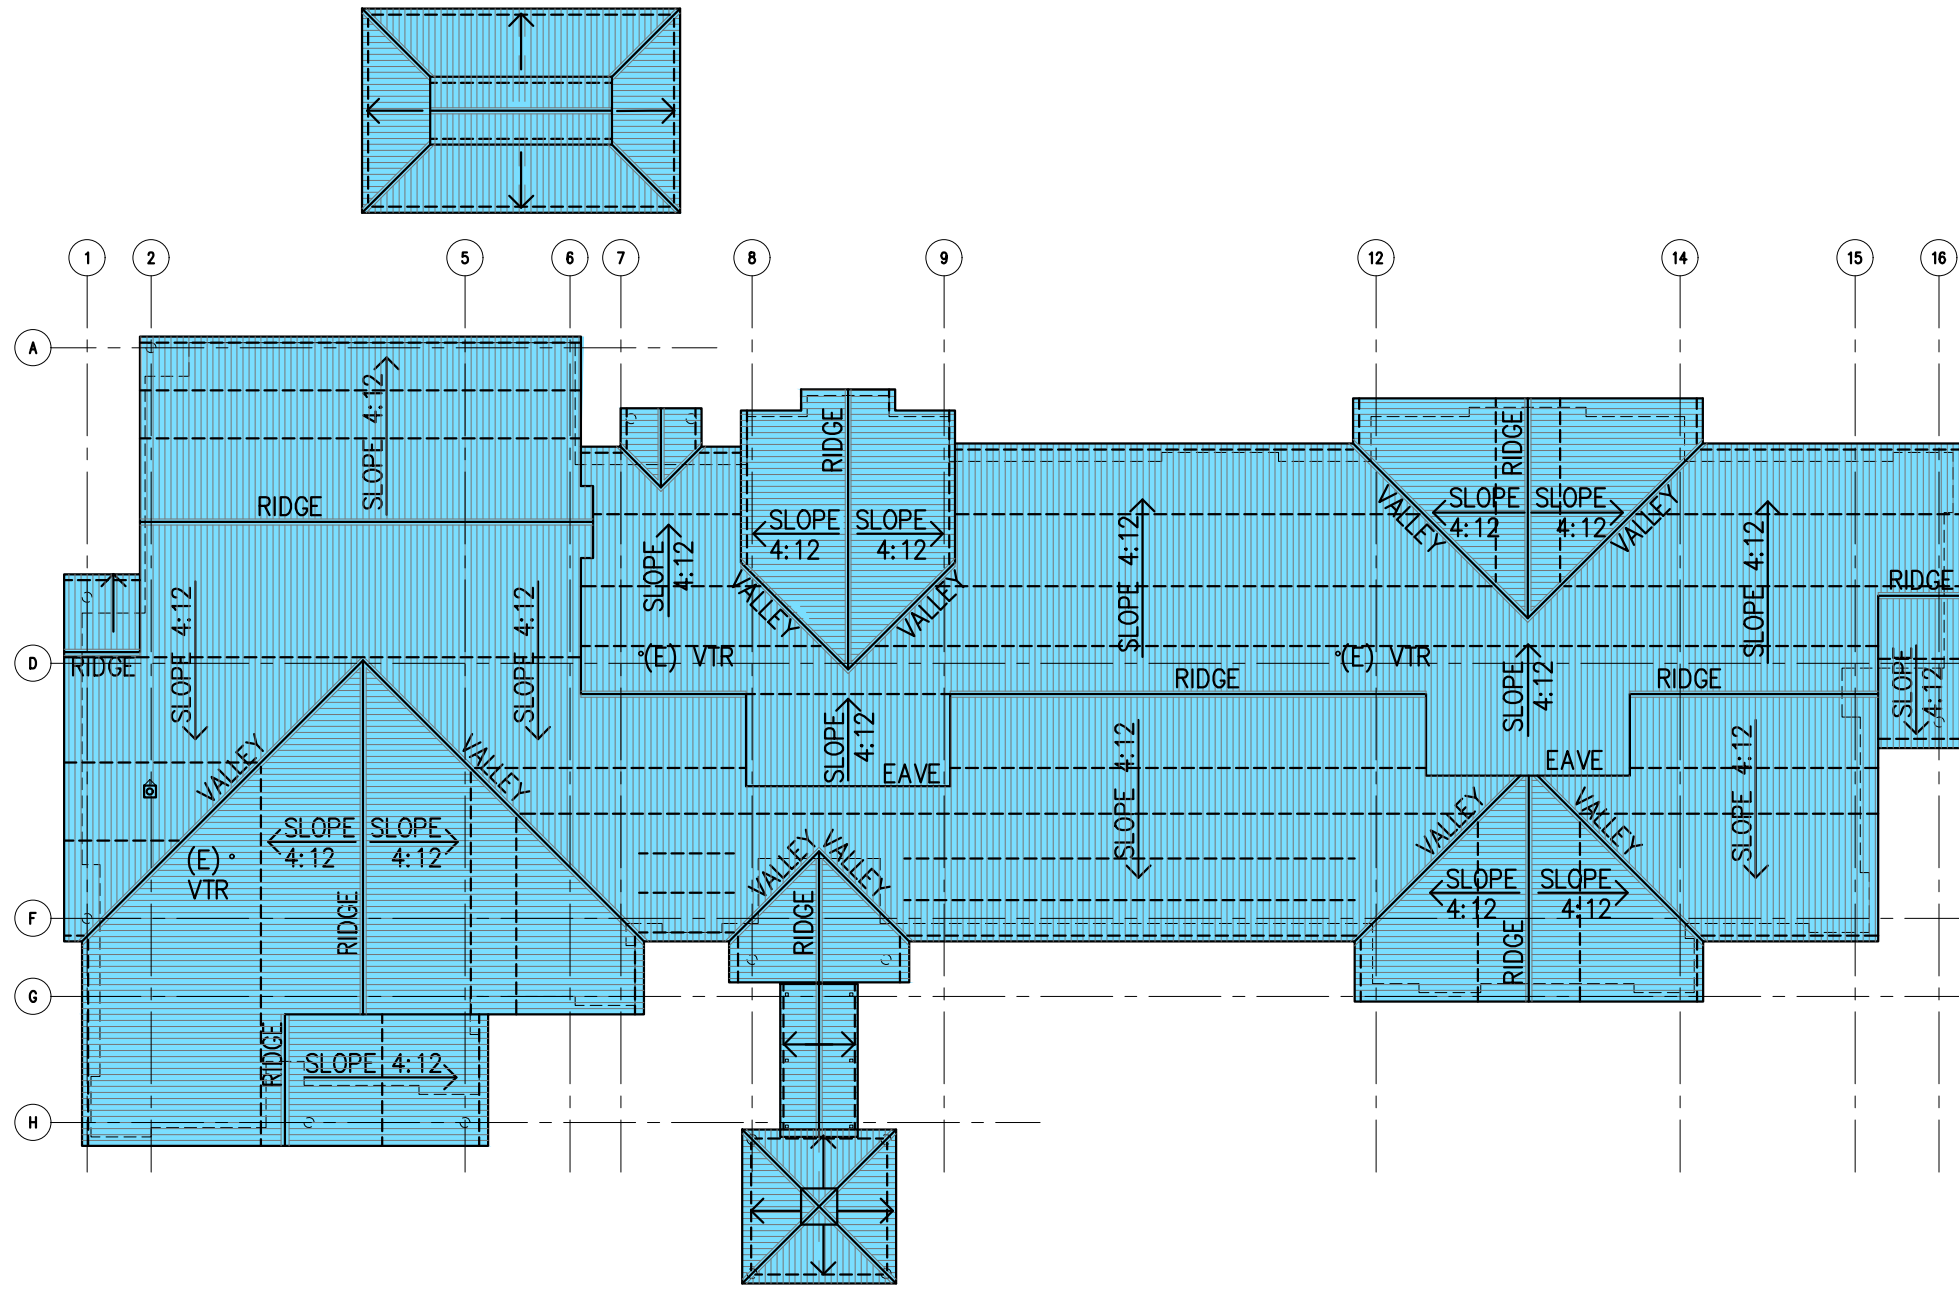
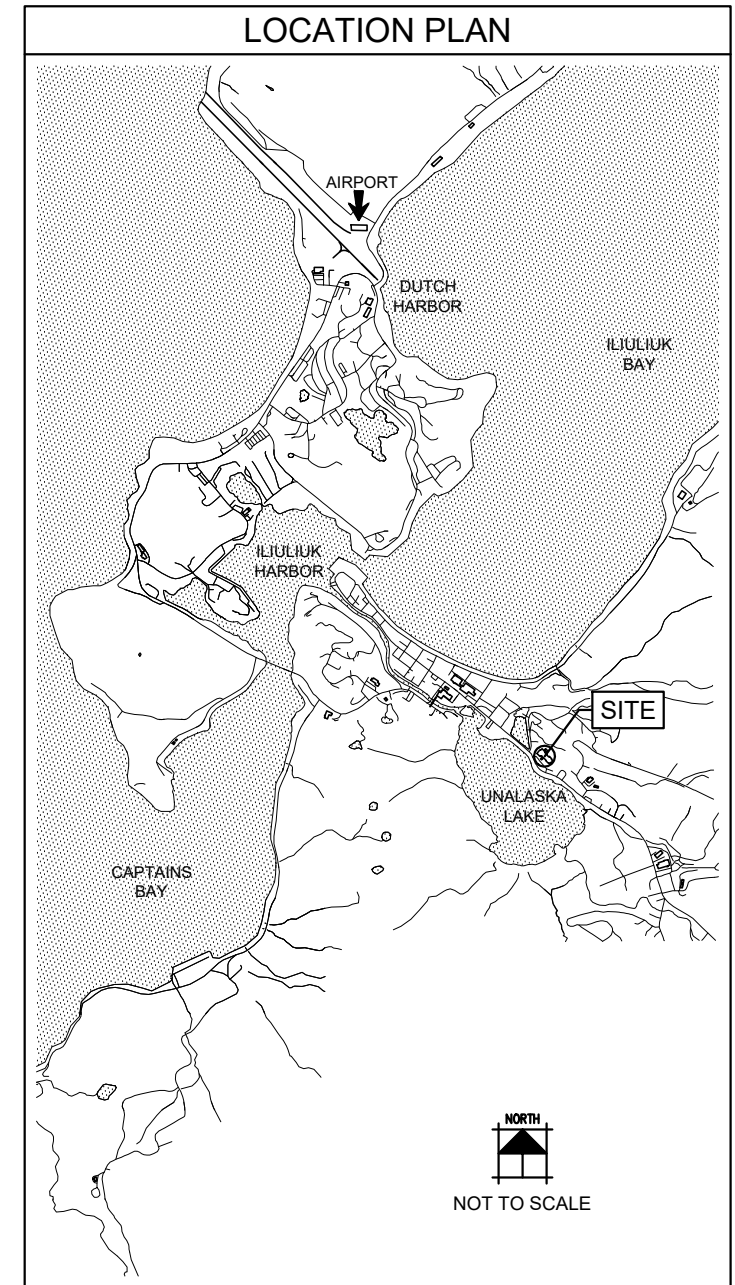
September 22, 2025 - 1:02 PM - BECKY - O:\GOVERNMENT\UNALASKA\3_DRAWINGS\00_AR SHEETS - REPORT\AR-5_EAGLE VIEW ES.DWG

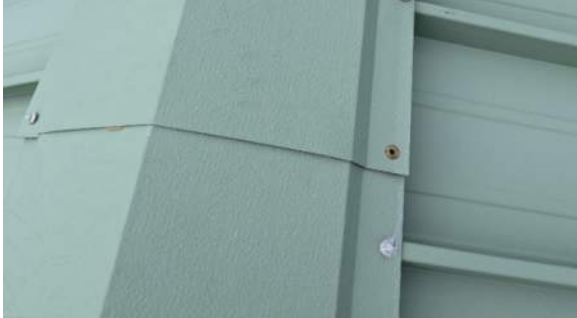
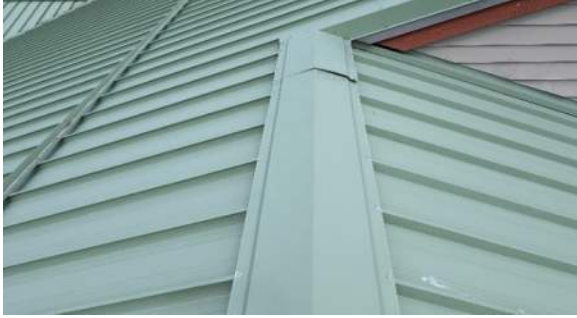
<p><i>Photo #1: Missing fasteners on ridge flashing</i></p> <p><i>Photo #2: Missing fasteners on ridge flashing, continued</i></p>

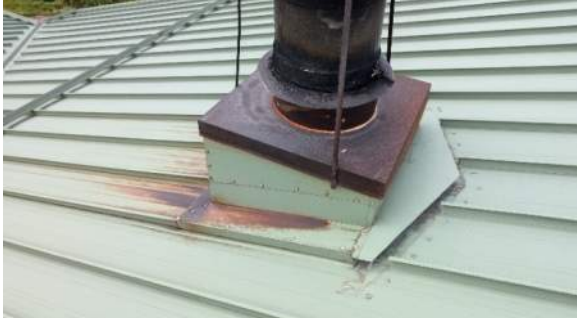
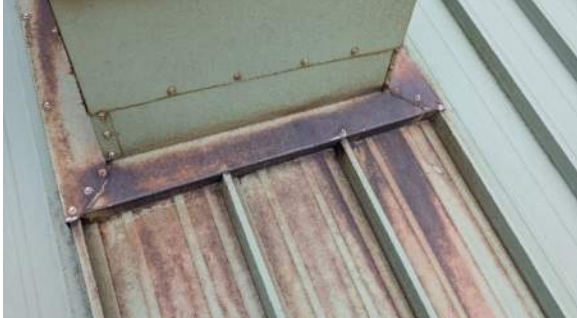
<p><i>Photo #3: Hot stack cap flashing rusting and starting to degrade</i></p> <p><i>Photo #4: Hot stack cap flashing rusting and starting to degrade, continued</i></p>

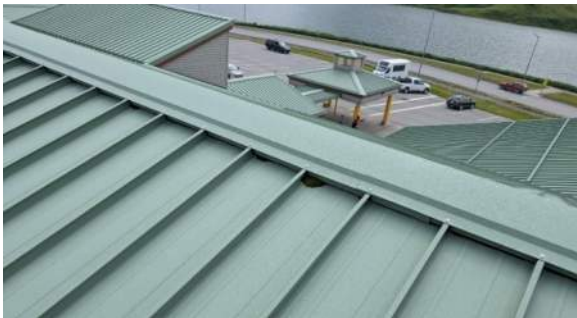
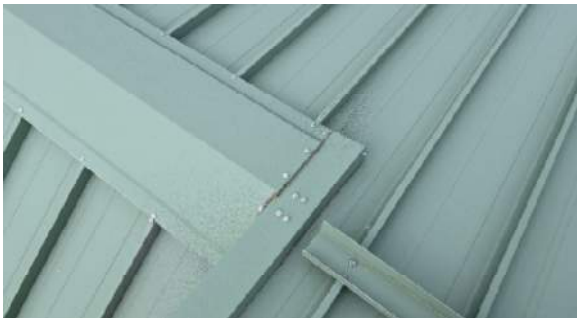
<p><i>Photo #5: Moss growing on the roof in places</i></p> <p><i>Photo #6: Sealant at ridge transition is starting to degrade</i></p>

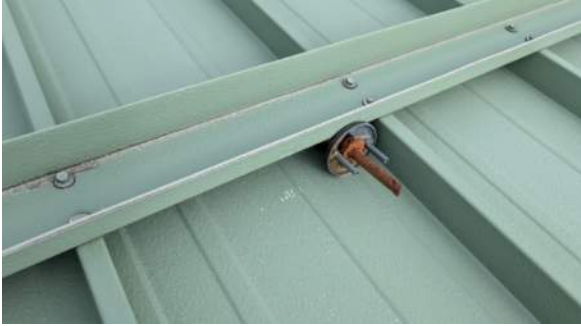
Photo #7: Rusty doorknob on roof. Removed.

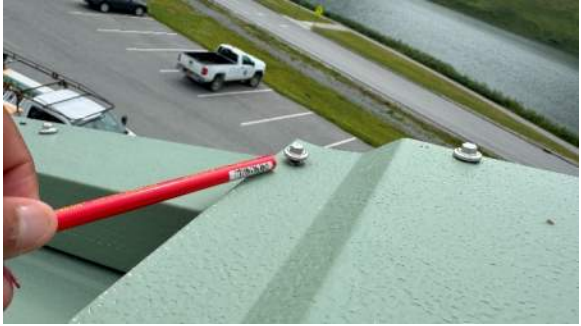
Photo #8: Hex head fasteners have backed out or are not installed properly. Locations include: valleys, ridges, and edge flashings

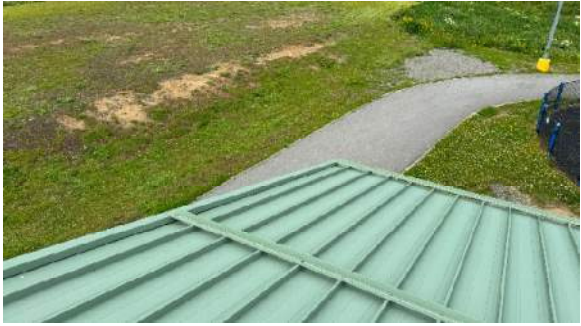
Photo #12: Roof rake/eave

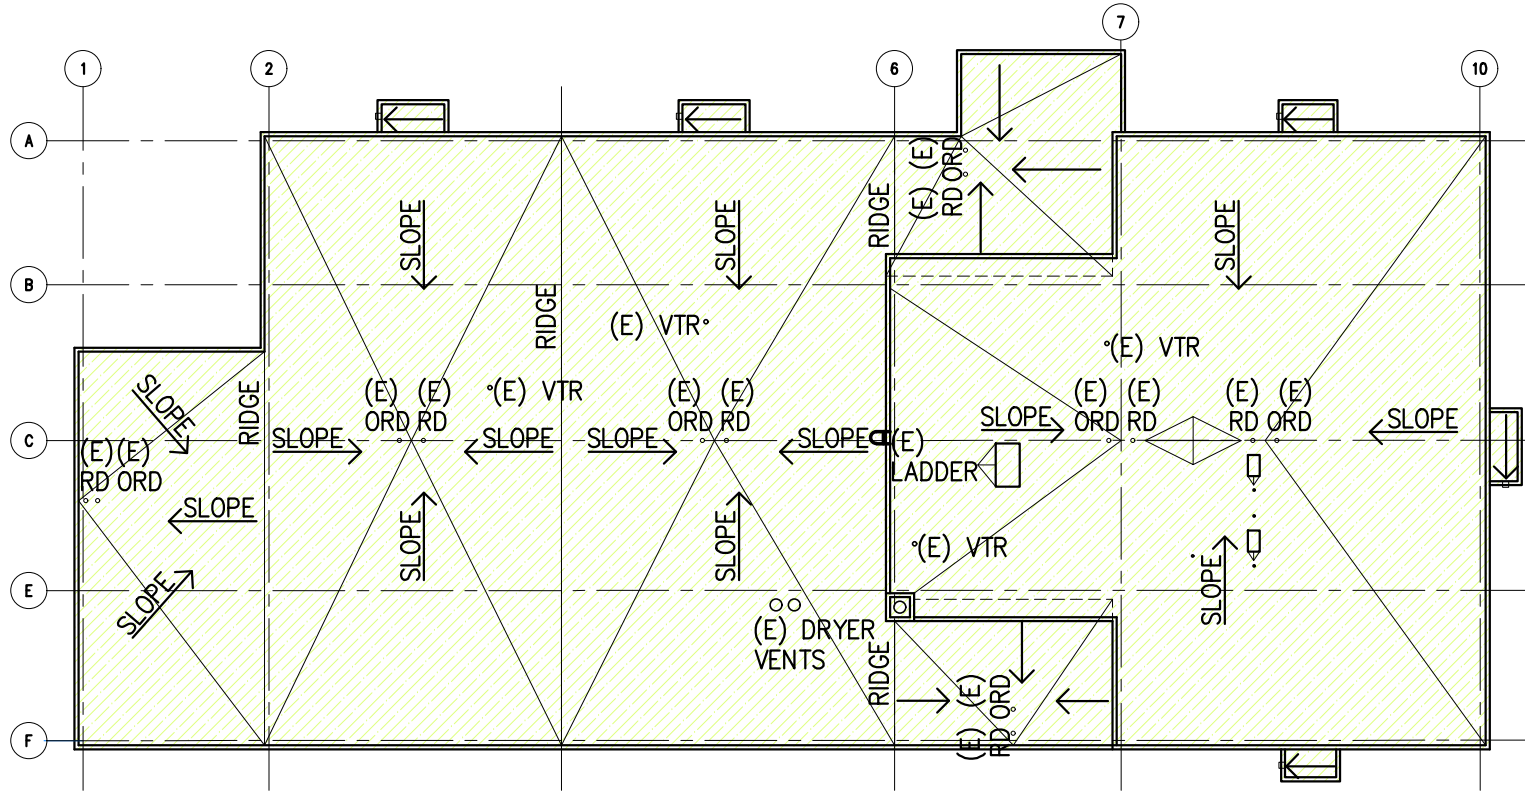
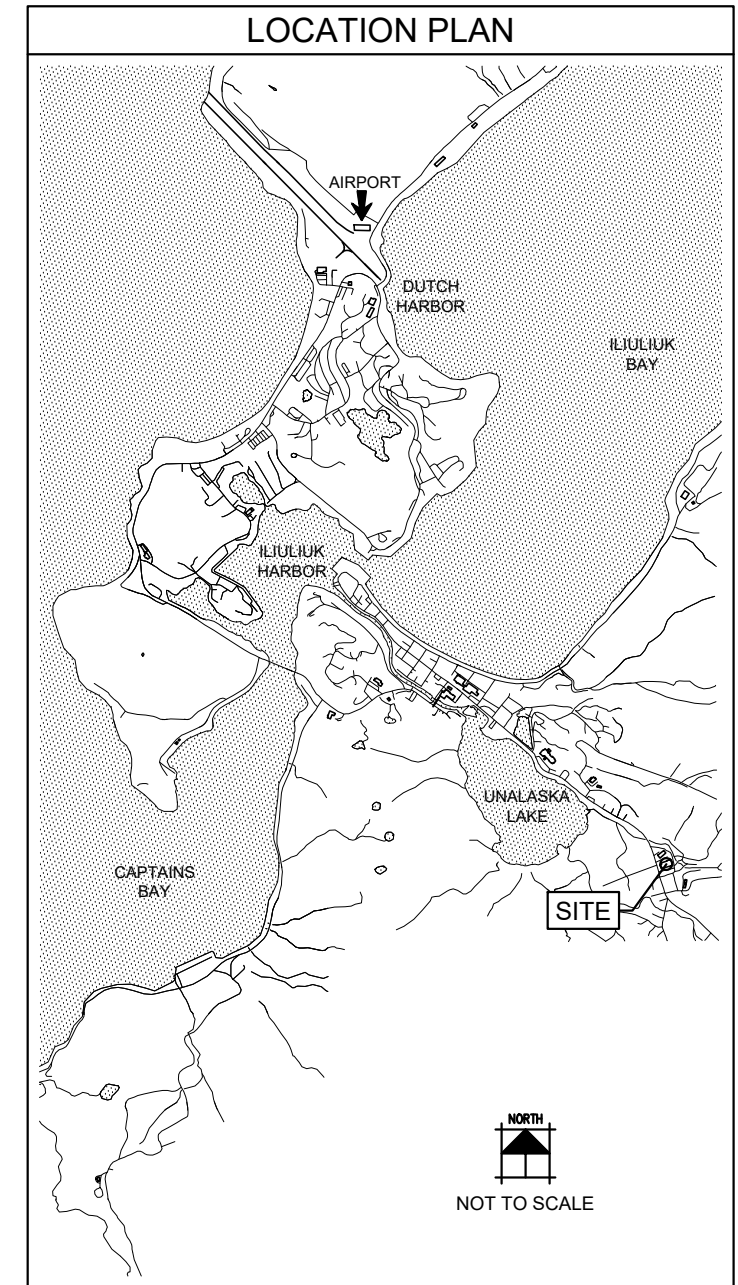
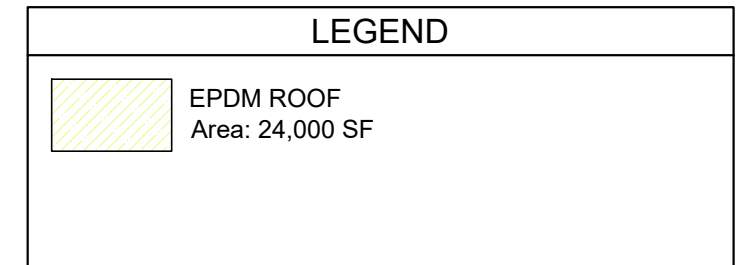
General Assessment	The existing EPDM membrane roof is in <u>fair</u> condition with some signs of degradation. With an overlay roof system enacted, the roof system should be extended 20+ years.
Recommendation	<p>Provide a maintenance project with the following scope of work -</p> <ol style="list-style-type: none"> 1. Clean the roof 2. Install a coverboard 3. Install an EPDM fleece back membrane in asphaltic adhesive (hot asphalt)
Estimated Cost of Repair & Budget	<p>Roof Area:</p> <p>EPDM Roof Recover Budget: 24,000 sf X \$65.00/sf = \$1,560,000.00</p>

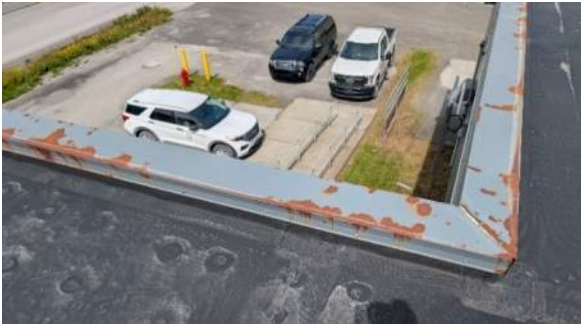
Photo #1: Coping rusting. Largely at connections and lapping.

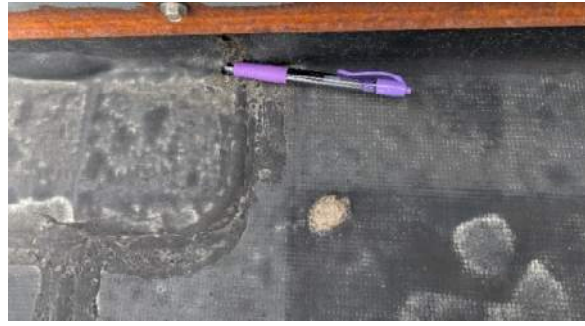
Photo #2: Roof membrane patched in multiple spots. Some have started to peel away.

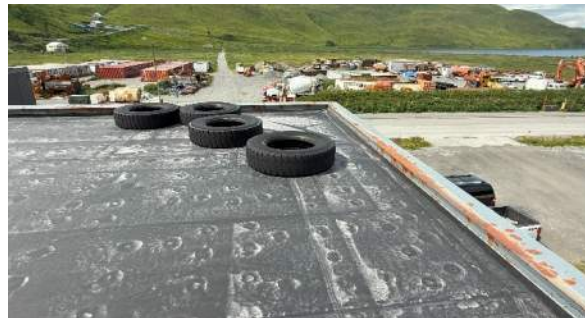
Photo #6: Perimeter membrane failure at roof corner. Weighted down with tires.

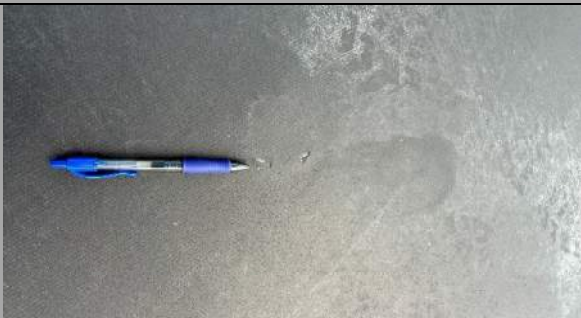
Photo #5: Hole in membrane

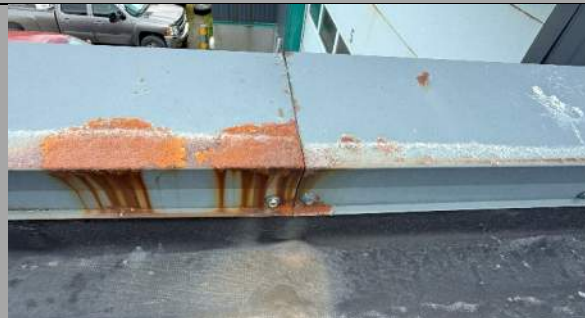
Photo #6: Corrosion at coping

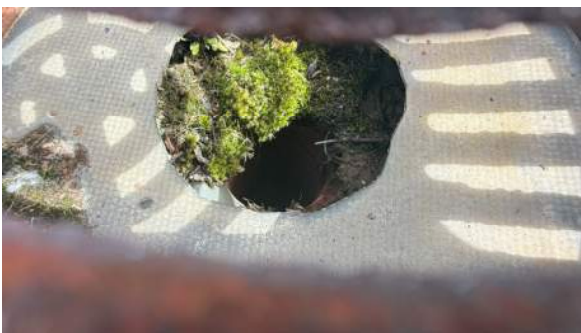
<p><i>Photo #11: Moss growing inside roof drains.</i></p>	<p><i>Photo #12: Roof membrane thinning out, scrim starting to show.</i></p>

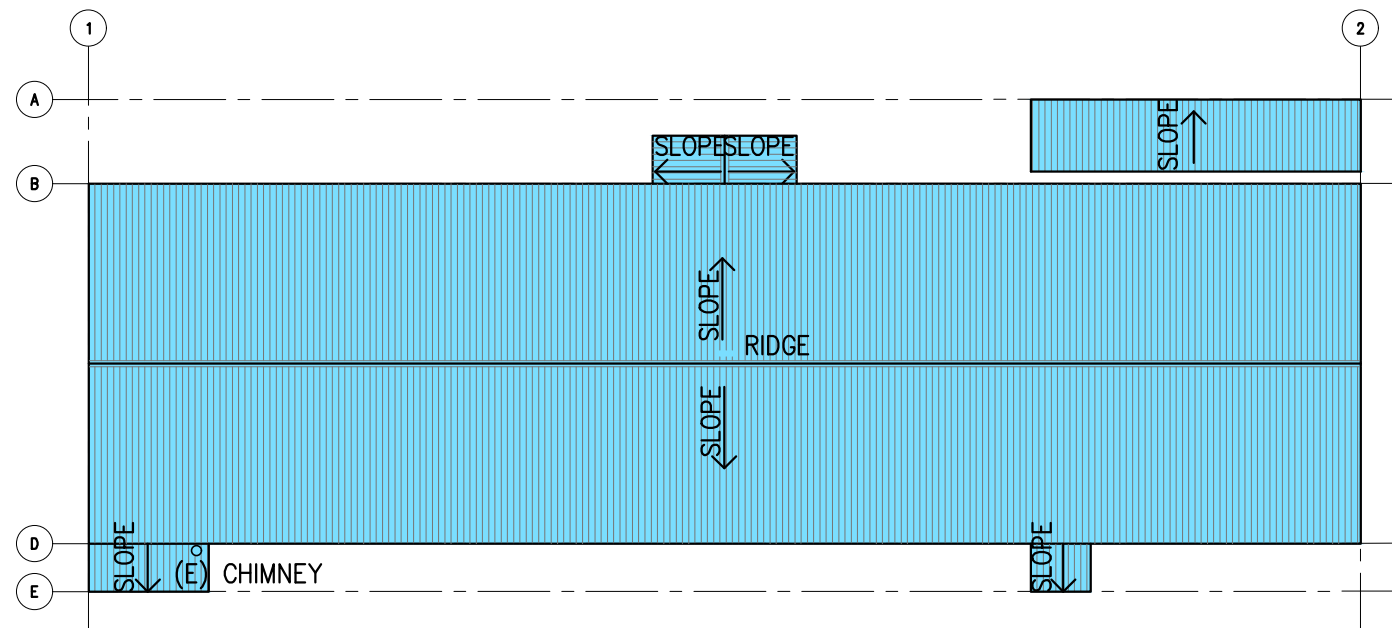
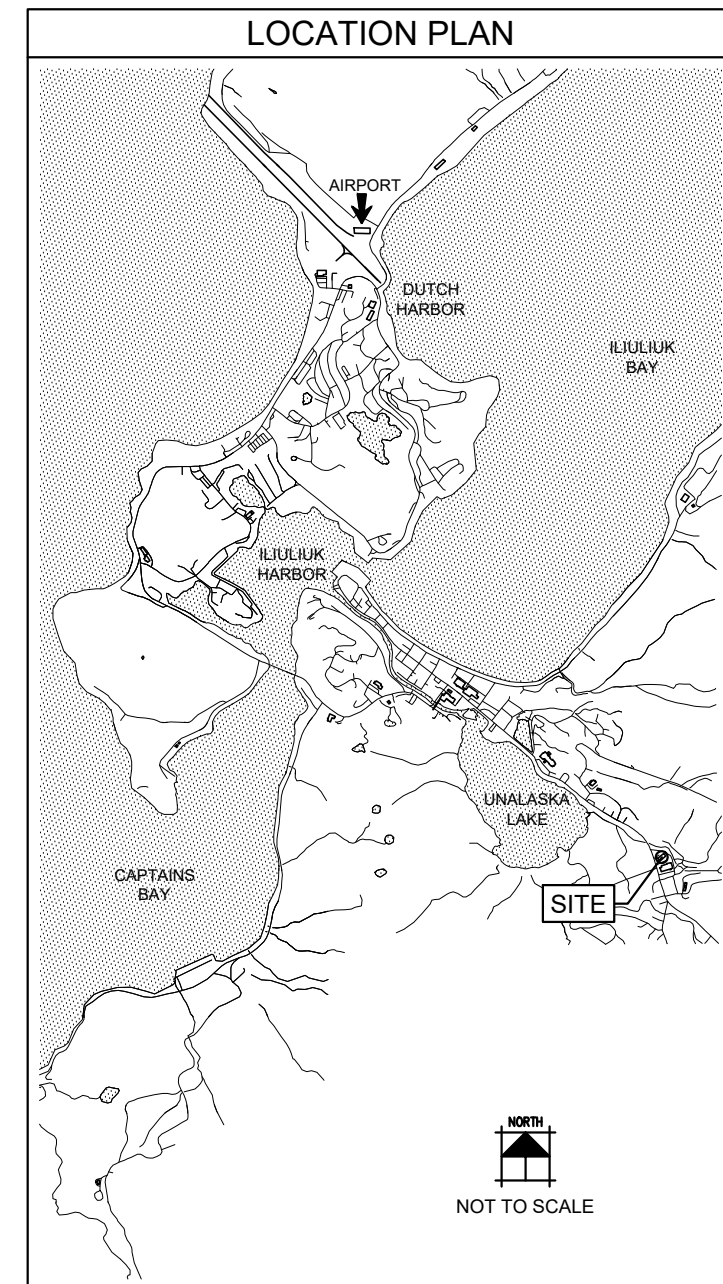
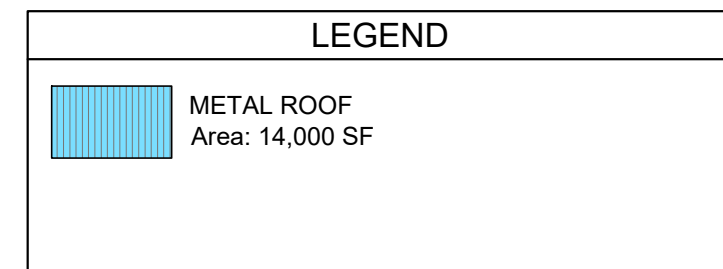
BUILDING ADDRESS
 995 E. Broadway Avenue
 Unalaska, AK 99685

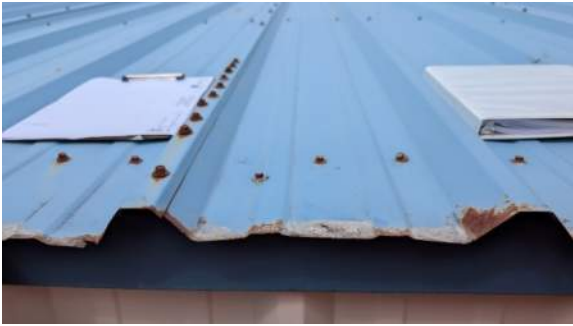
Photo #1: Metal roof edge is rusting and weakening.

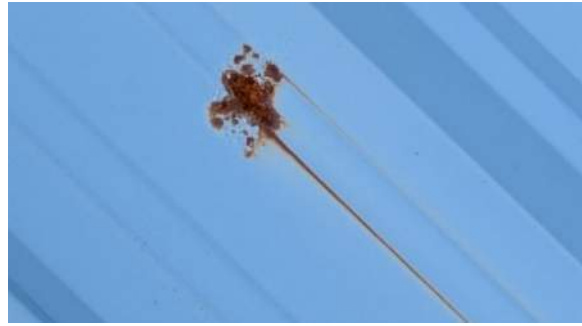
Photo #2: Portions of the metal roofing have severe rust spots causing holes.

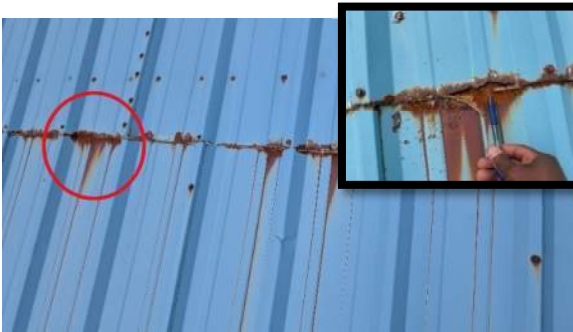
Photo #3: Edges where corrugated sheets overlap have rusted away. Sealant at these locations is attached to nothing at this point.

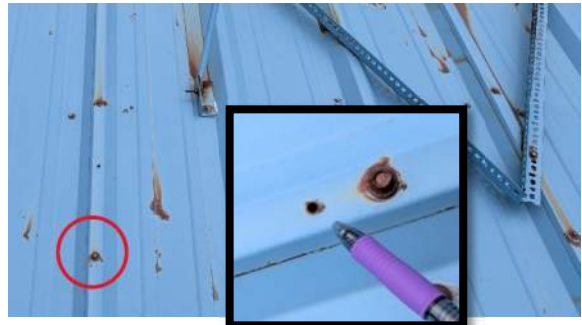
Photo #4: Fasteners are missing in multiple spots, leaving holes in the roofing.

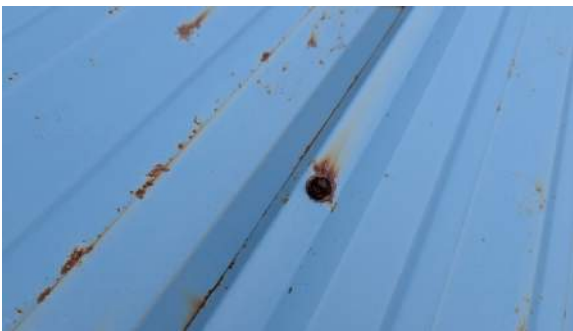
Photo #5: Hex head fasteners in the standing seams are rusted. Gaskets are either missing or cracked.

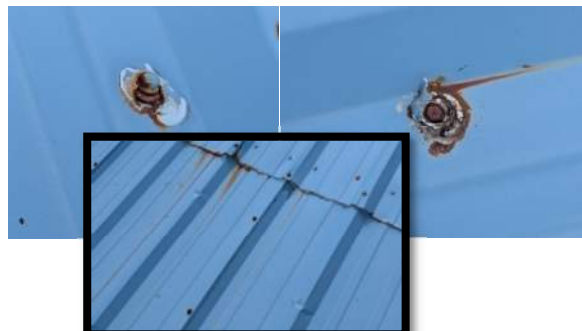
Photo #6: Top: Fasteners that have been caulked over are peeling away due to fasteners rusting. Bottom: Portions of roof are bent and damaged.

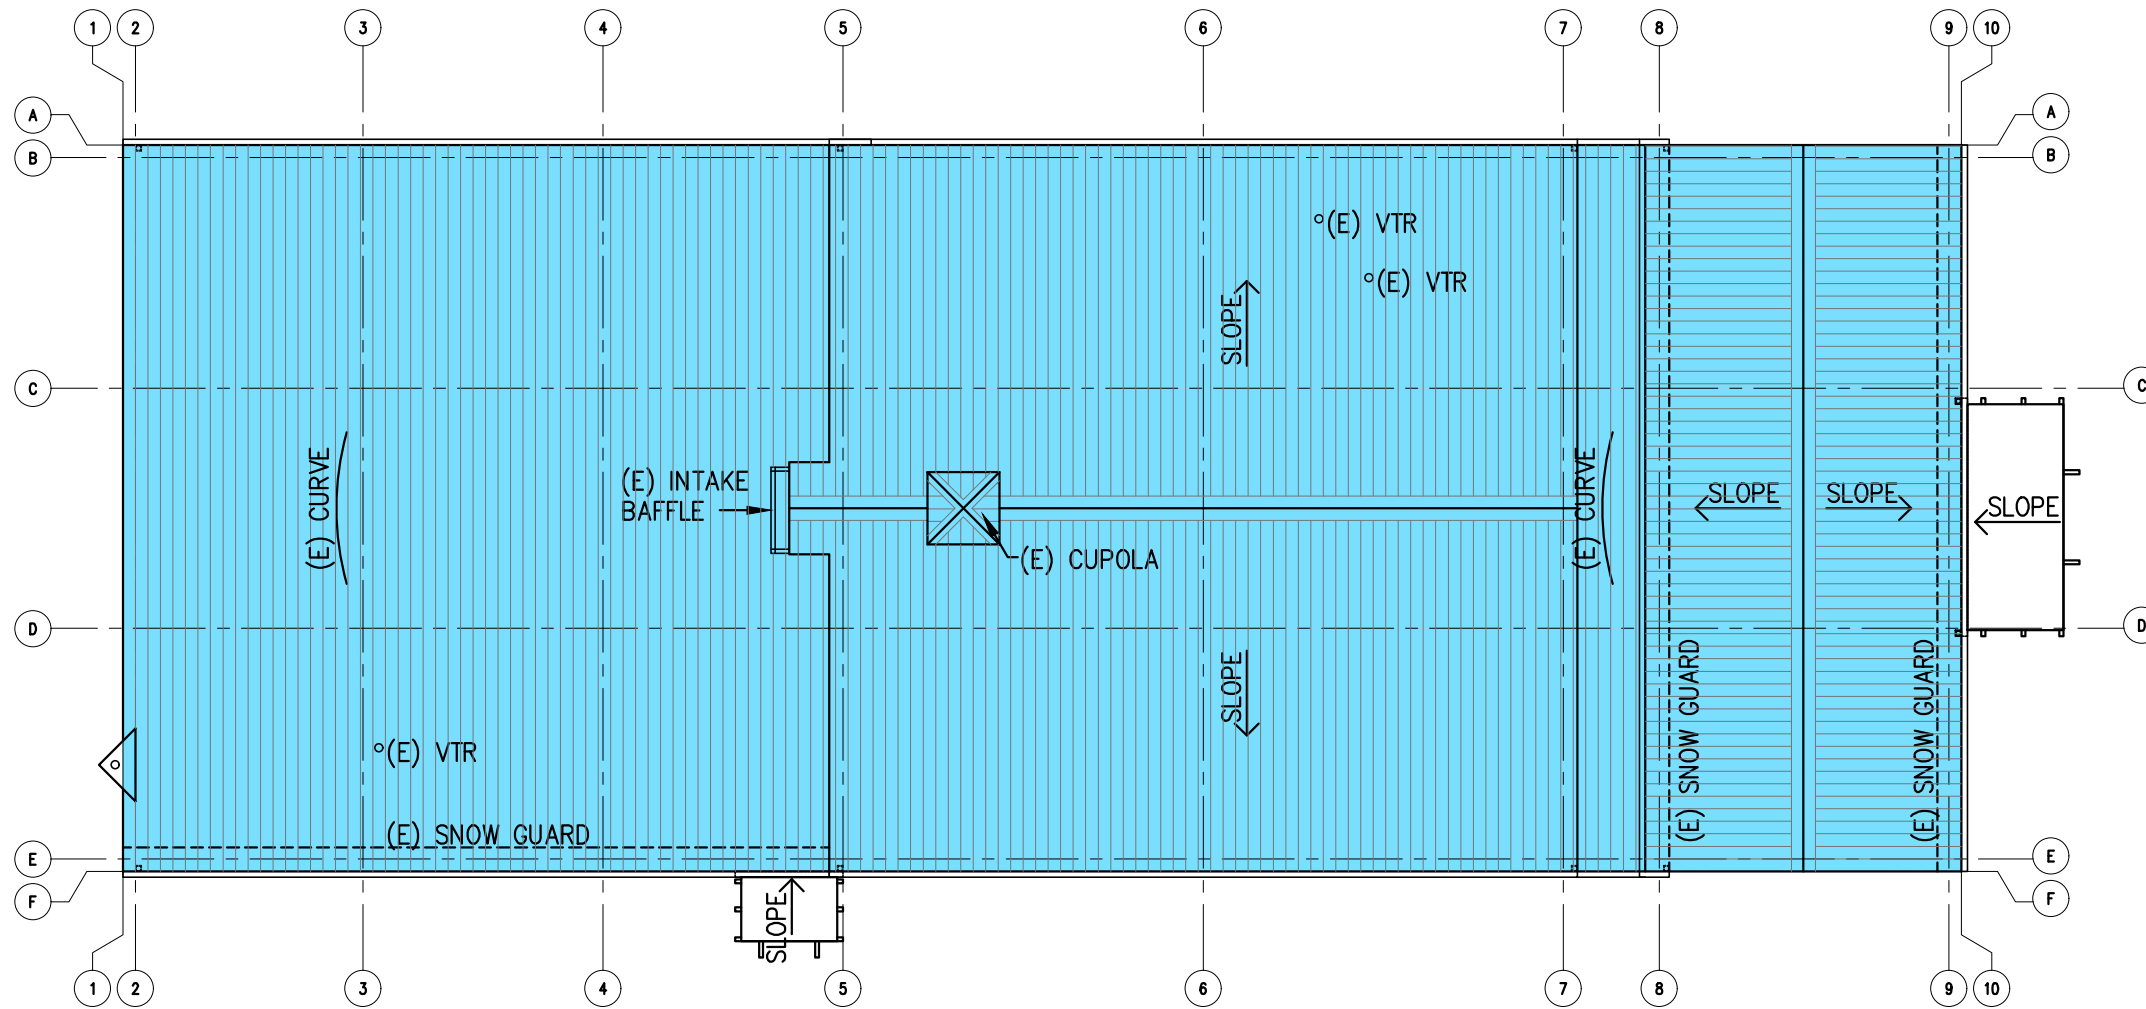
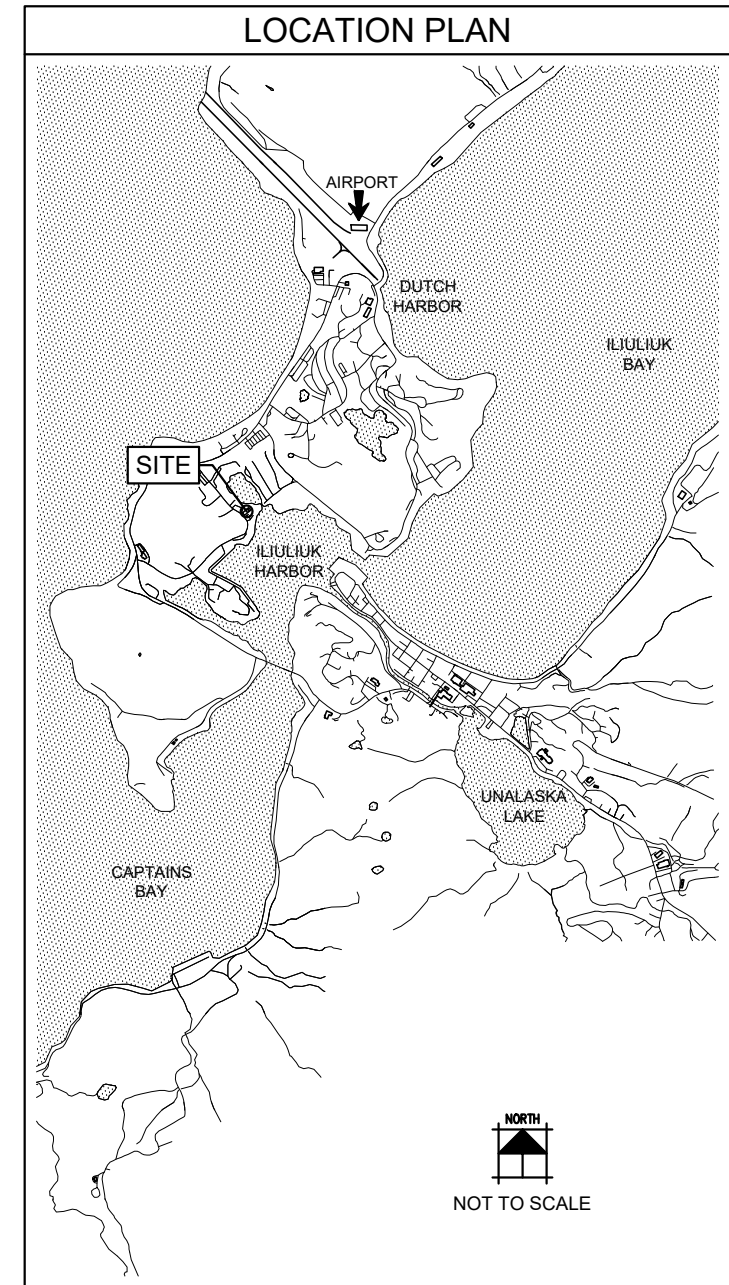
September 25, 2025 - 10:43 AM - MKORETZ - O:\GOVERNMENT\UNALASKA\3_DRAWINGS\00_AR_SHEETS - REPORT\AR-8_MUSEUM.DWG

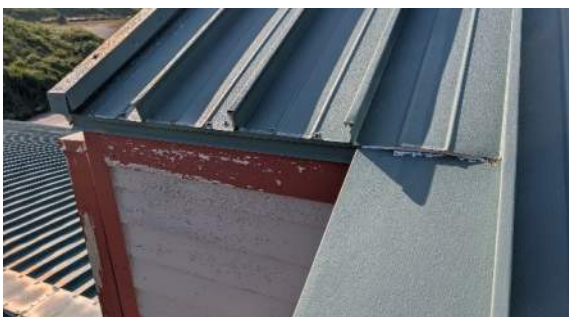
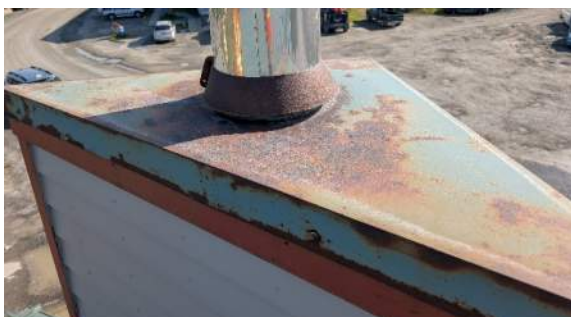
<p><i>Photo #5: Gap where roof panels overlap.</i></p>	<p><i>Photo #6: Chimney Cap metal rusting.</i></p>

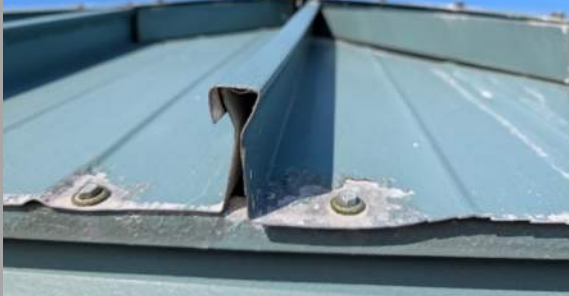
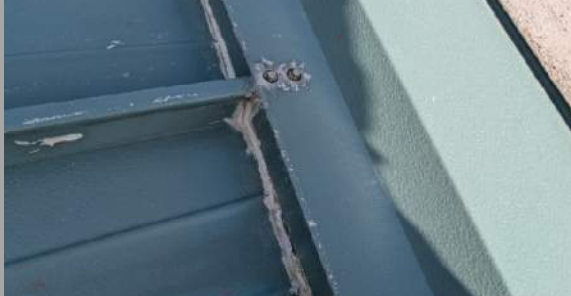
<p><i>Photo #7: Paint peeling away to edge fasteners.</i></p>	<p><i>Photo #8: Caulk peeling away. No longer doing its job.</i></p>

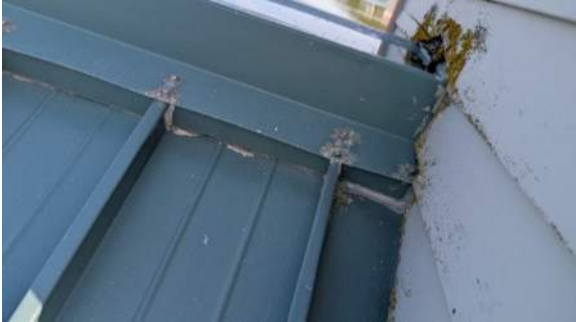
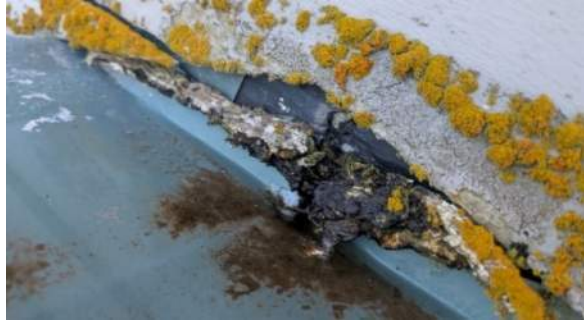
<p><i>Photo #9: Improper flashing at tower where ridge flashing meets wall. Ponding at this location.</i></p>	<p><i>Photo #10: Vapor Barrier at this location has a hole in it.</i></p>

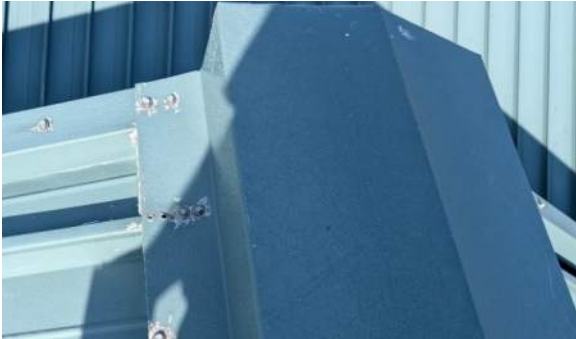
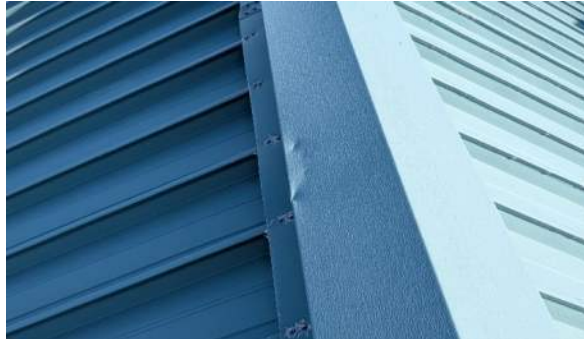
<p><i>Photo #11: Fasteners are missing. Holes not filled in.</i></p>	<p><i>Photo #12: Dents in ridge cap.</i></p>

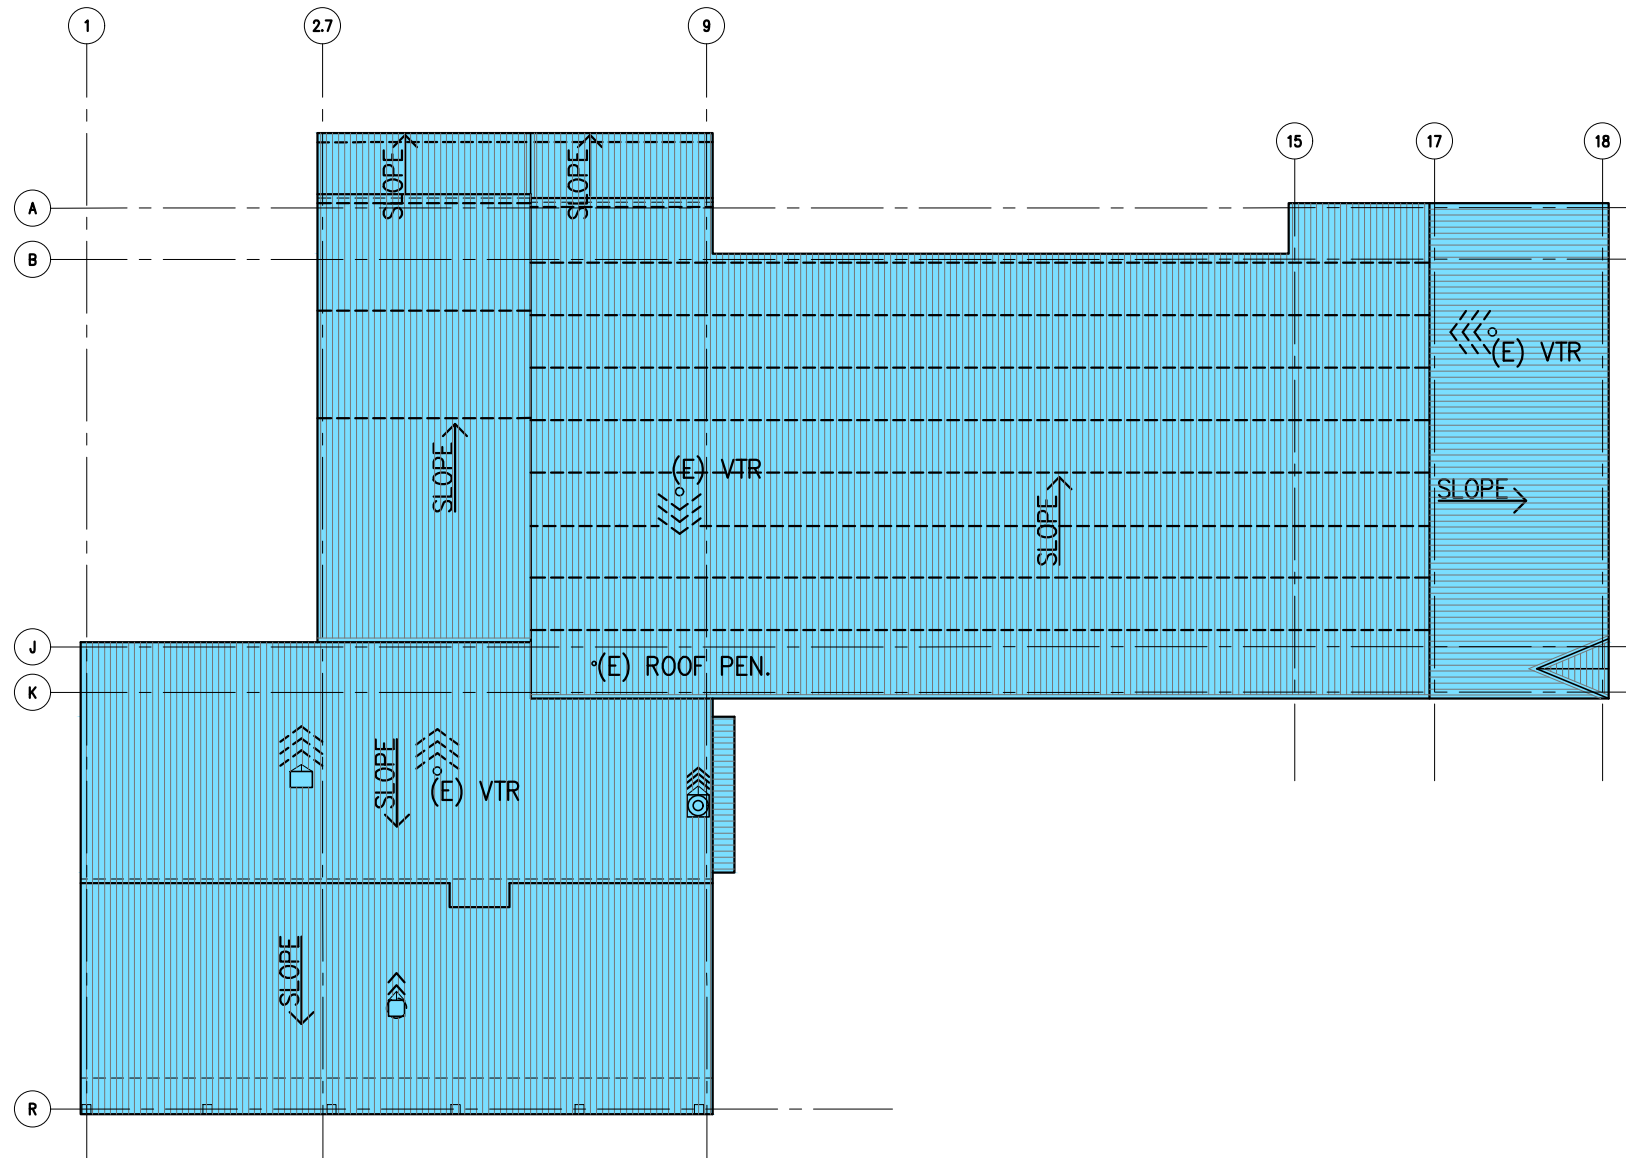
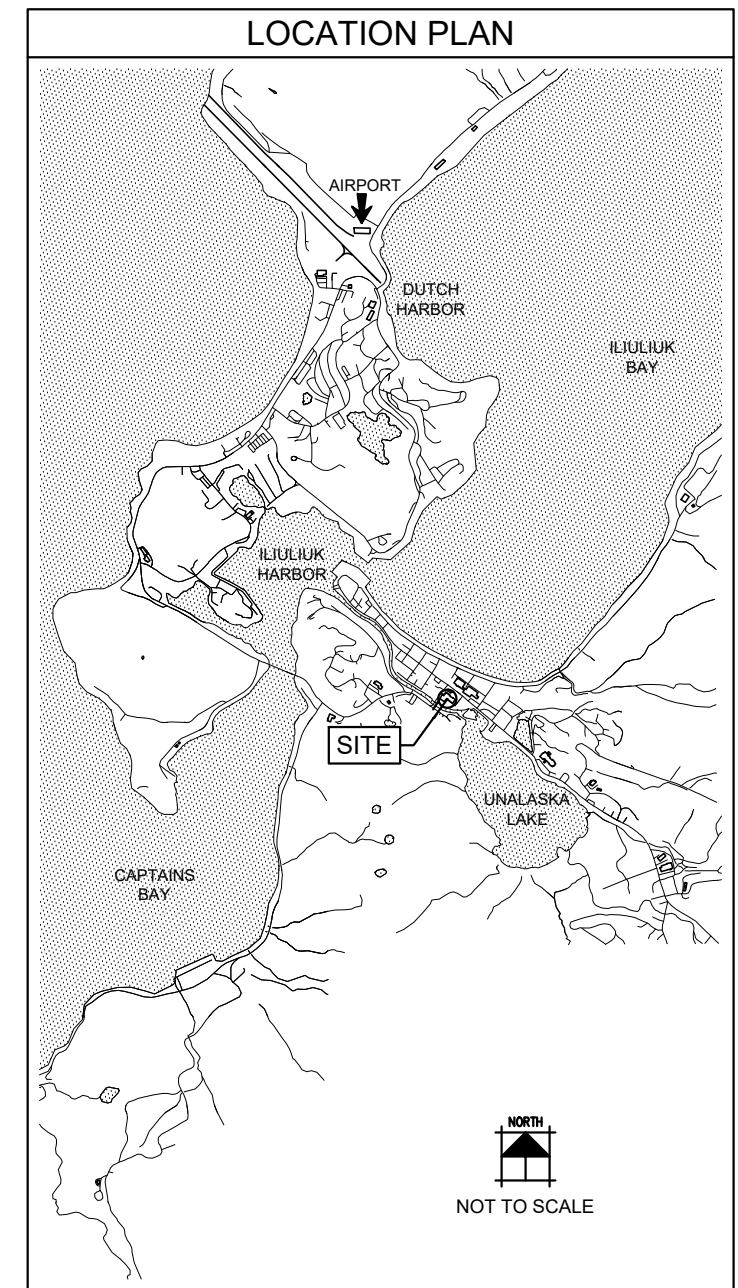
September 25, 2025 - 10:43 AM - MKORETZ - O:\GOVERNMENT\UNALASKA\3_DRAWINGS\00_AR SHEETS - REPORT\AR-9_COMMUNITY CENTER.DWG

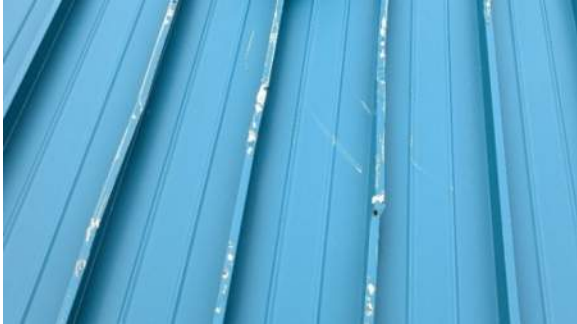
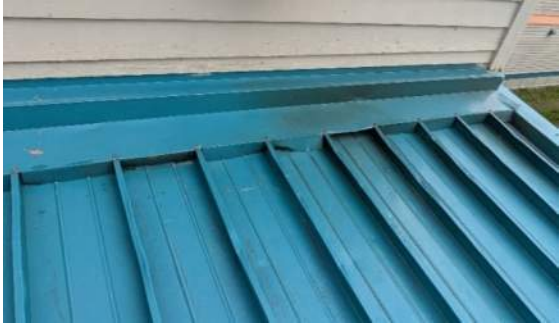
<p><i>Photo #1: Bent, torn and damaged standing seams.</i></p>	<p><i>Photo #2: Wall to roof flashing bent in at multiple places.</i></p>

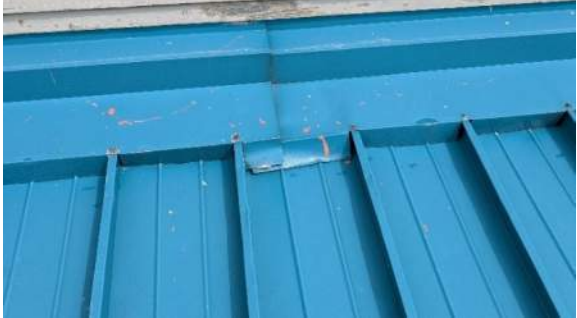
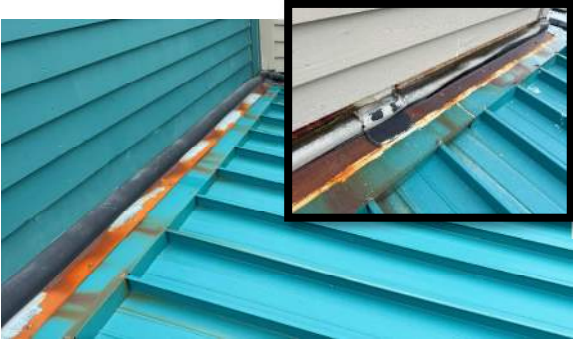
<p><i>Photo #3: Gaps with no sealant where wall to roof flashing overlaps.</i></p>	<p><i>Photo #4: Flashing at seismic joint is rusting.</i></p>

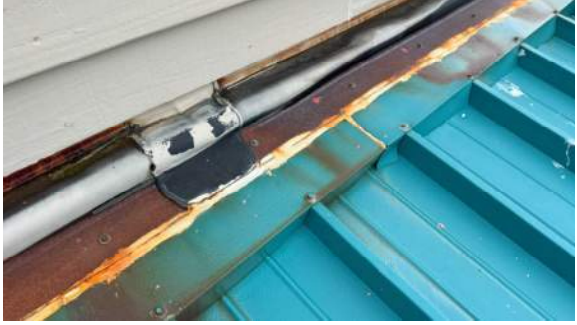
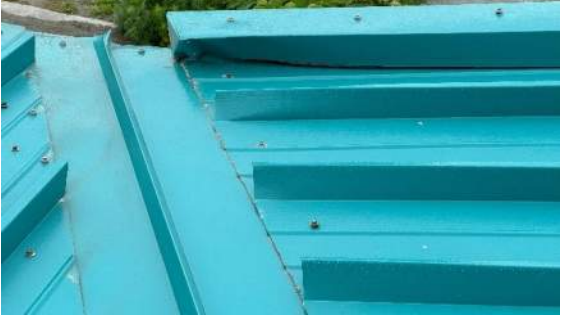
<p><i>Photo #5: Mechanical hood/unit rusted through.</i></p>	<p><i>Photo #6: Damaged rake closure flashing.</i></p>

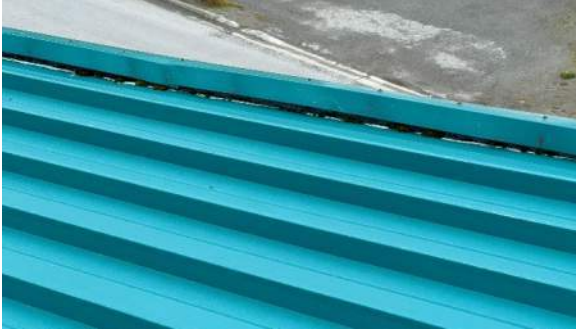
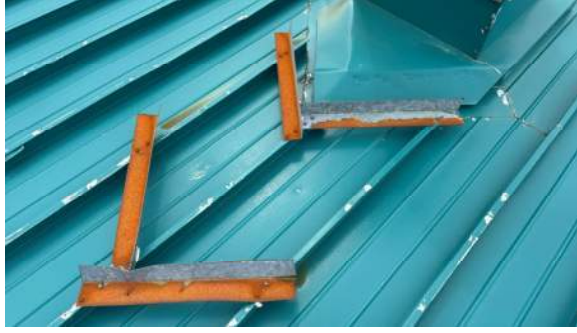
<p><i>Photo #7: Damaged rake flashing.</i></p>	<p><i>Photo #8: Snow guard near Mech Unit rusting.</i></p>

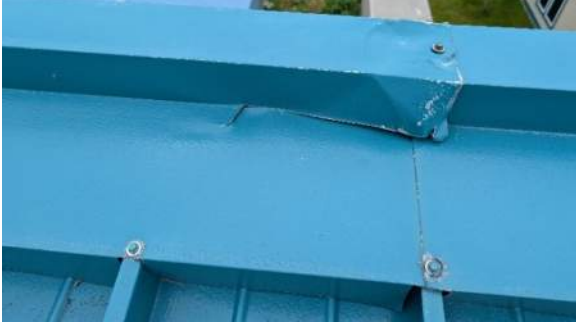
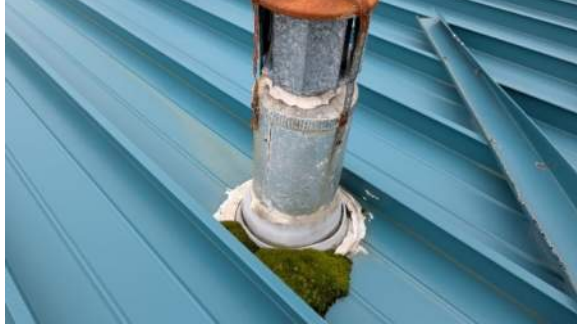
<p><i>Photo #9: Bent, torn and damaged ridge flashing.</i></p>	<p><i>Photo #10: Moss growing on roof.</i></p>
