ATTACHMENT A

AGREEMENT FOR CONSULTING AND RELATED SERVICES

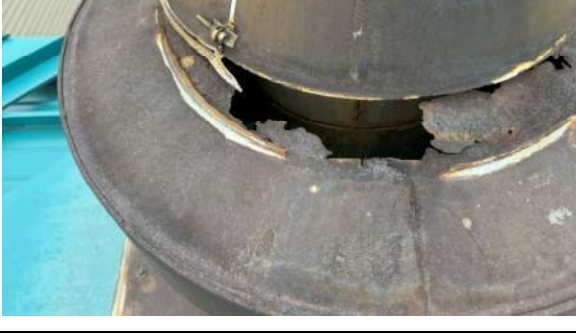
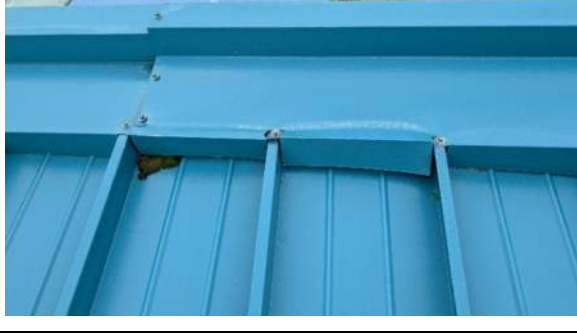
<p><i>Photo #11: Flashing at seismic joints and fasteners rusting</i></p>	<p><i>Photo #12: Edge flashing is not properly fastened, causing large gaps. Moss growing in the same area.</i></p>

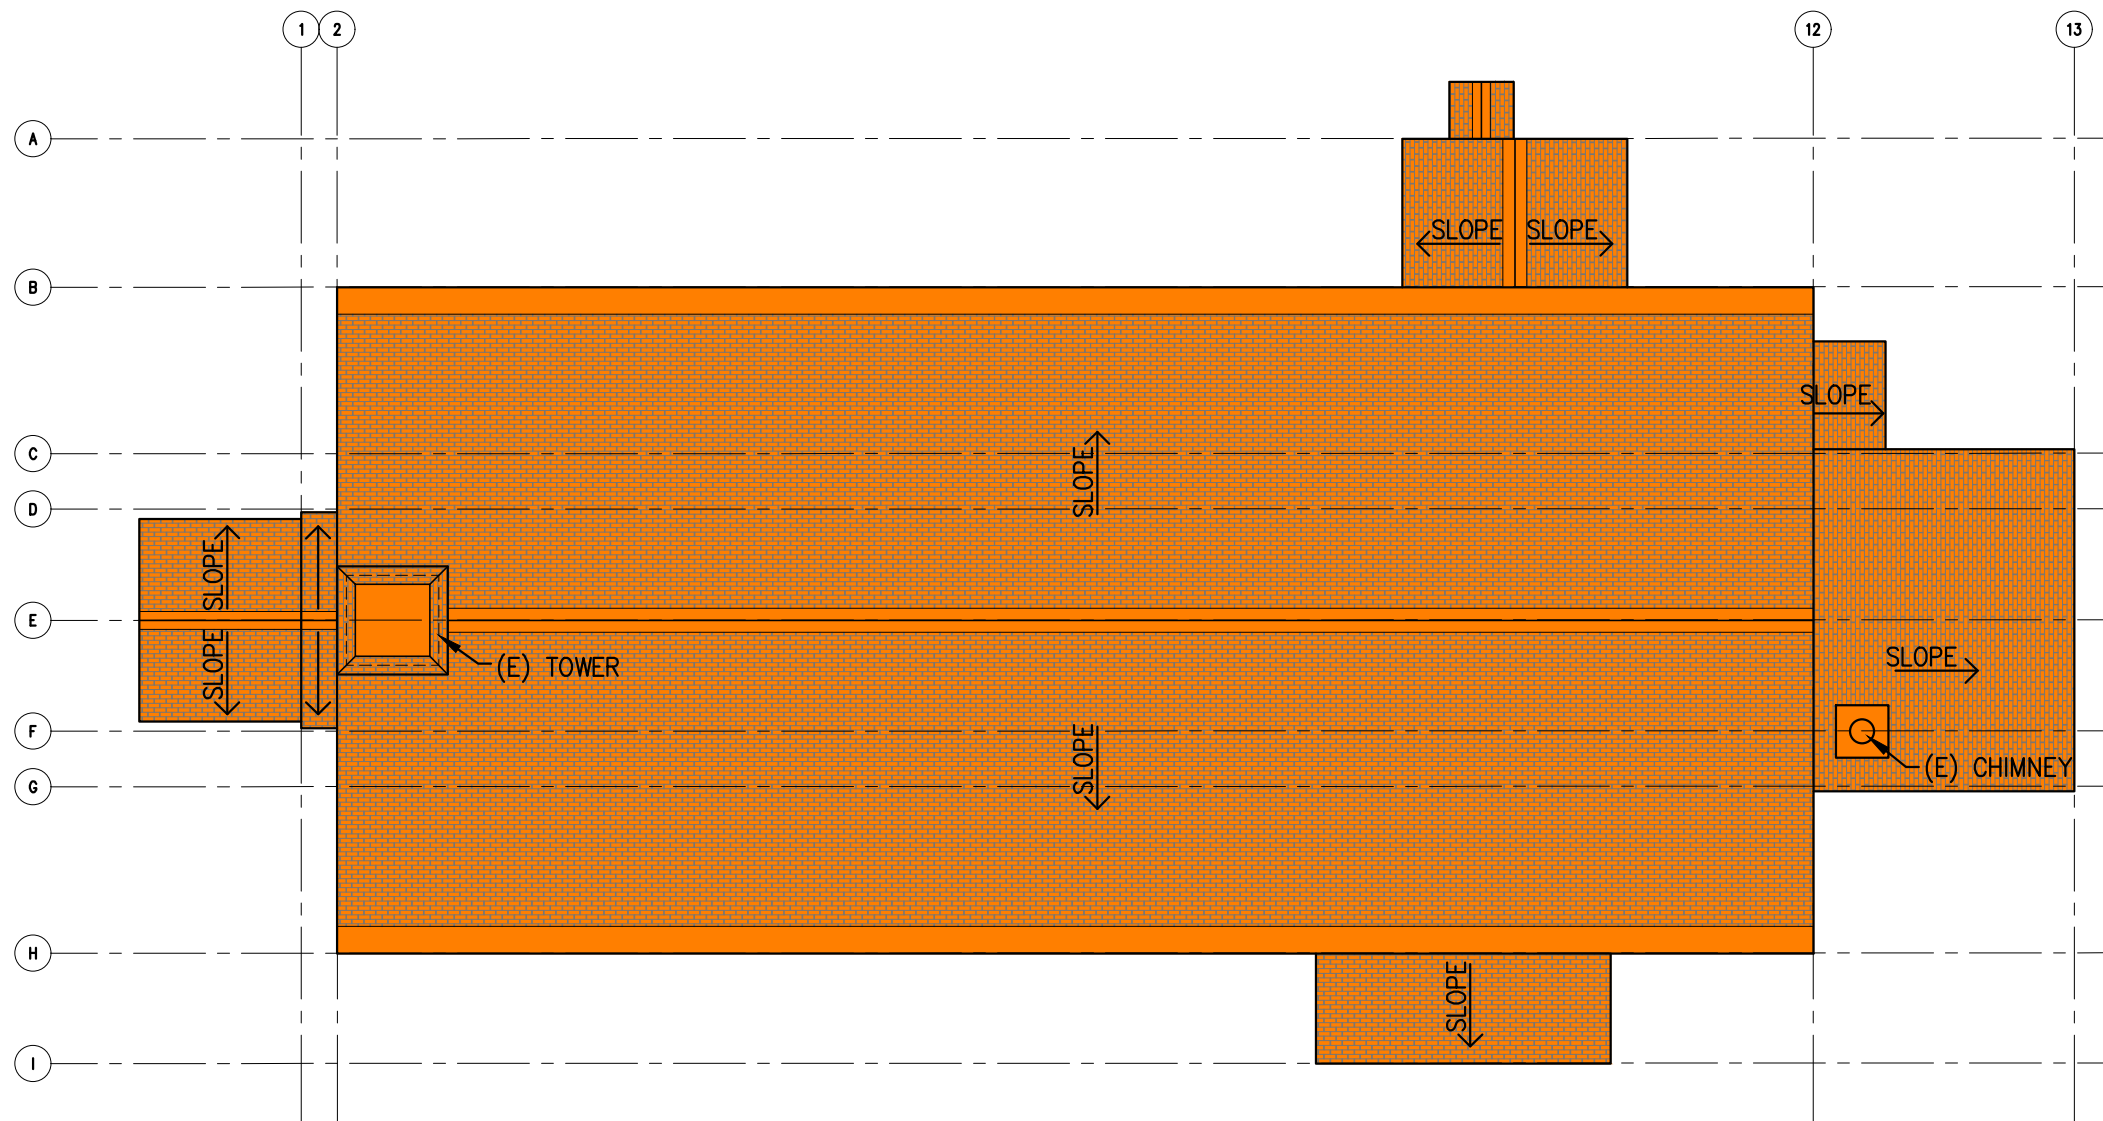
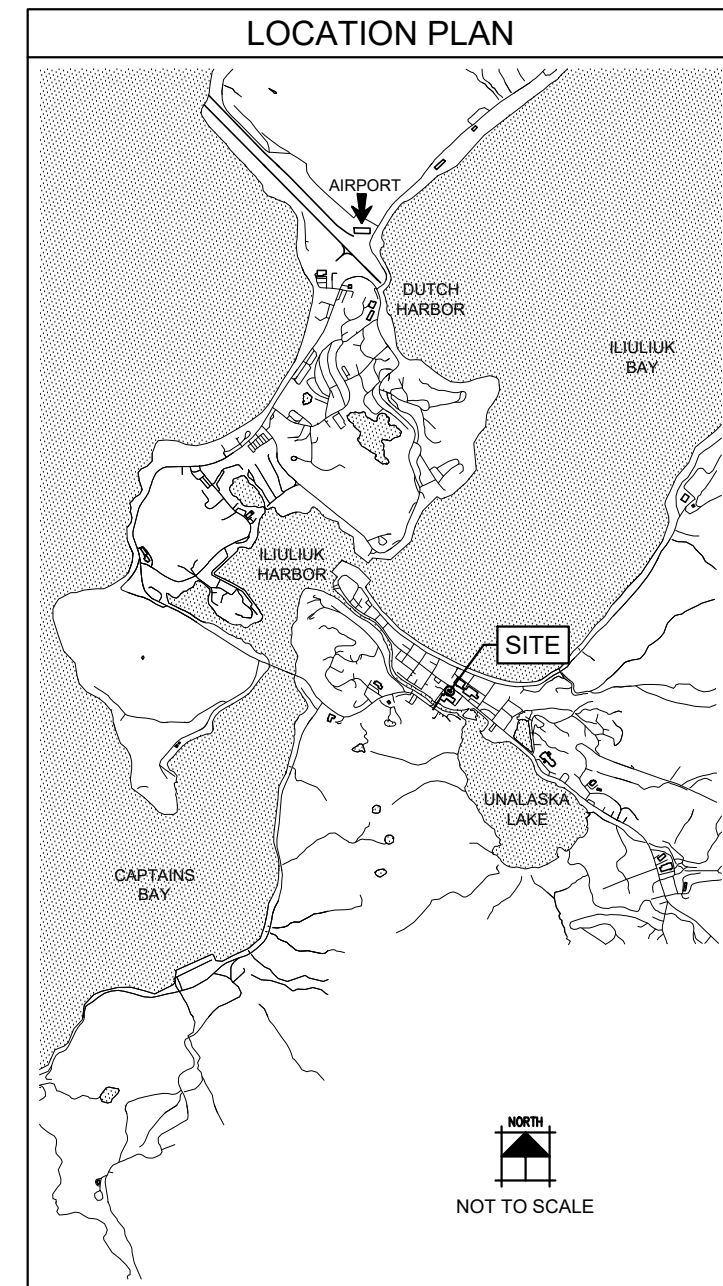
September 22, 2025 - 1:20 PM - BECKY - O:\GOVERNMENT\UNALASKA\3_DRAWINGS\00_AR SHEETS - REPORT\AR-10_BURMA ROAD CHAPEL.DWG

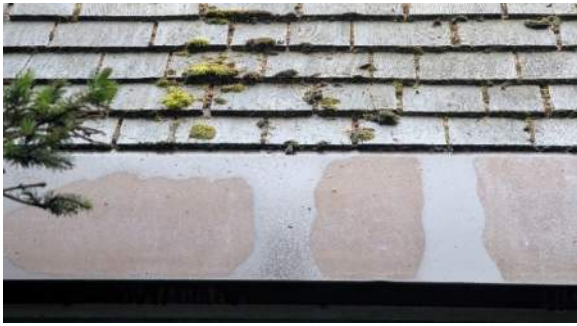
Photo #1: Galvanized metal eave flashing is rusting.

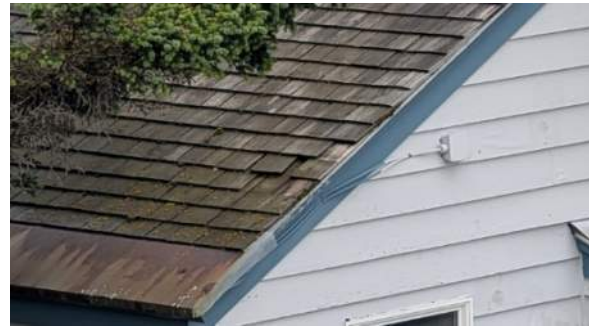
Photo #2: Missing Cedar shakes.

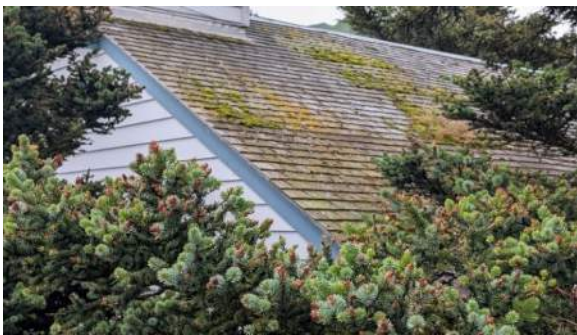
Photo #3: Roof is growing moss, grass and lichen.

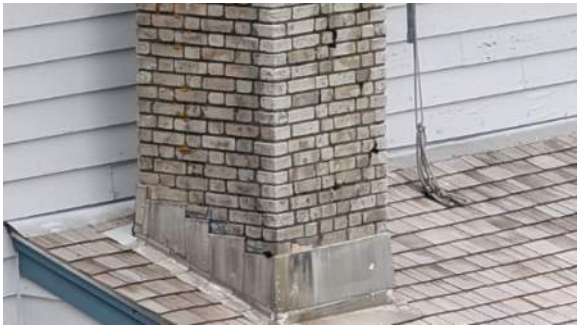
Photo #5: Roof to wall flashing at entrance is missing.

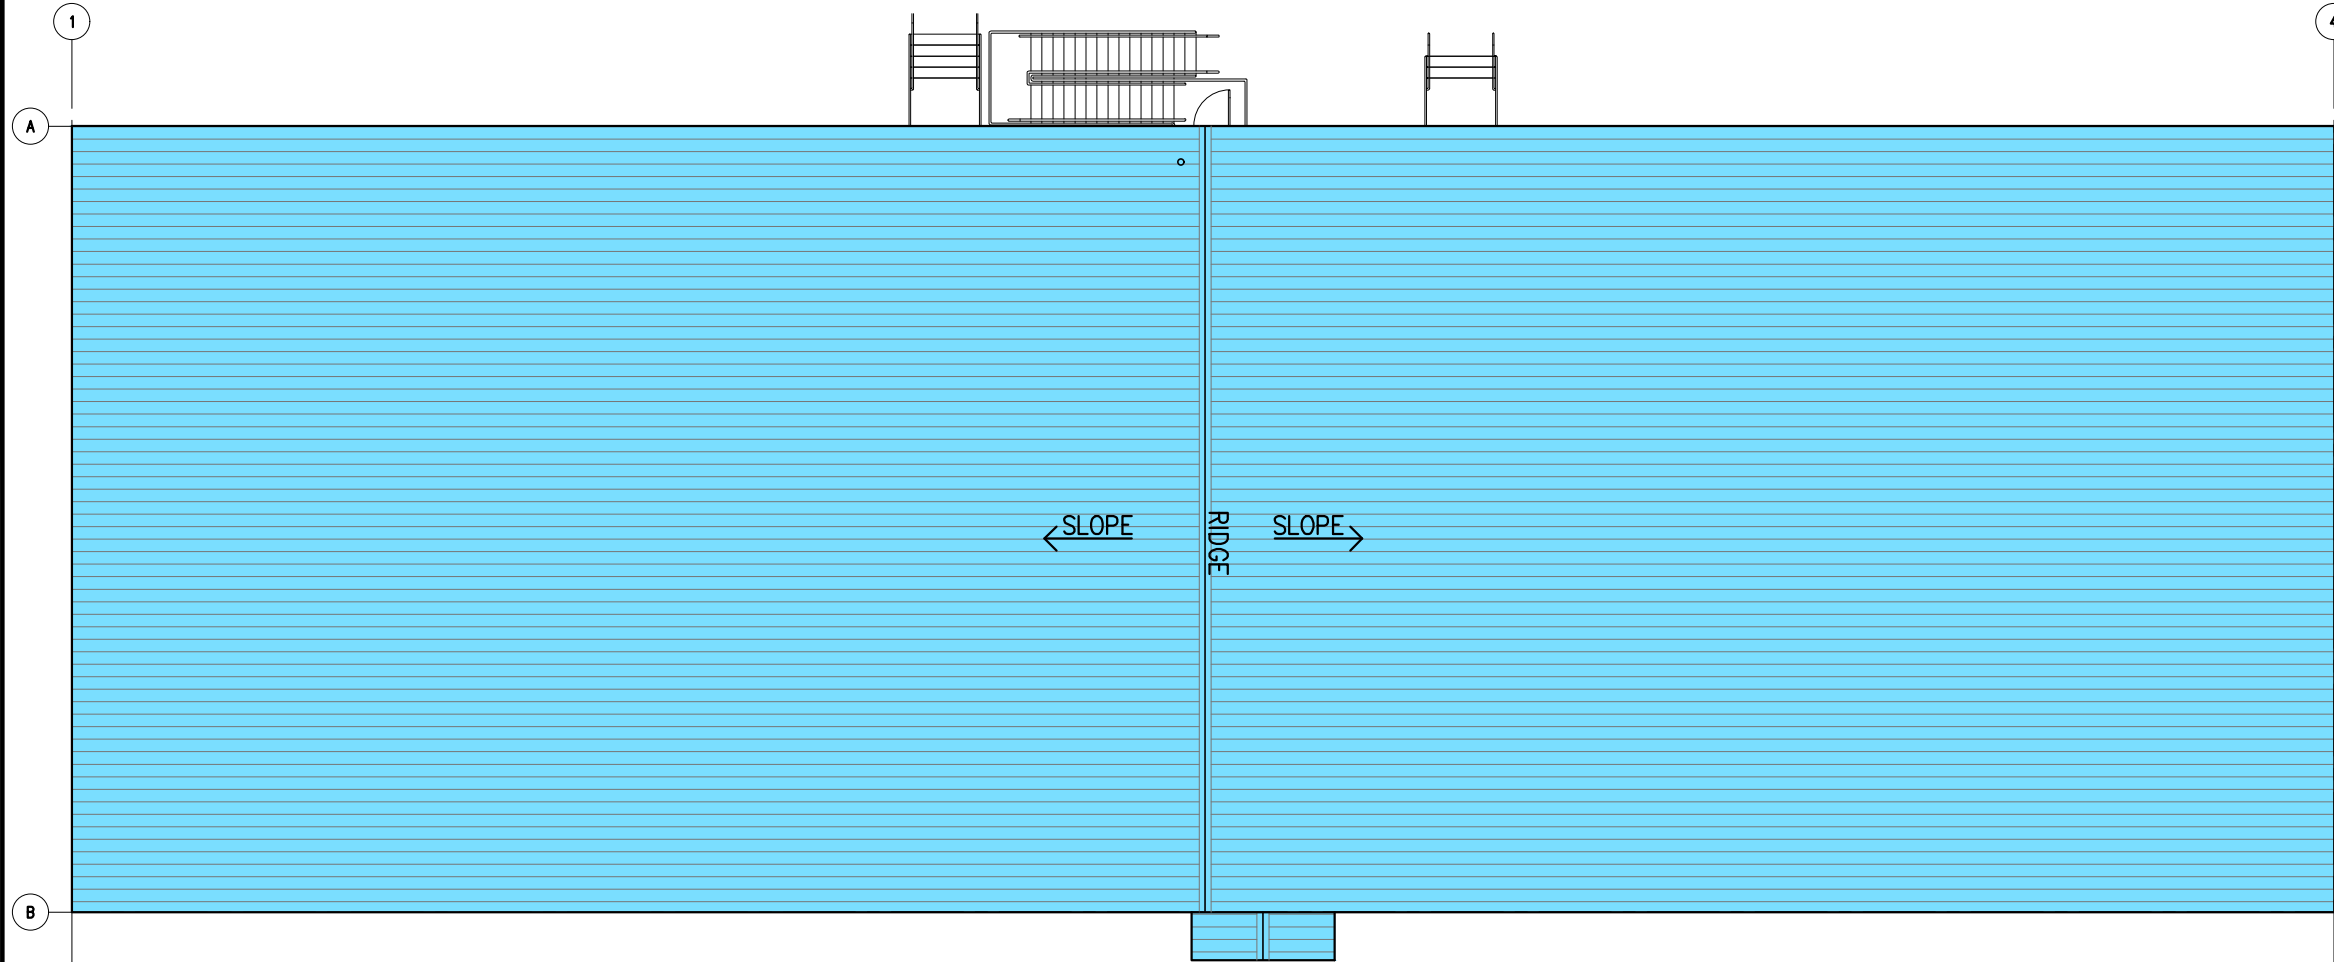
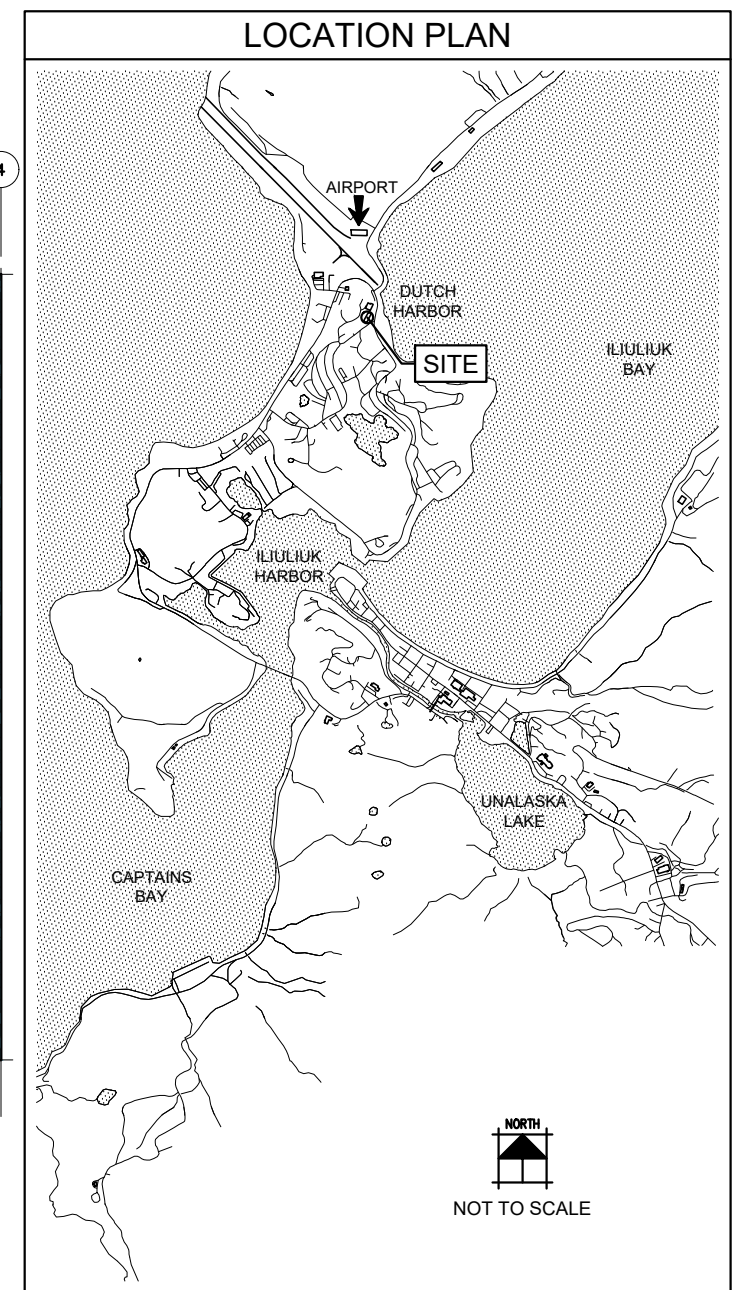
September 25, 2025 - 10:43 AM - MKORETZ - O:\GOVERNMENT\UNALASKA\3_DRAWINGS\00_AR_SHEETS - REPORT\AR-11_NEW POWERHOUSE.DWG

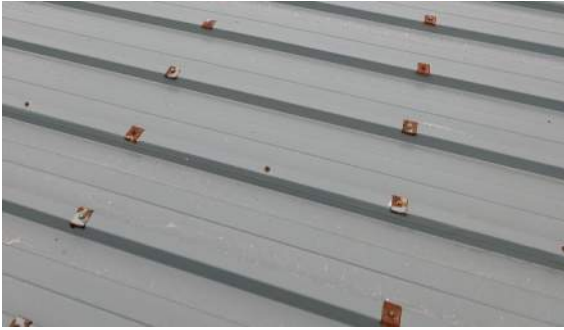
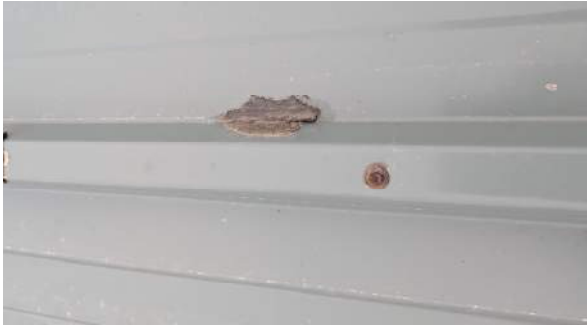
<p><i>Photo #1: Fasteners and fastener cleats are rusting.</i></p>	<p><i>Photo #2: Sealant on possible hole is peeling.</i></p>

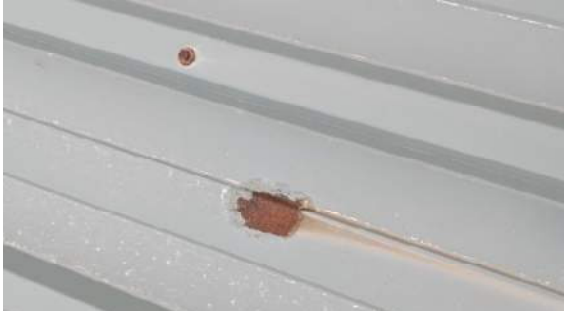
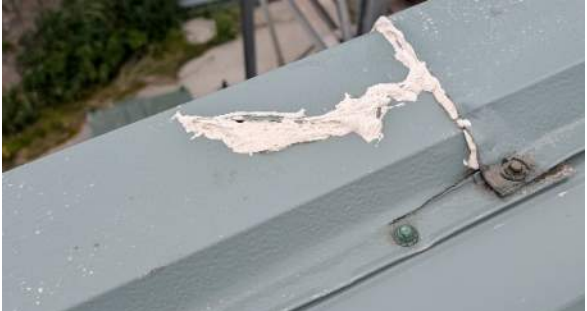
<p><i>Photo #3: Areas on metal roofs are starting to rust.</i></p>	<p><i>Photo #4: Bent, torn and damaged edge flashing.</i></p>

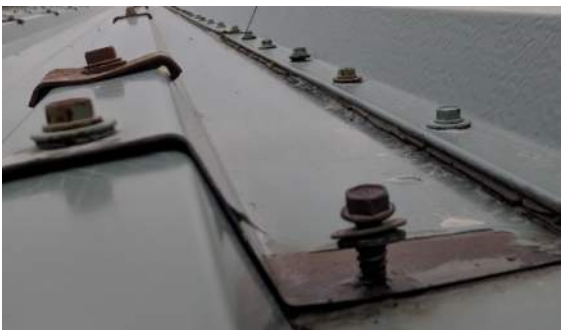
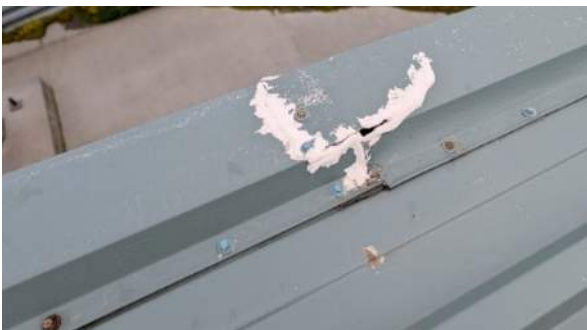
<p><i>Photo #5: Hex head fasteners backed out.</i></p>	<p><i>Photo #6: Hole on edge flashing. Sealant failure.</i></p>

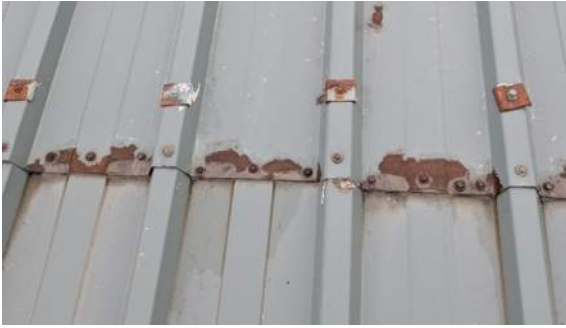
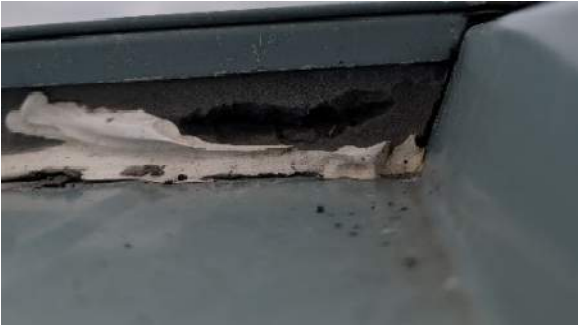
<p><i>Photo #7: Edge where roof sheathing overlap rusting.</i></p>	<p><i>Photo #8: Foam between ridge flashing and roofing damaged; peck or pulled out.</i></p>

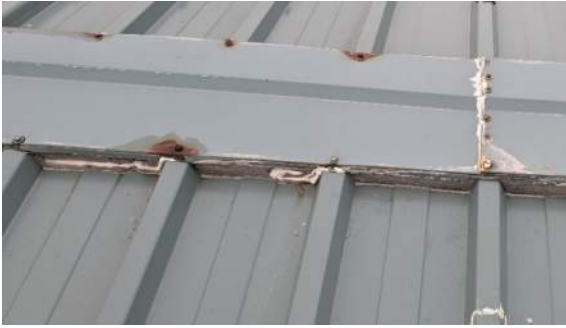
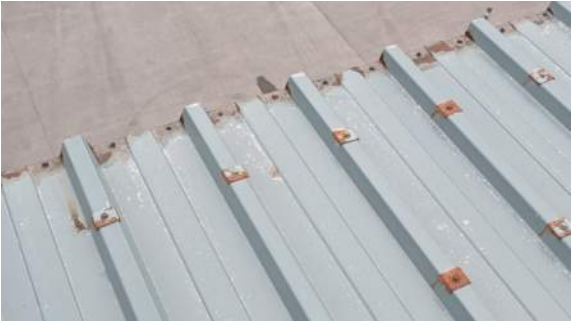
<p><i>Photo #9: Ridge flashing rusting at fasteners.</i></p>	<p><i>Photo #10: Eave of corrugated roof rusting.</i></p>

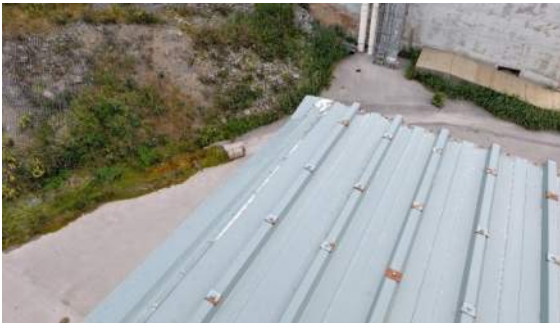
<p><i>Photo #11: Damaged edge flashing. Appears to have blown off and reattached.</i></p>

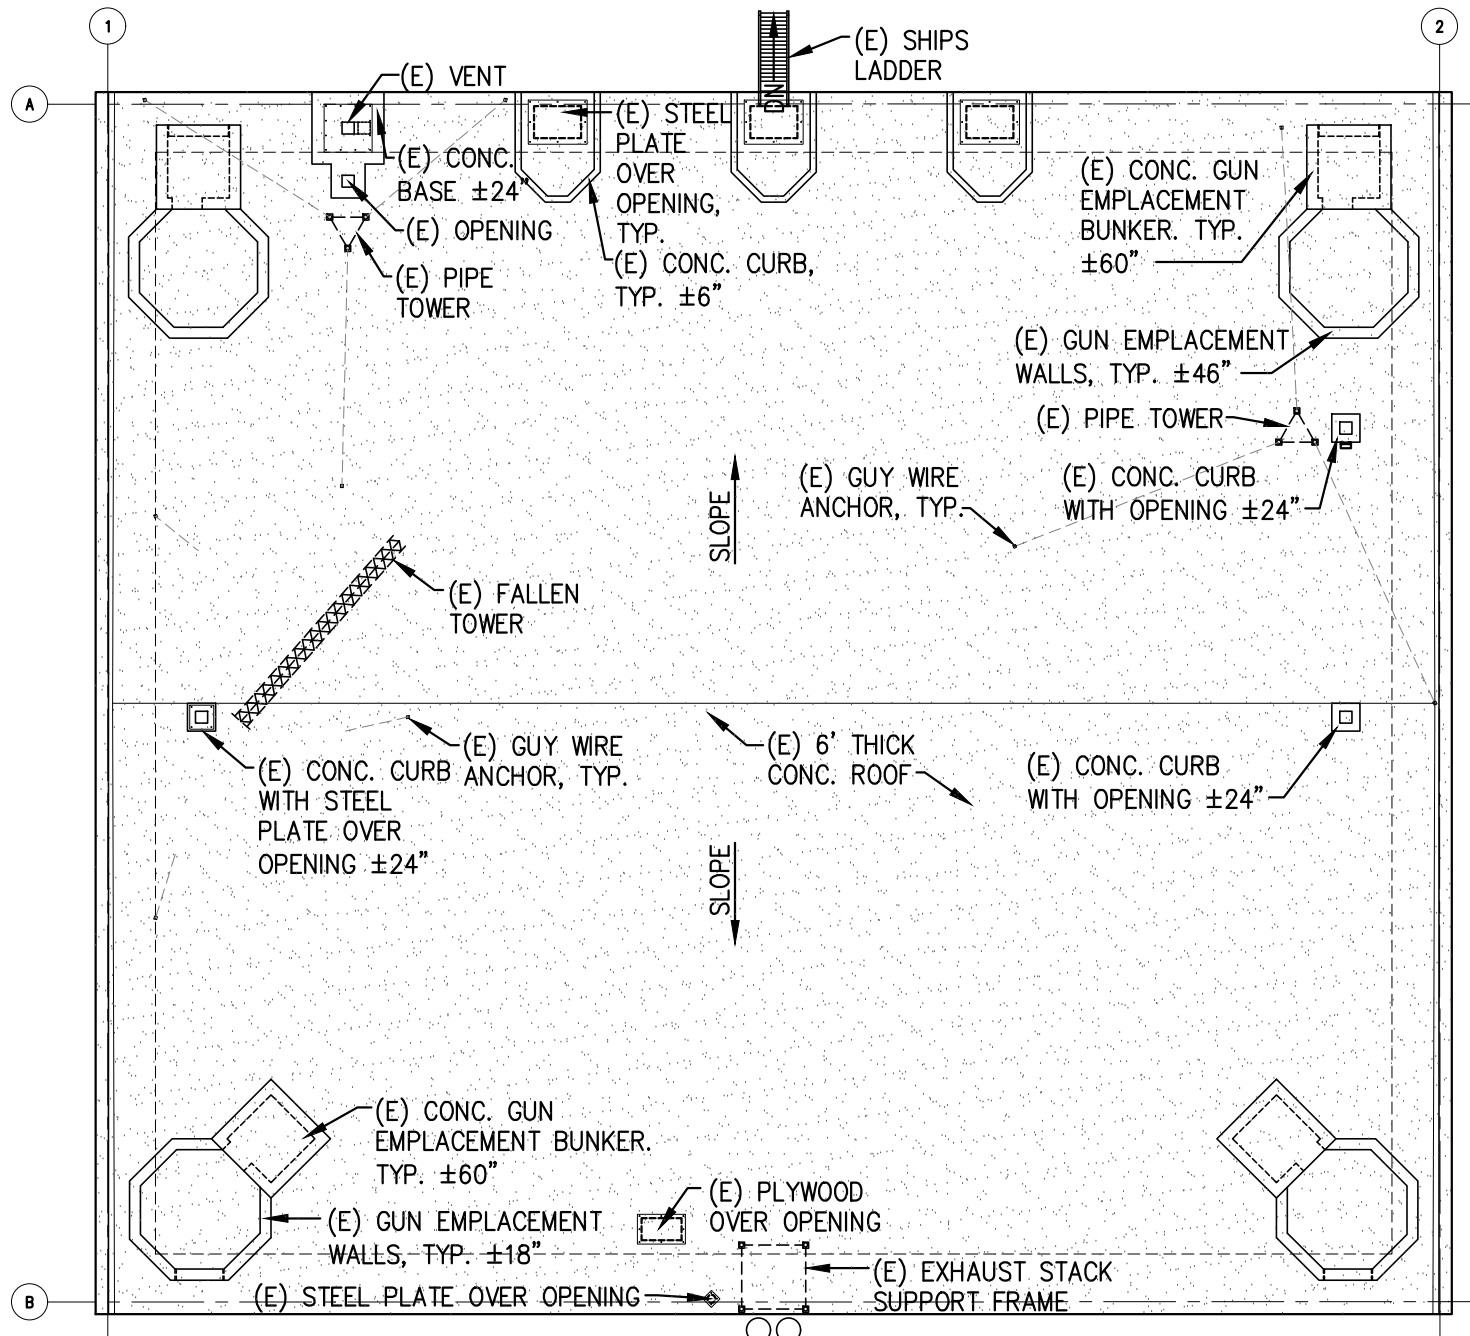
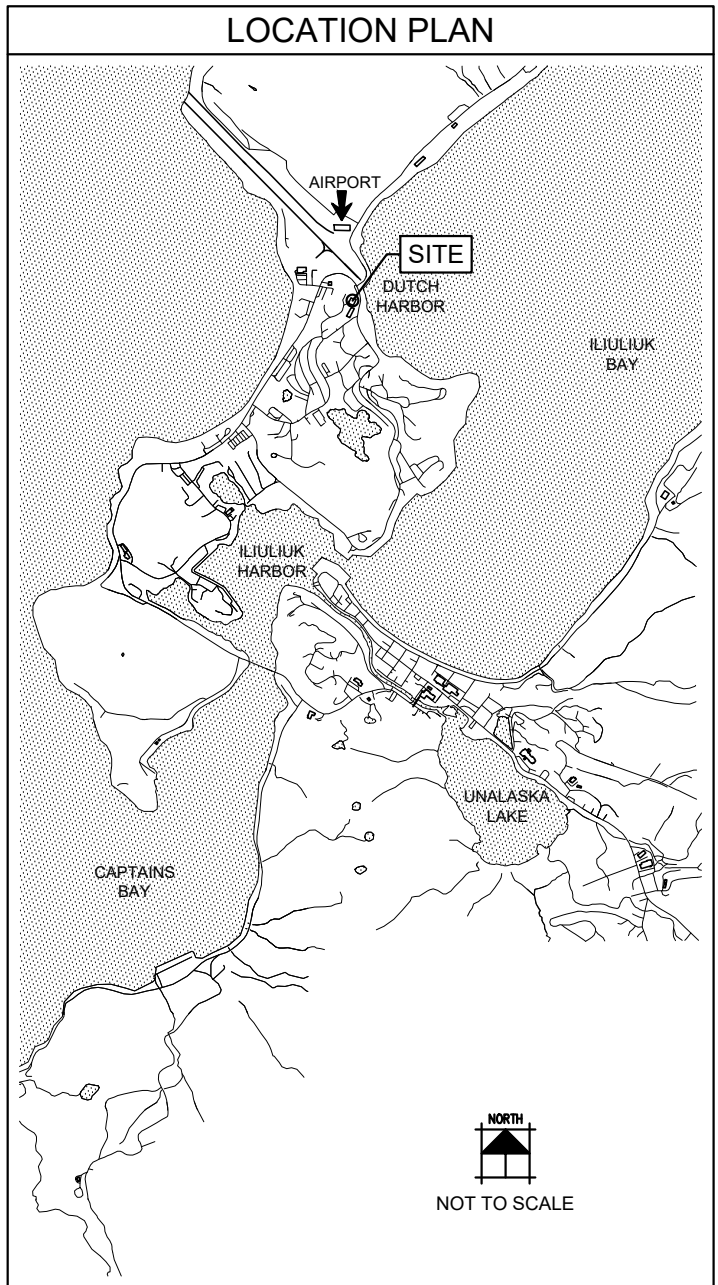
LEGEND	
	CONCRETE ROOF Area: 11,750 SF

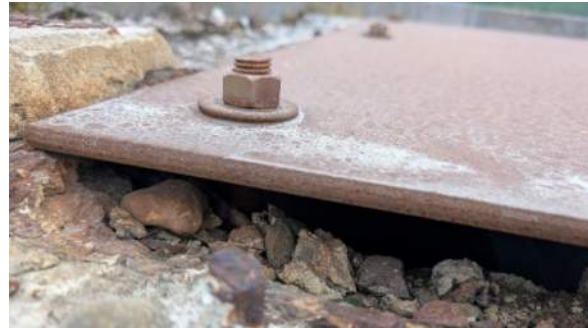
Photo #2: Rusted steel plates over openings. Edges of openings underneath are crumbling in.

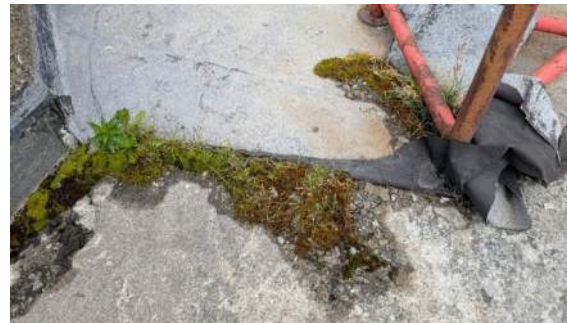
Photo #3: Moss and lichen growing on roof in spots.

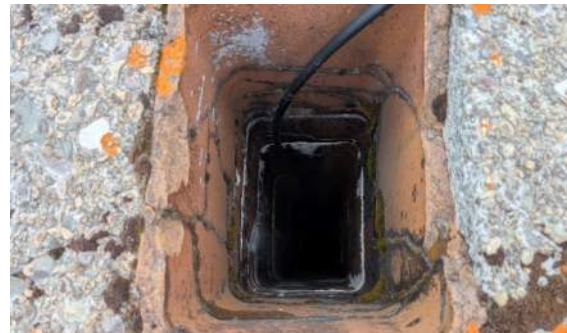
Photo #5: Damaged chimney lining.

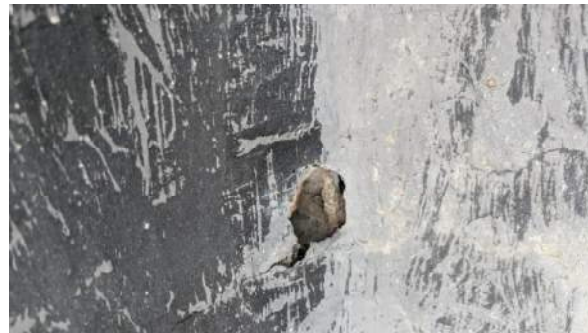
Photo #6: Roofing material damaged, holes, pulled away and destroyed.

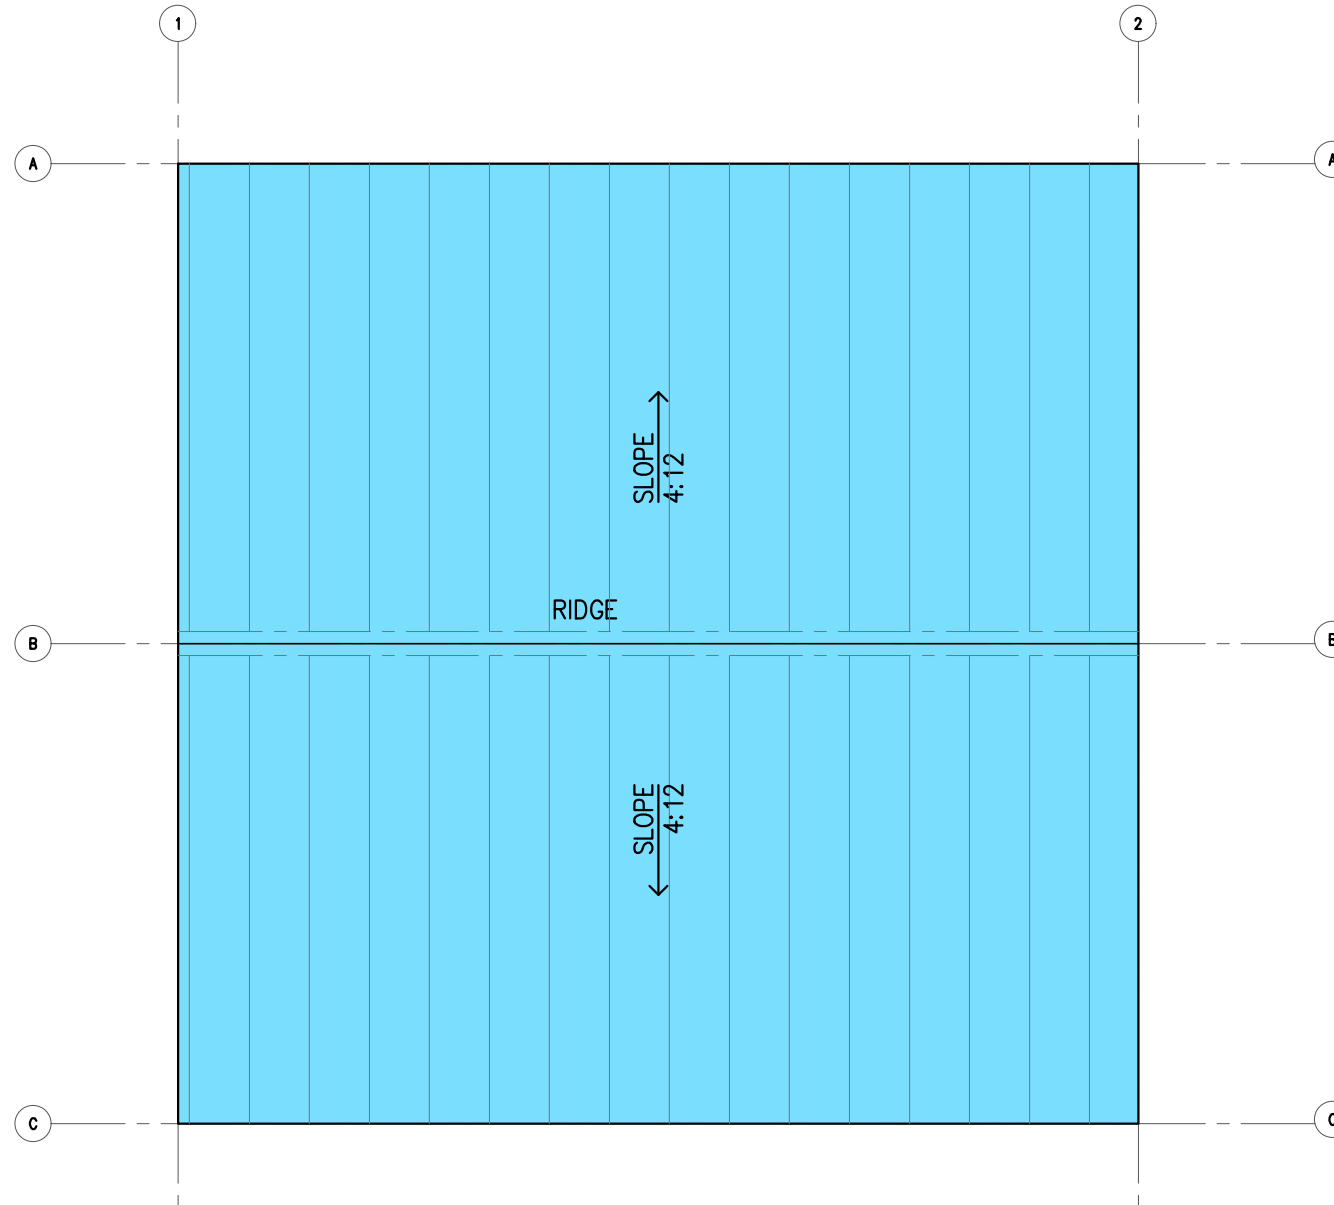
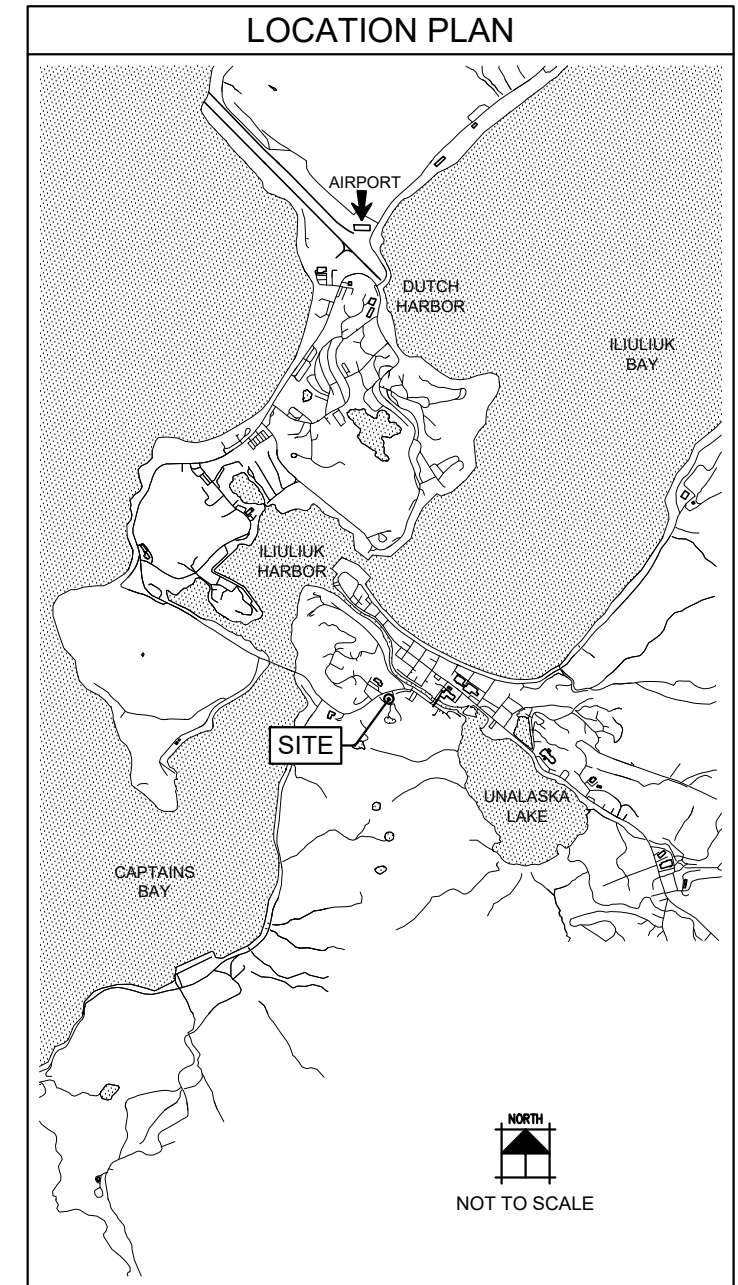
September 22, 2025 - 1:27 PM - BECKY - O:\GOVERNMENT\UNALASKA\3_DRAWINGS\00_AR SHEETS - REPORT\AR-13_POWER SUBSTATION.DWG

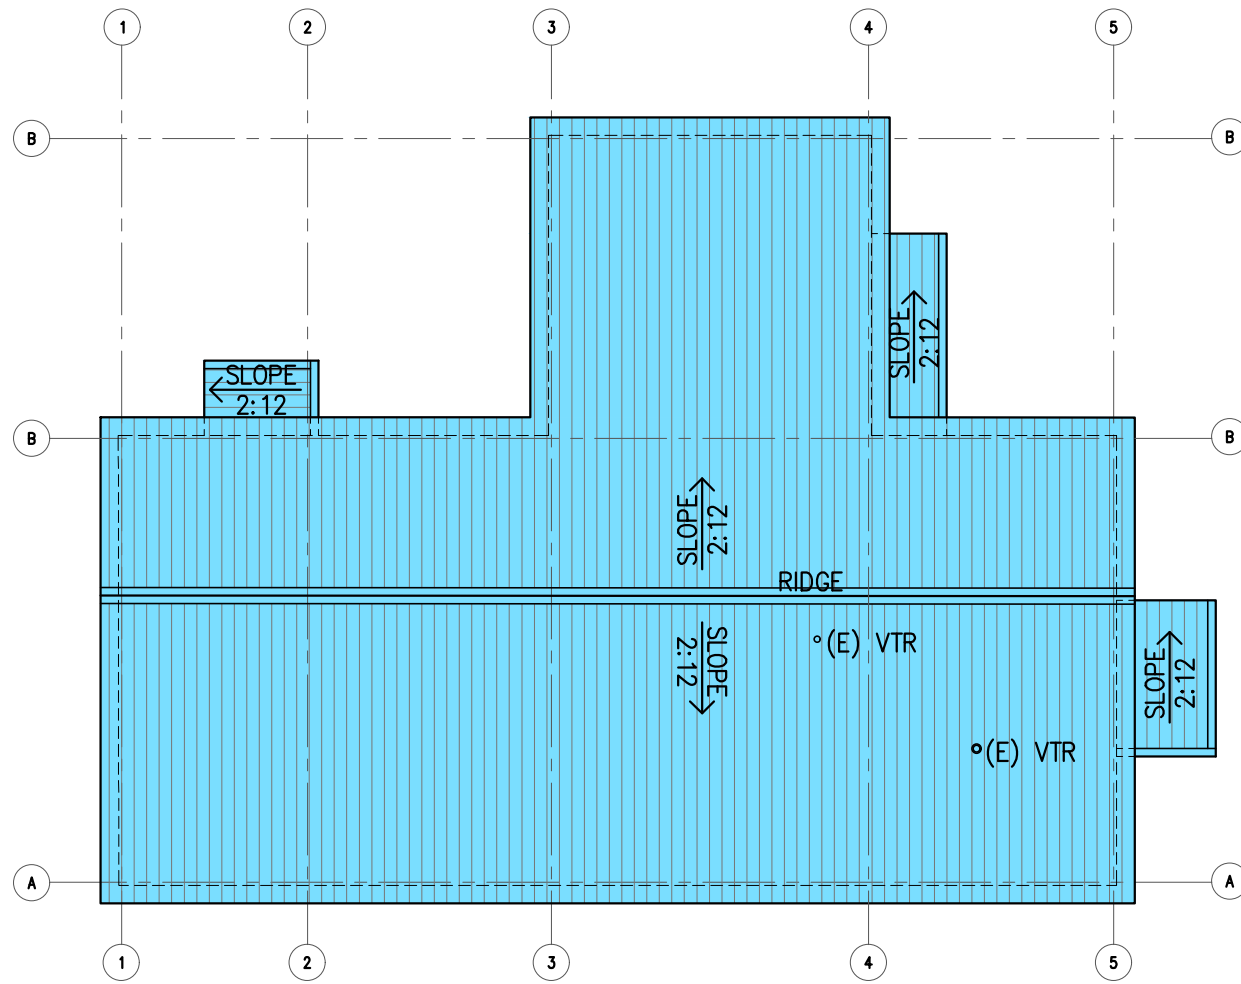
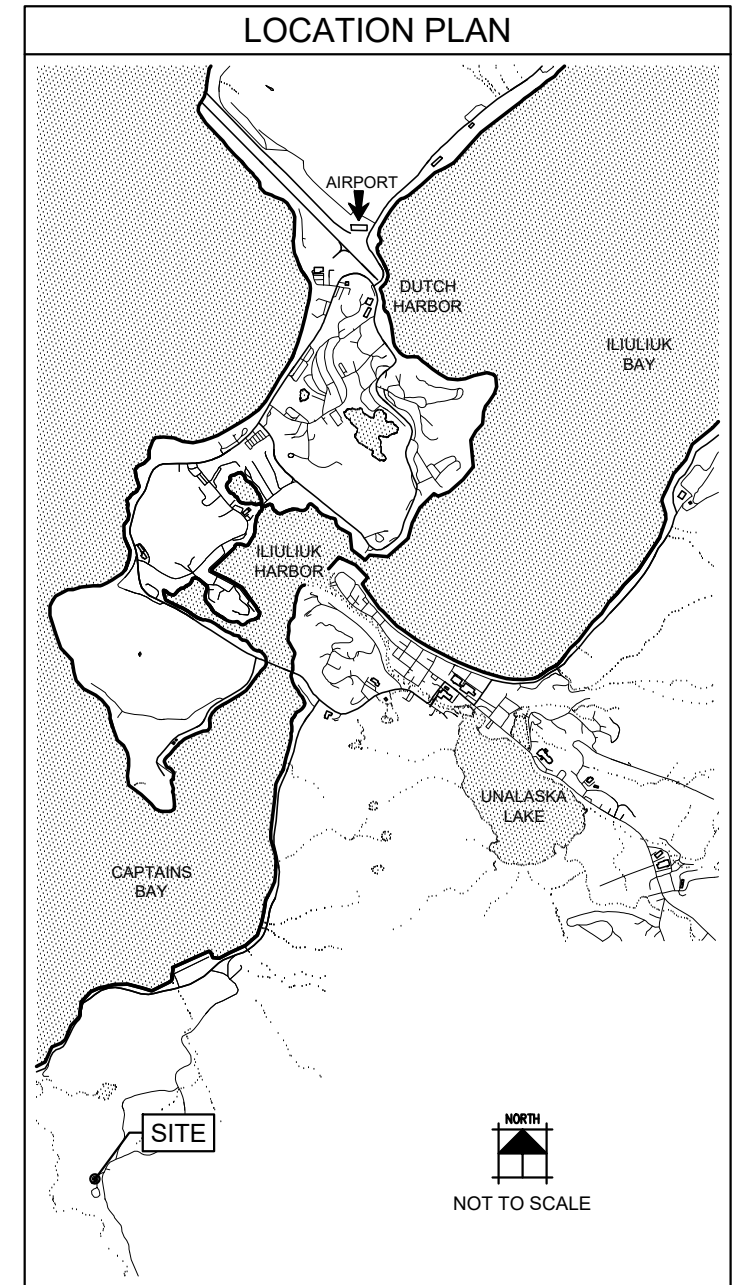
September 22, 2025 - 1:28 PM - BECKY - O:\GOVERNMENT\UNALASKA\3_DRAWINGS\00_AR SHEETS - REPORT\AR-14_PYRAMID WATER TREATMENT PLANT.DWG

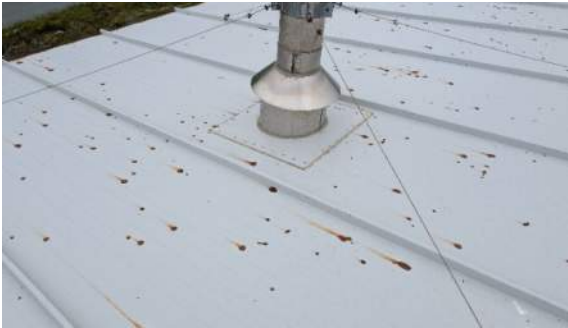
Photo #1: Rust spots across the entire roof.

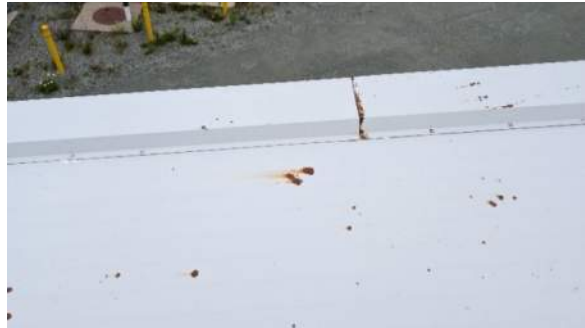
Photo #2: Eave of roof panels are rusting.

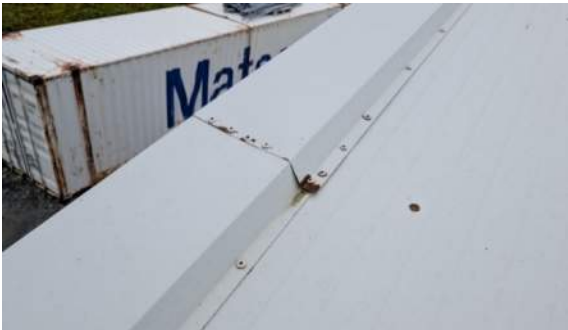
Photo #3: Gaps between edge flashings.

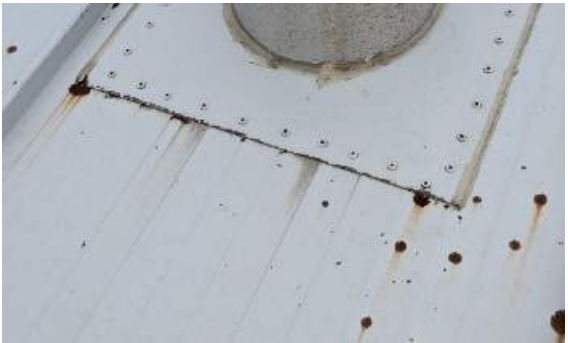
Photo #5: Pitted rust spots at chimney flashing to roof.

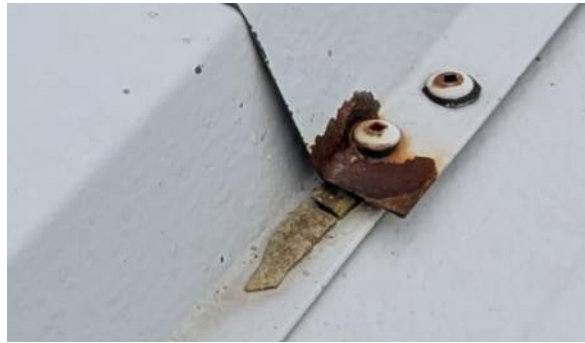
Photo #5: Fastener backing out.

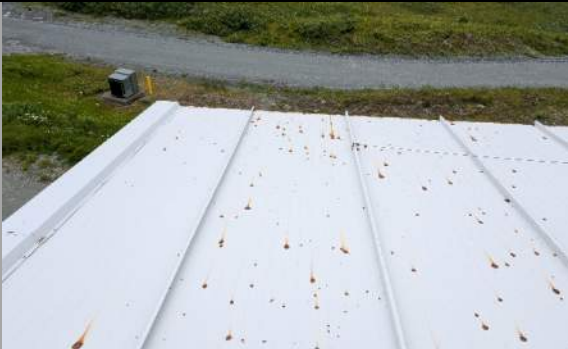
Photo #6: Rust spots across the entire roof, continued

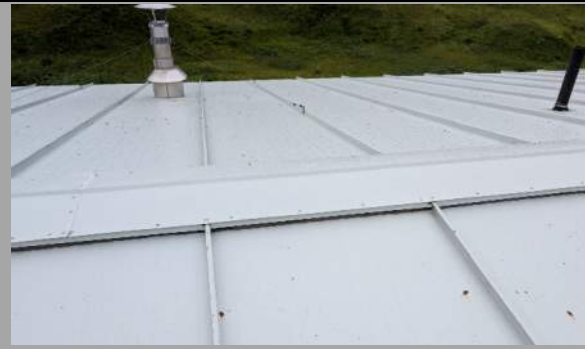
Photo #7: Fastener backing out.

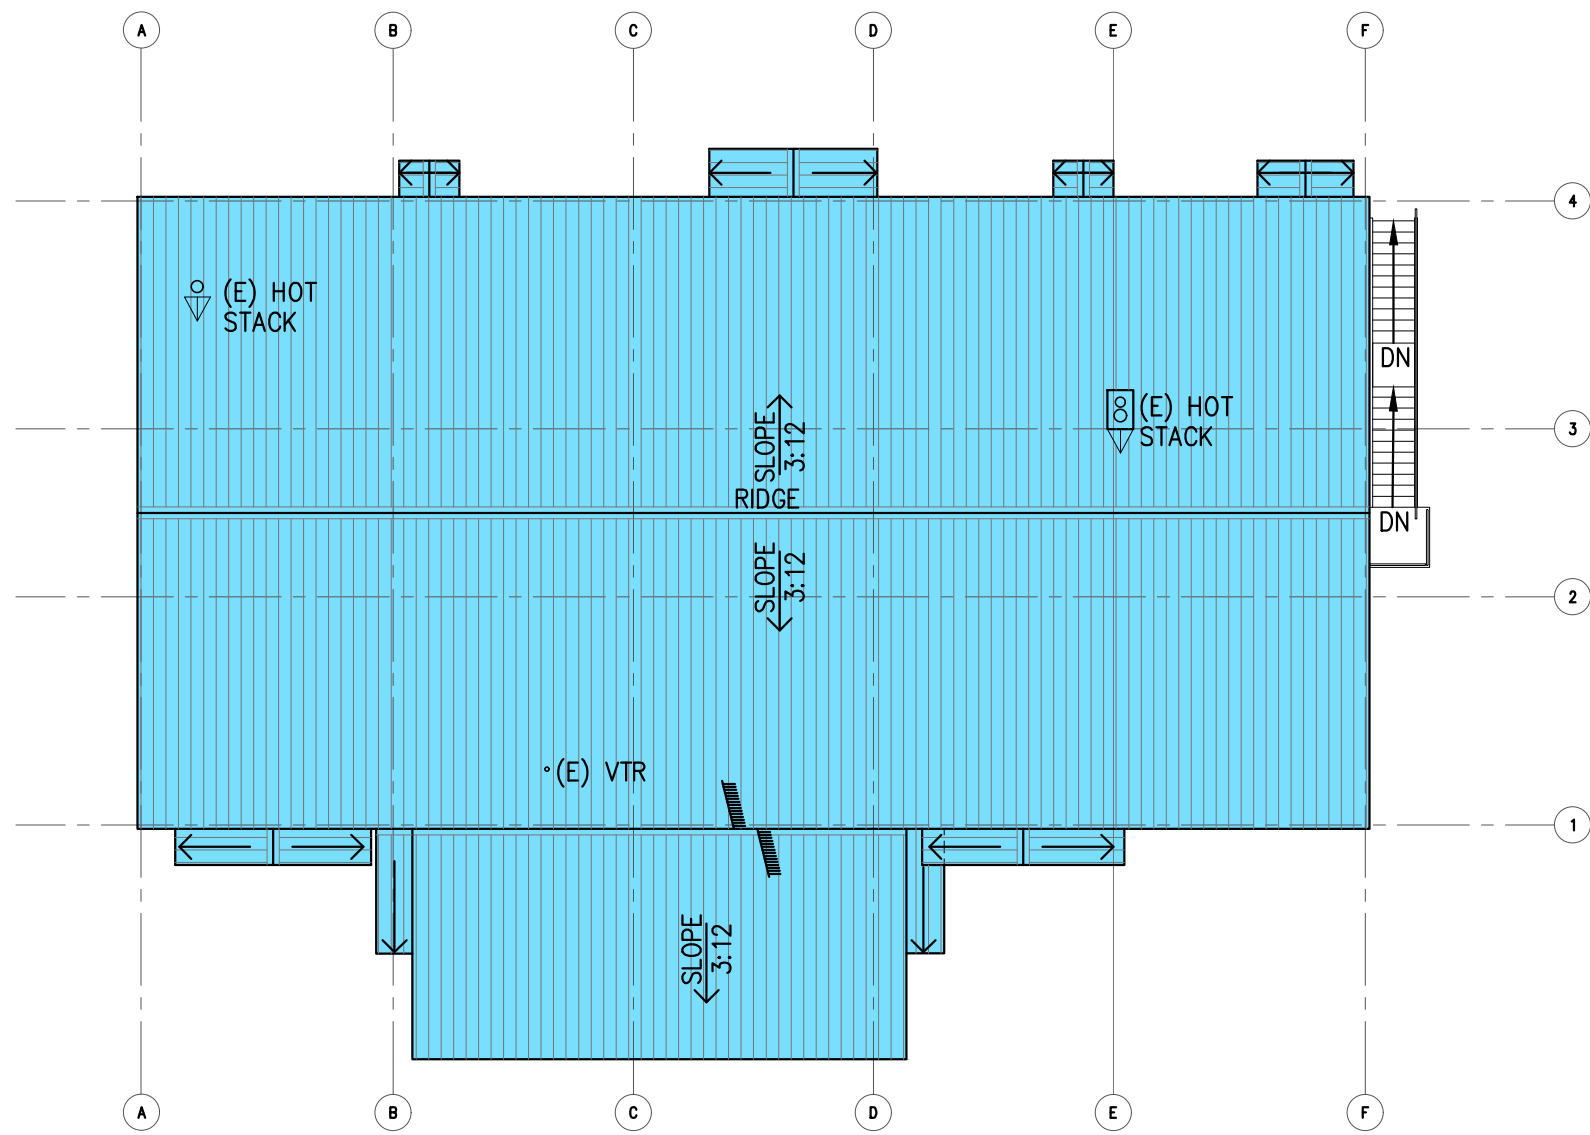
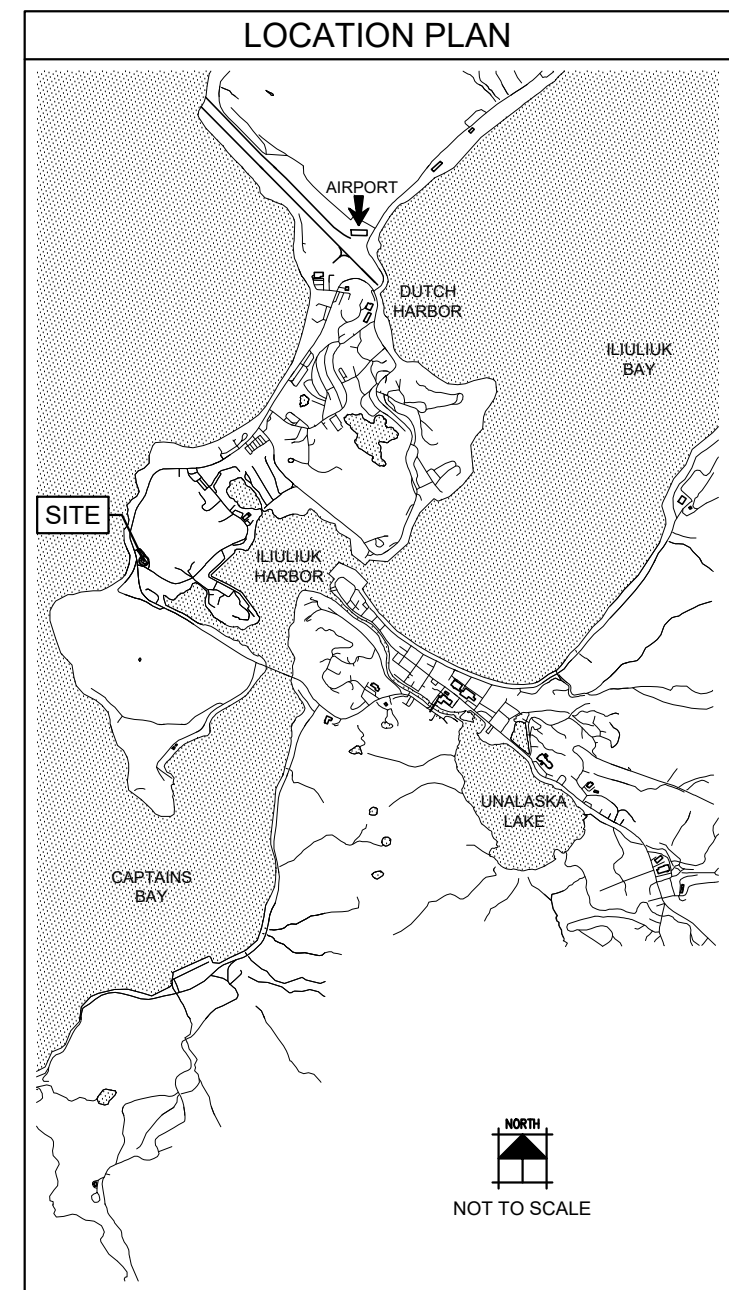
September 25, 2025 - 10:43 AM - MKORETZ - O:\GOVERNMENT\UNALASKA\3_DRAWINGS\00_AR_SHEETS - REPORT\AR-15_WASTEWATER TREATMENT PLANT.DWG

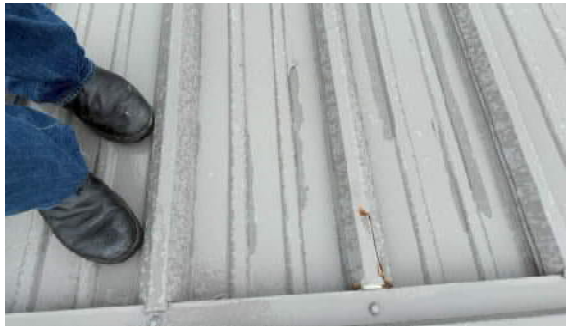
Photo #9: Rib cover is rusting and causing paint to peel.

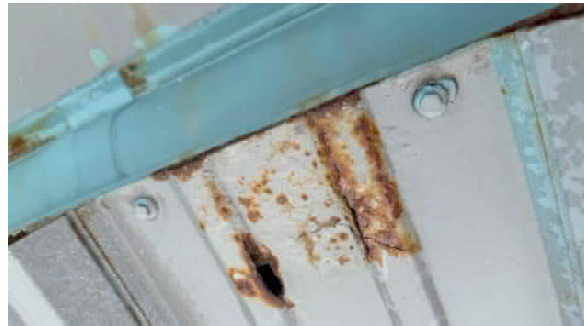
Photo #10: Roof panel at eave has hole rusted into it.
