ATTACHMENT A

AGREEMENT FOR CONSULTING AND RELATED SERVICES

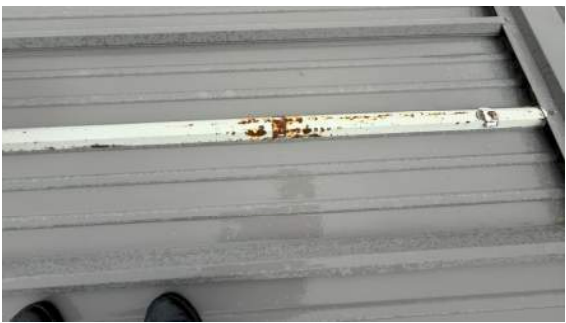
Photo #11: Multiple roofing rib covers missing, shifting or coming off.

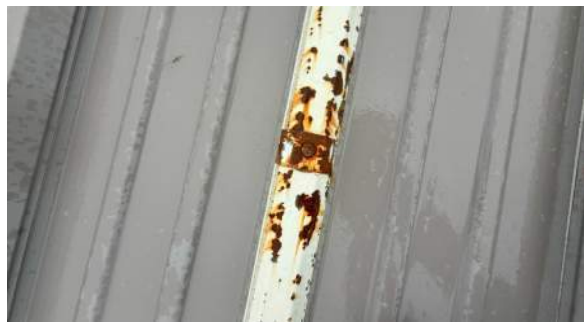
Photo #12: At missing rib cover, the rib and fastener are heavily rusted.

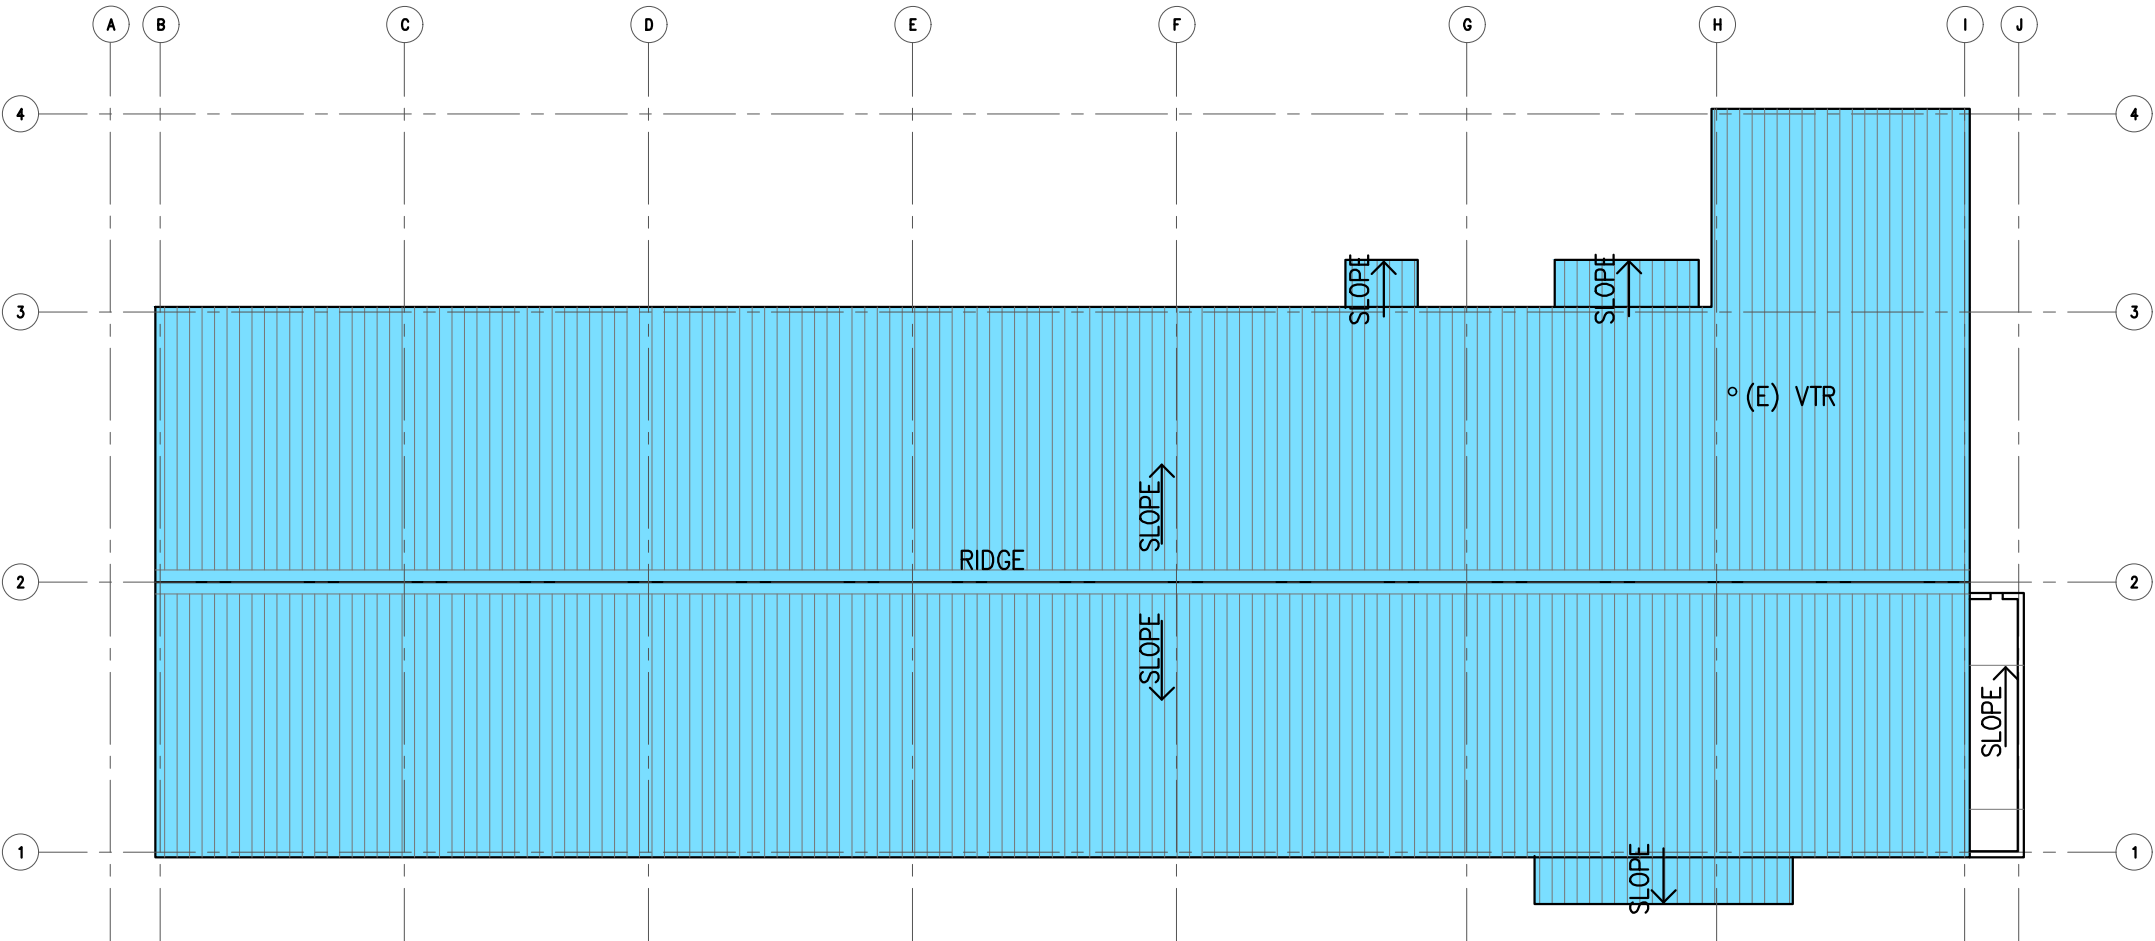
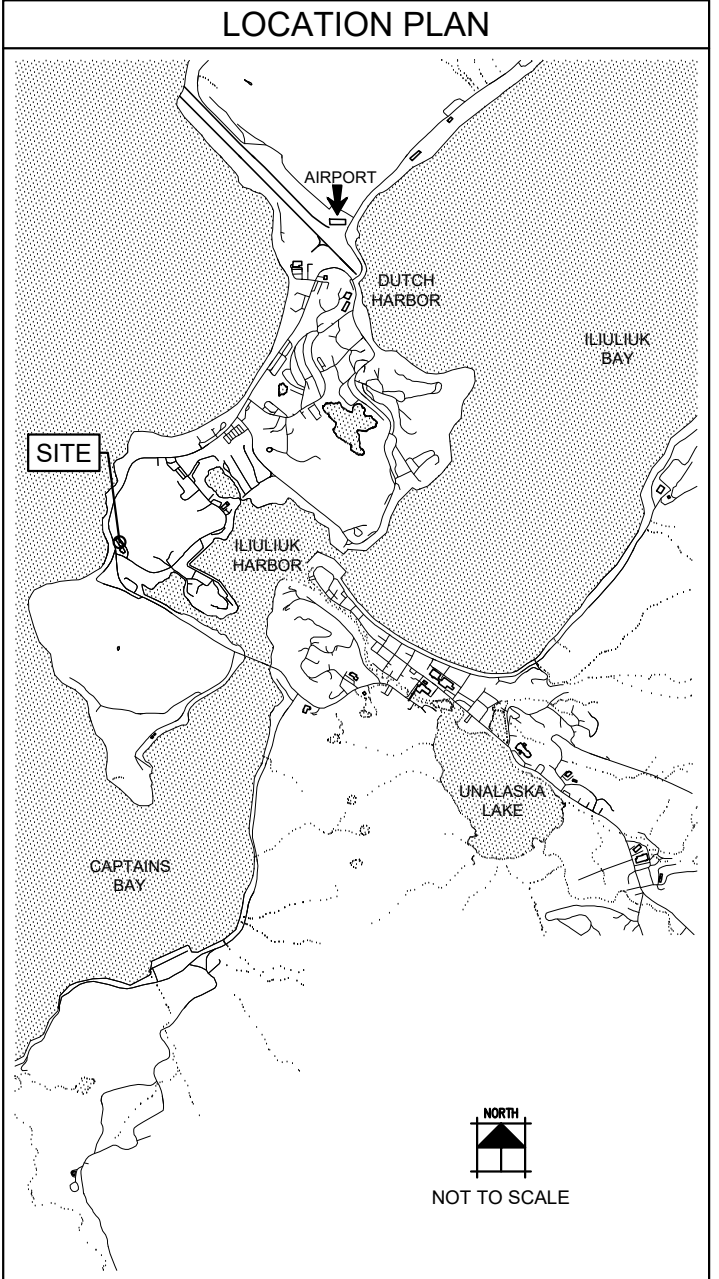
September 22, 2025 - 2:17 PM - BECKY - 0:\GOVERNMENT\UNALASKA\3_DRAWINGS\00_AR SHEETS - REPORT\AR-16_LIQUID STREAM BUILDING.DWG

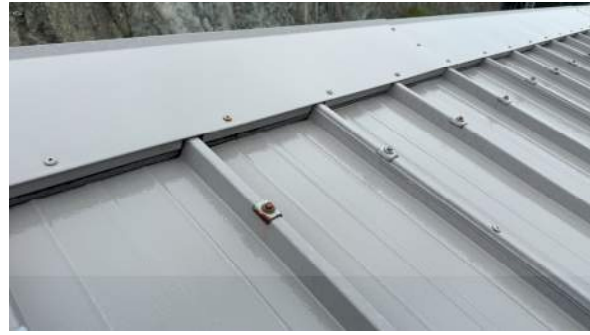
Photo #2: Rib fasteners and clamps are starting to rust.

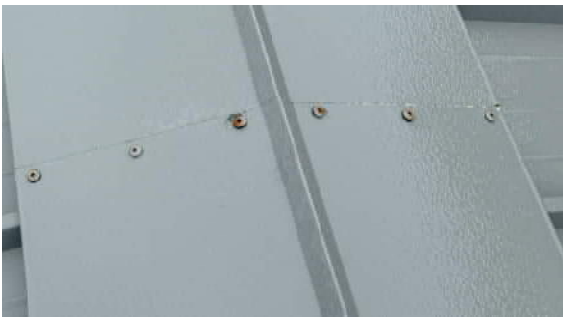
Photo #3: Rib fasteners and clamps are starting to rust. Ridge cap paint is starting to chip at fasteners.

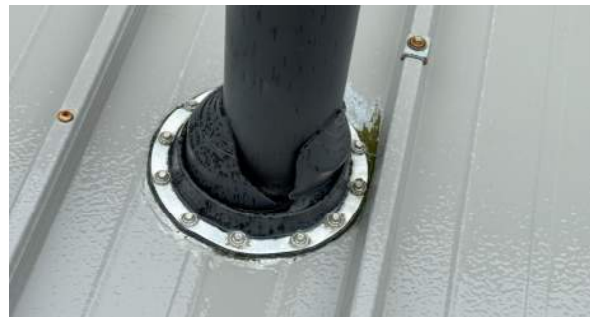
Photo #4: At PVC vent the boot is torn apart and no longer provides water protection.

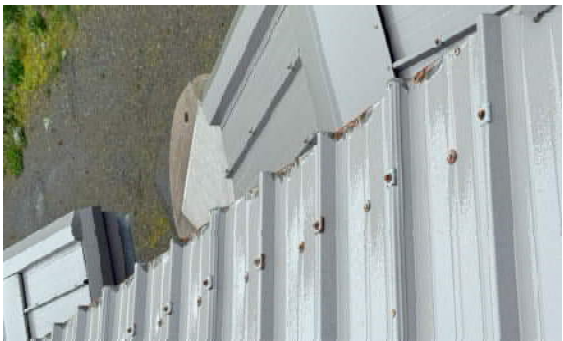
Photo #5: Roof eave paint is peeling away and starting to rust.

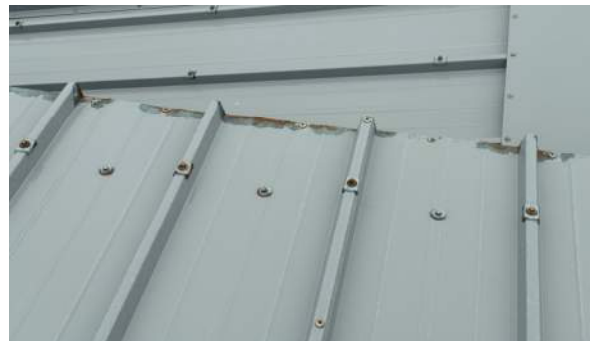
Photo #6: Roof eave paint is peeling away and starting to rust, continued.

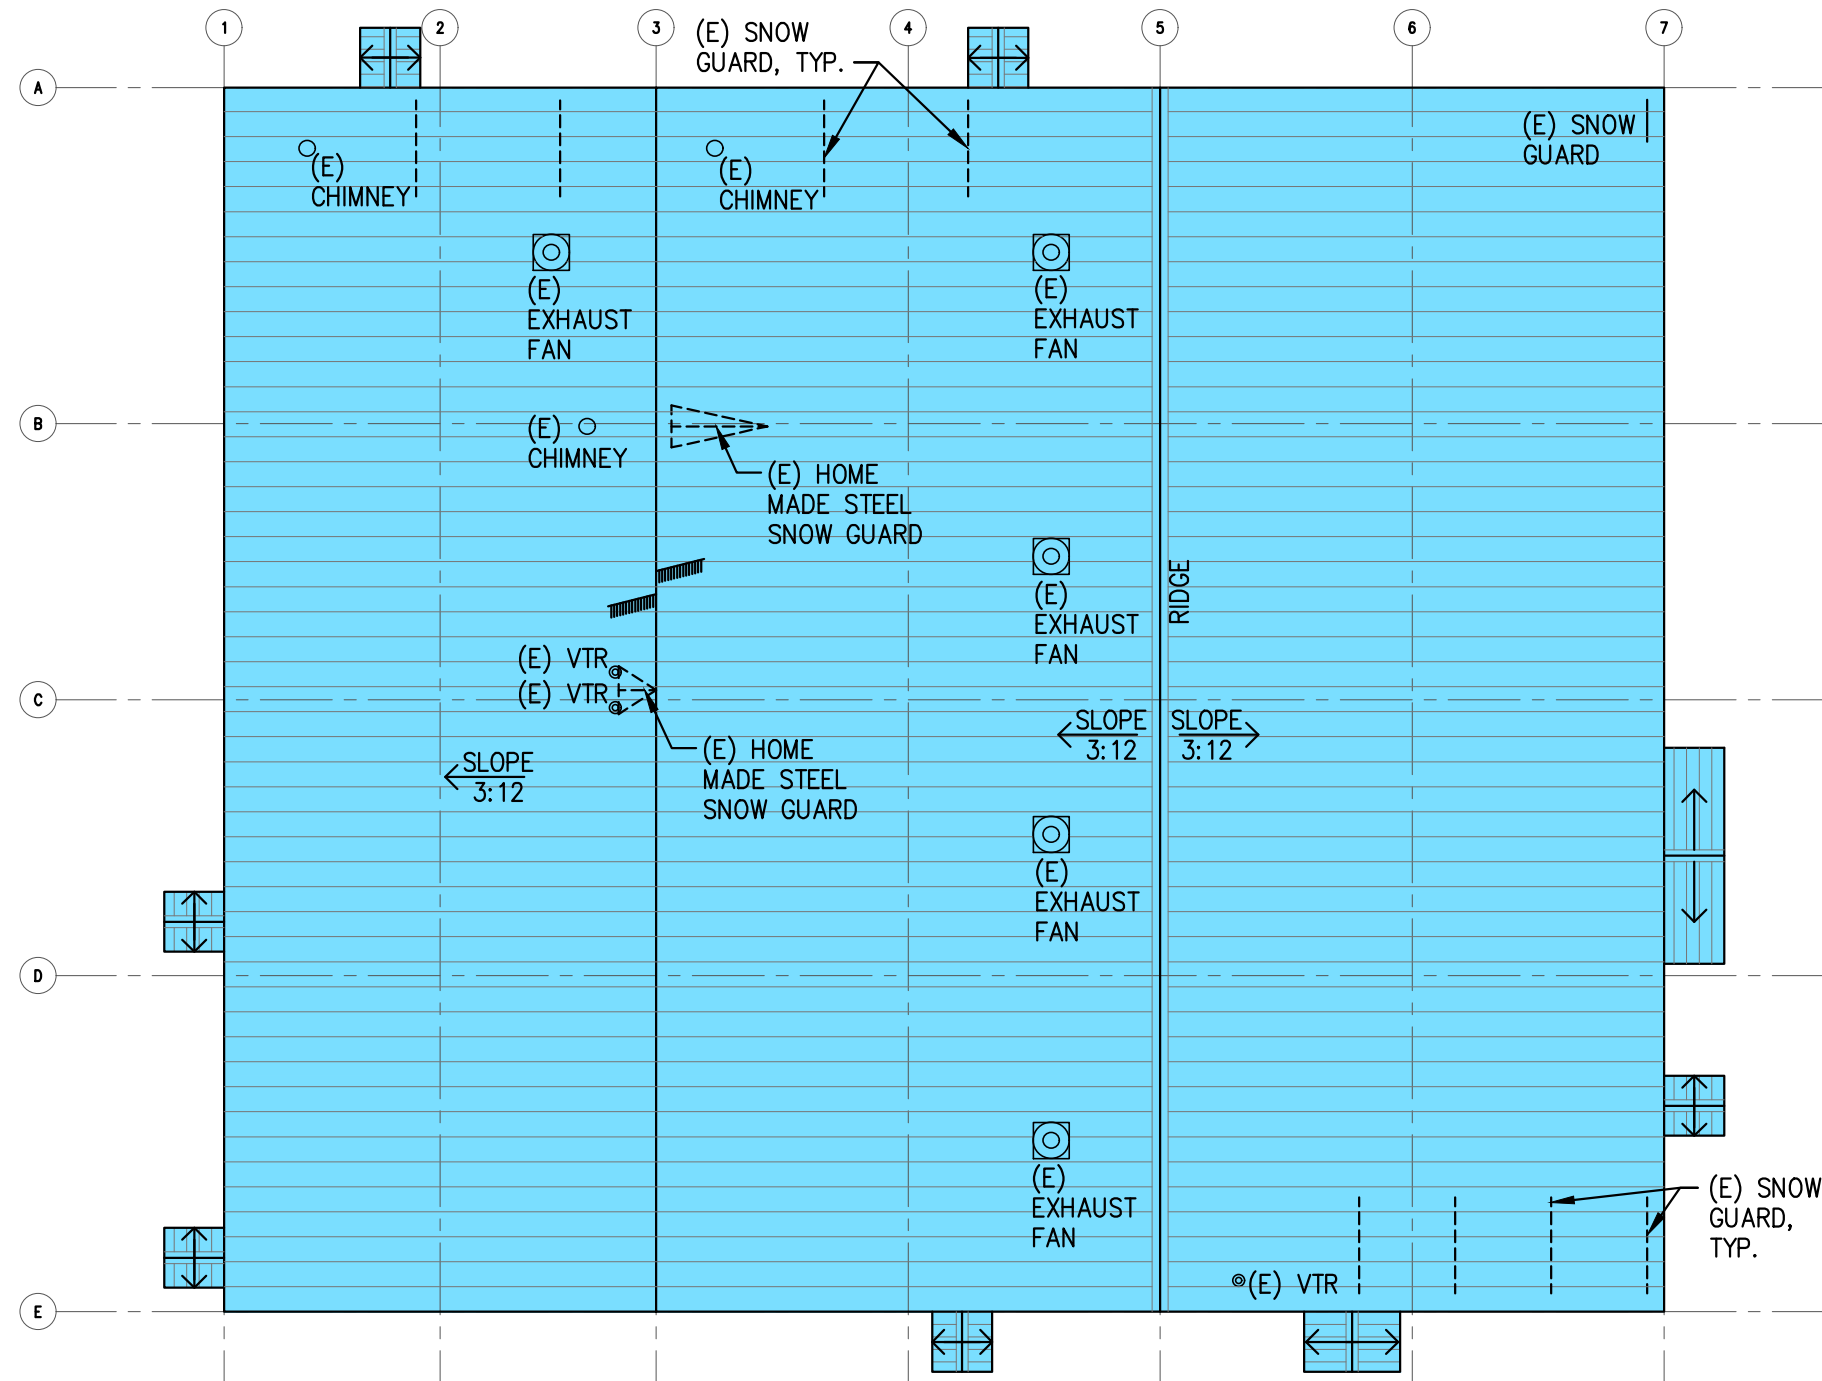
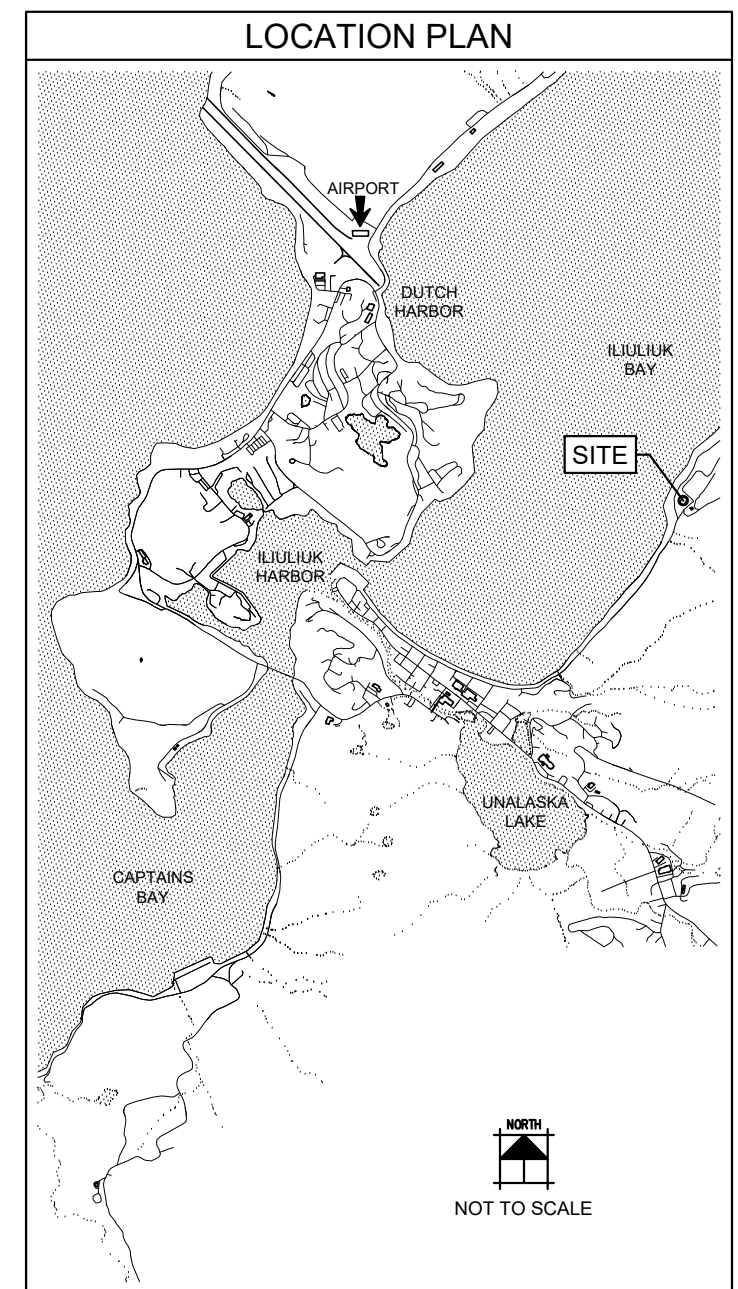
LEGEND	
	METAL ROOF Area: 12,600 SF

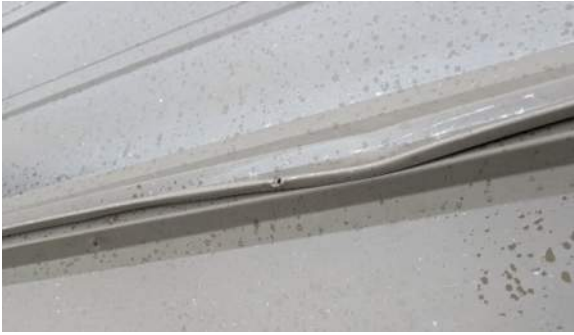
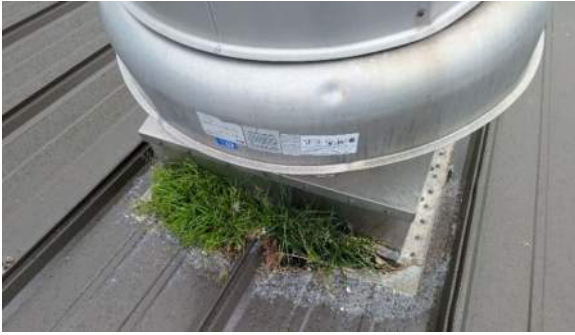
<p><i>Photo #1: Bent standing seam metal roof. Missing gasketed hex head fasteners.</i></p> <p><i>Photo #2: Grass is growing on roof.</i></p>

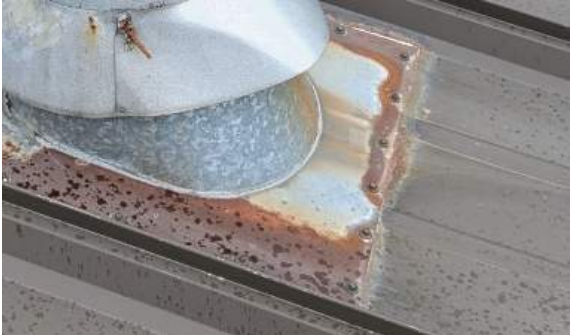
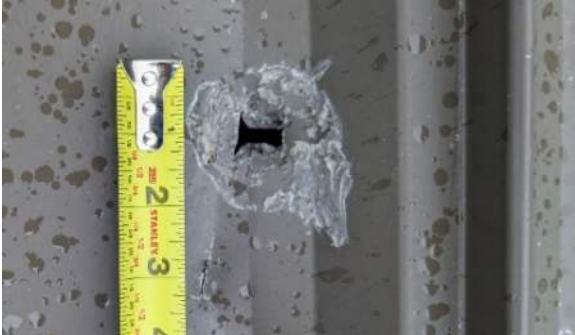
<p><i>Photo #3: Flashing at vent is rusty. Rust has spread to roof panel around the flashing.</i></p> <p><i>Photo #4: Two holes in roof panel; looks like something heavy was dropped on it.</i></p>

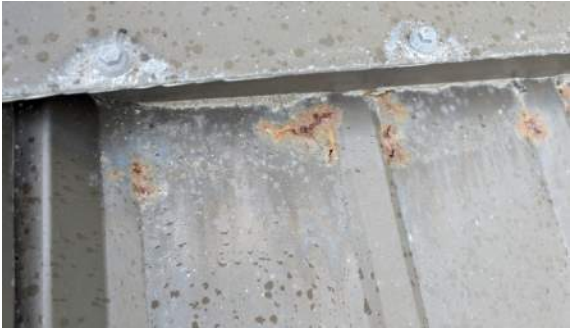
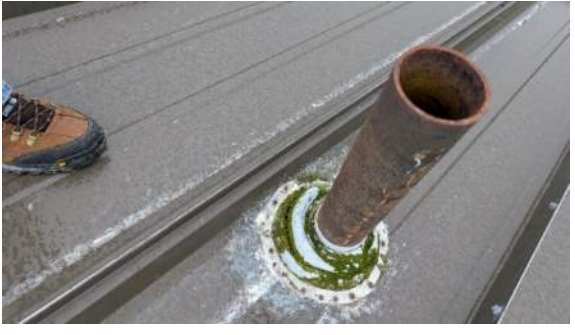
<p><i>Photo #5: Roof panel has multiple rust holes.</i></p> <p><i>Photo #6: Moss growing on ventilation rubber boot.</i></p>

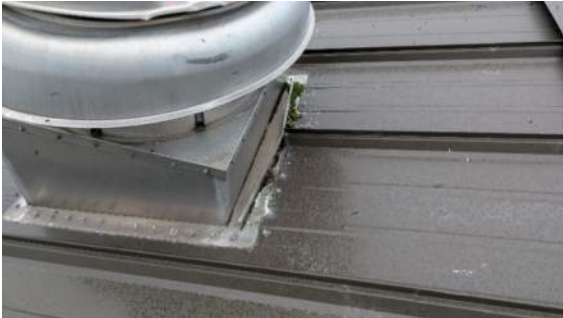
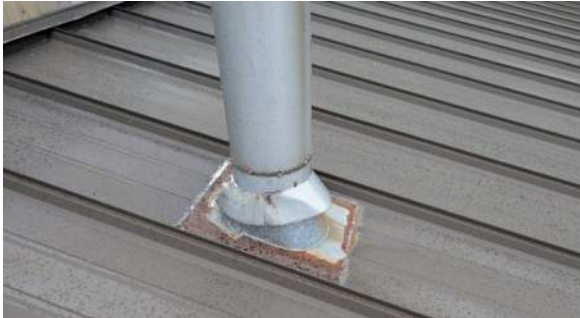
<p><i>Photo #7: Moss growing on roof, dented exhaust hood.</i></p> <p><i>Photo #8: Chimney mounts are rusting at roof connections.</i></p>

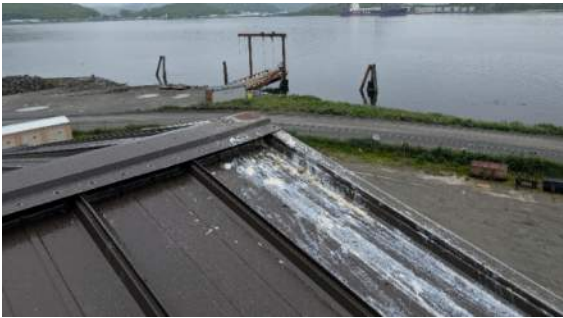
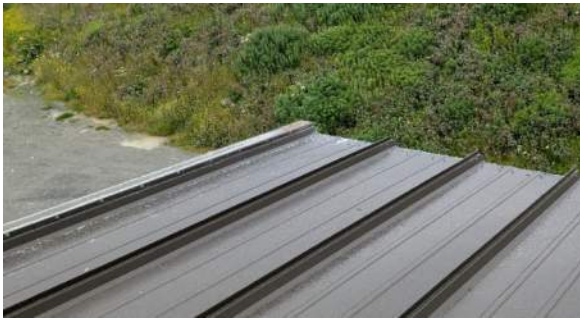
<p><i>Photo #9: Ridge flashing is rusting at the end where the eagles like to sit.</i></p> <p><i>Photo #10: Ridge flashing is rusting at the end where the eagles like to sit, continued.</i></p>

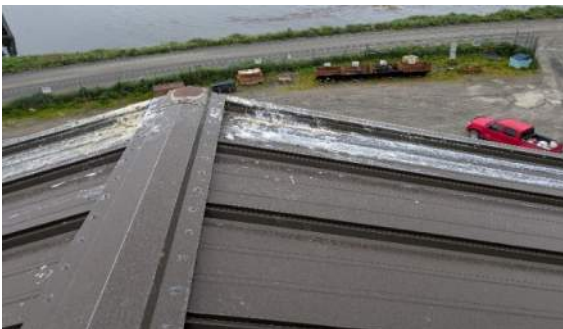
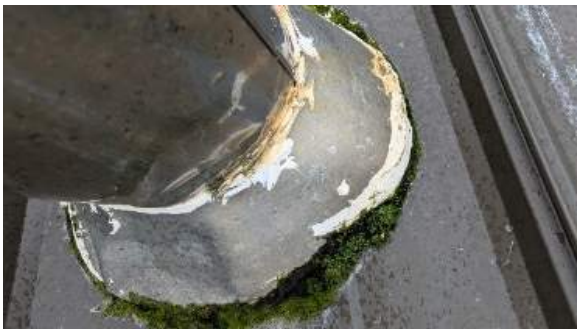
<p><i>Photo #11: Ridge Flashing is rusting at the end where the eagles like to sit, continued.</i></p> <p><i>Photo #12: Moss and grass are growing at exhaust vents.</i></p>

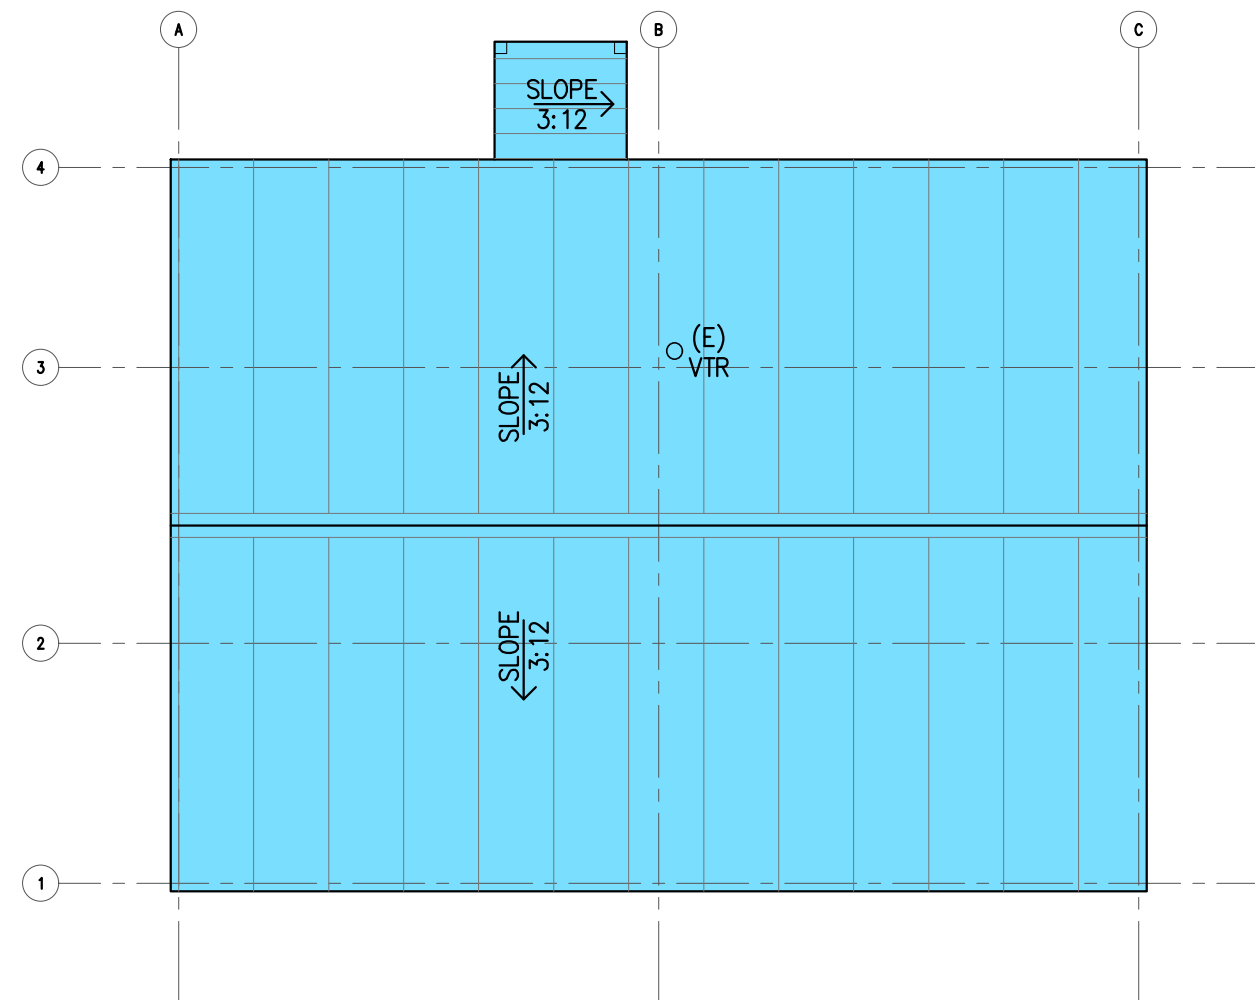
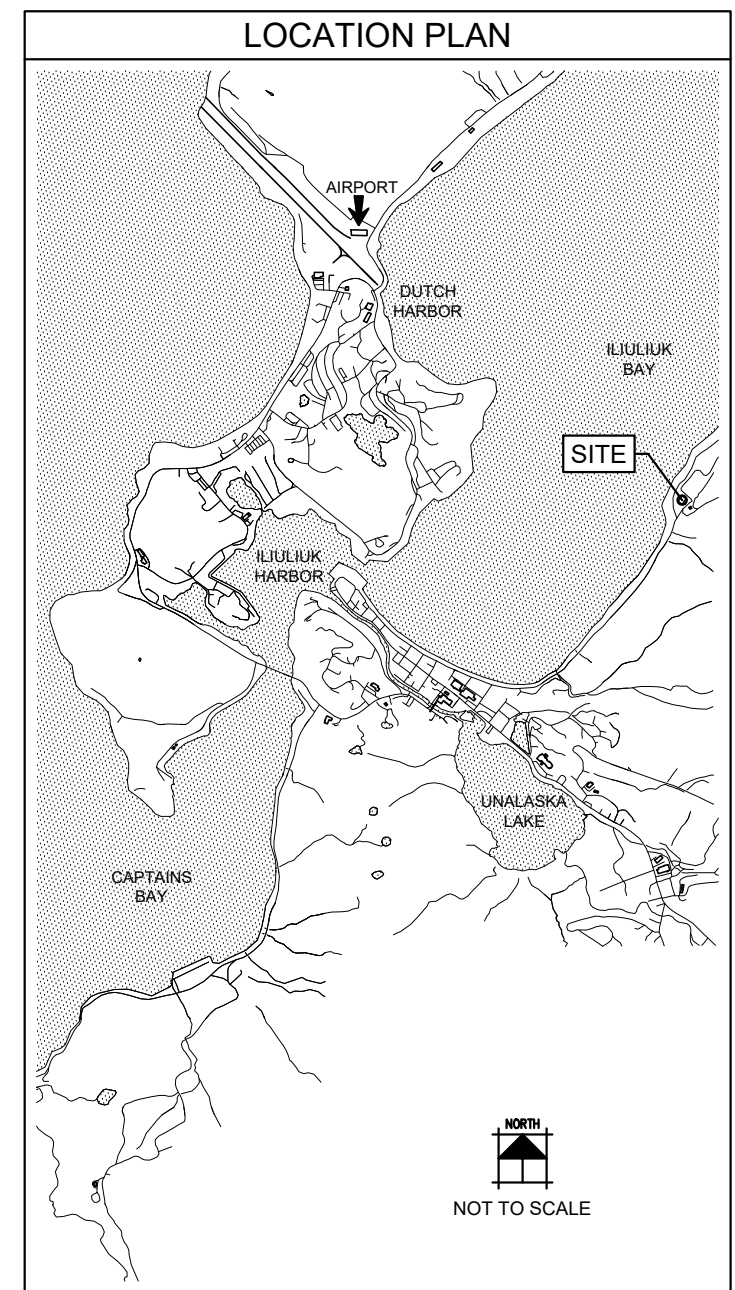
September 22, 2025 - 2:19 PM - BECKY - O:\GOVERNMENT\UNALASKA\3_DRAWINGS\00_AR_SHEETS - REPORT\AR-18_LEACHATE BUILDING.DWG

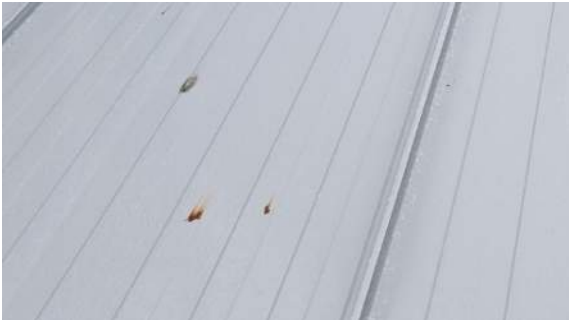
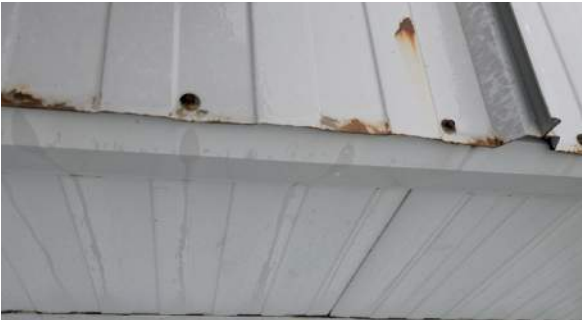
<p><i>Photo #1: Paint coating has worn through at spots and has started to rust.</i></p>	<p><i>Photo #2: Paint coating has worn through at edges and has started to rust.</i></p>

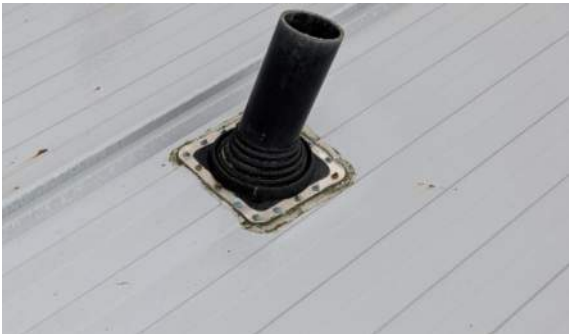
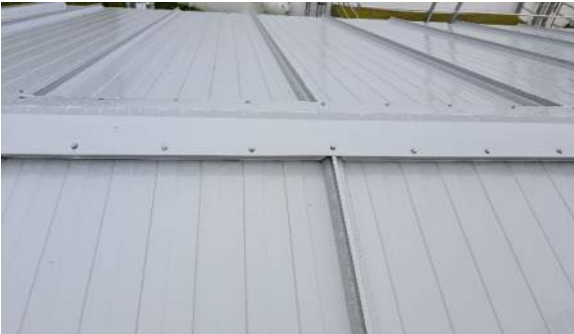
<p><i>Photo #3: Moss growing in sealant.</i></p>	<p><i>Photo #4: Gaps at ridge seam closures.</i></p>

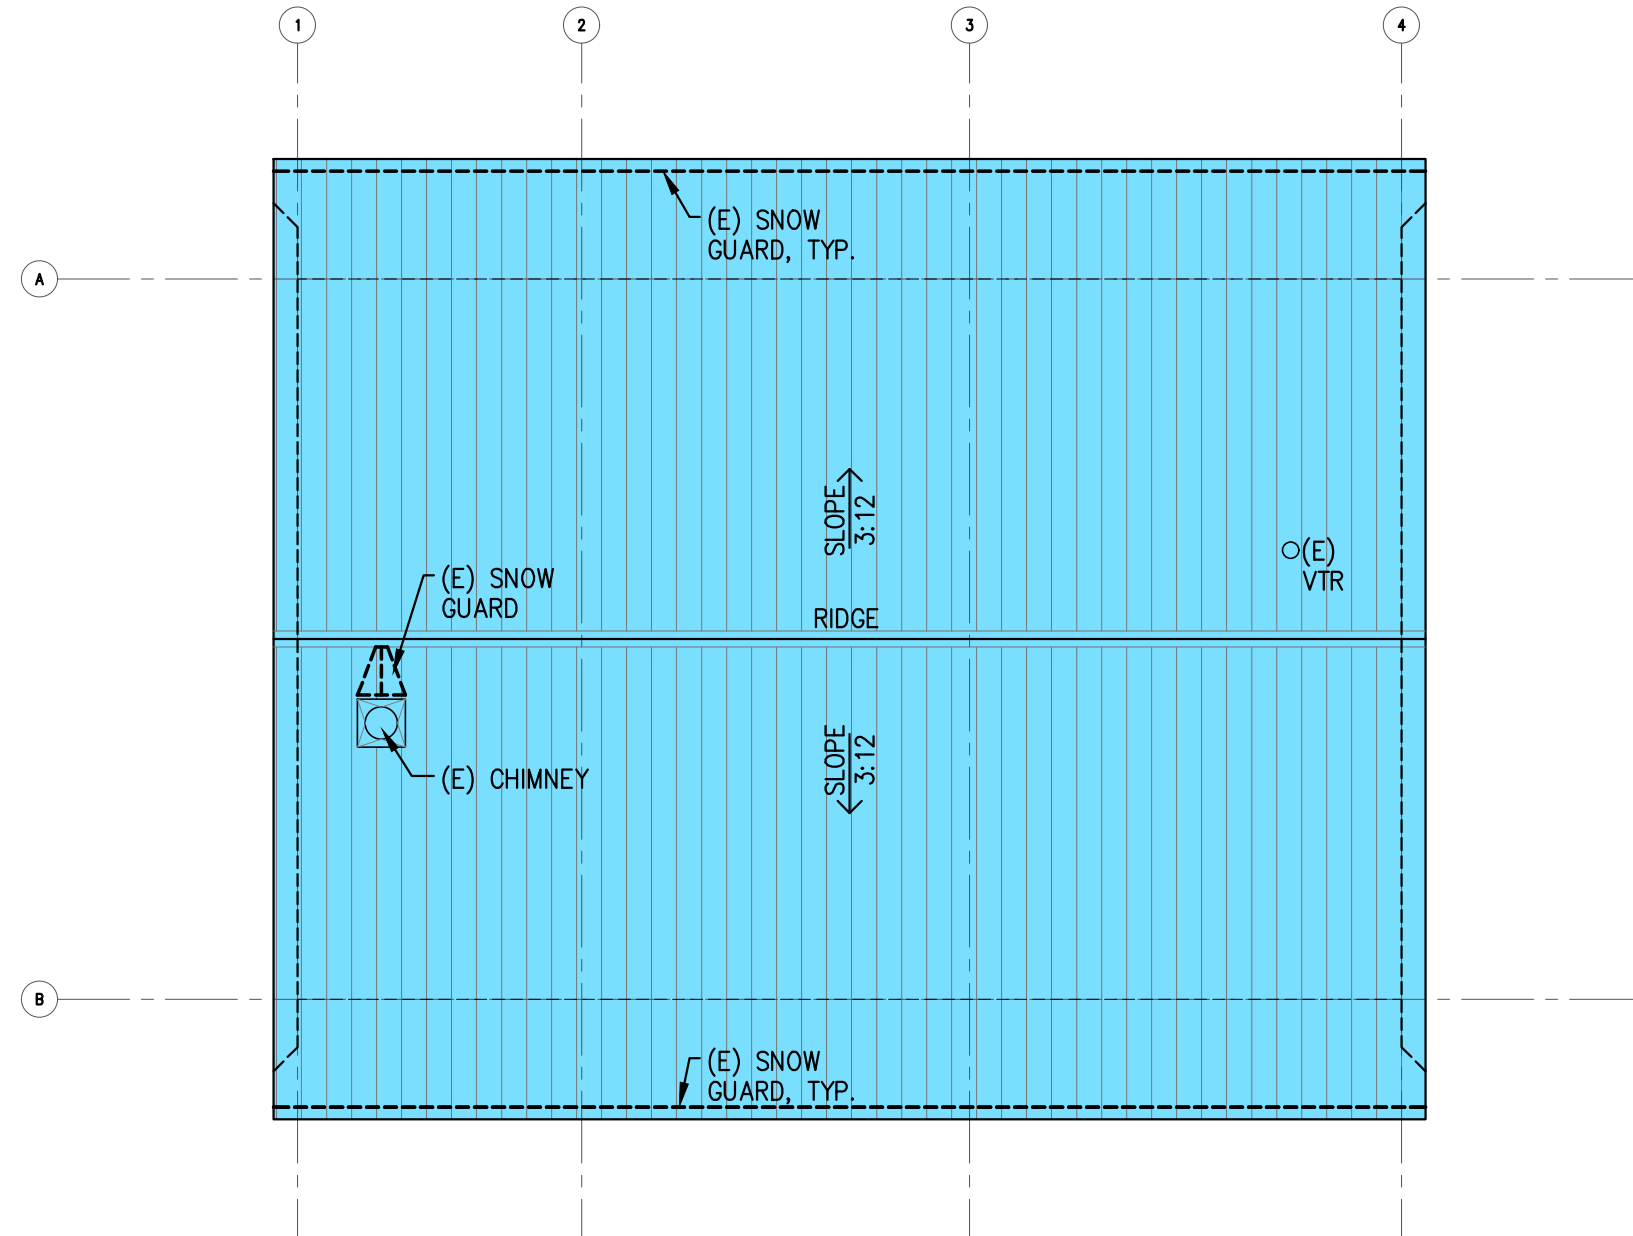
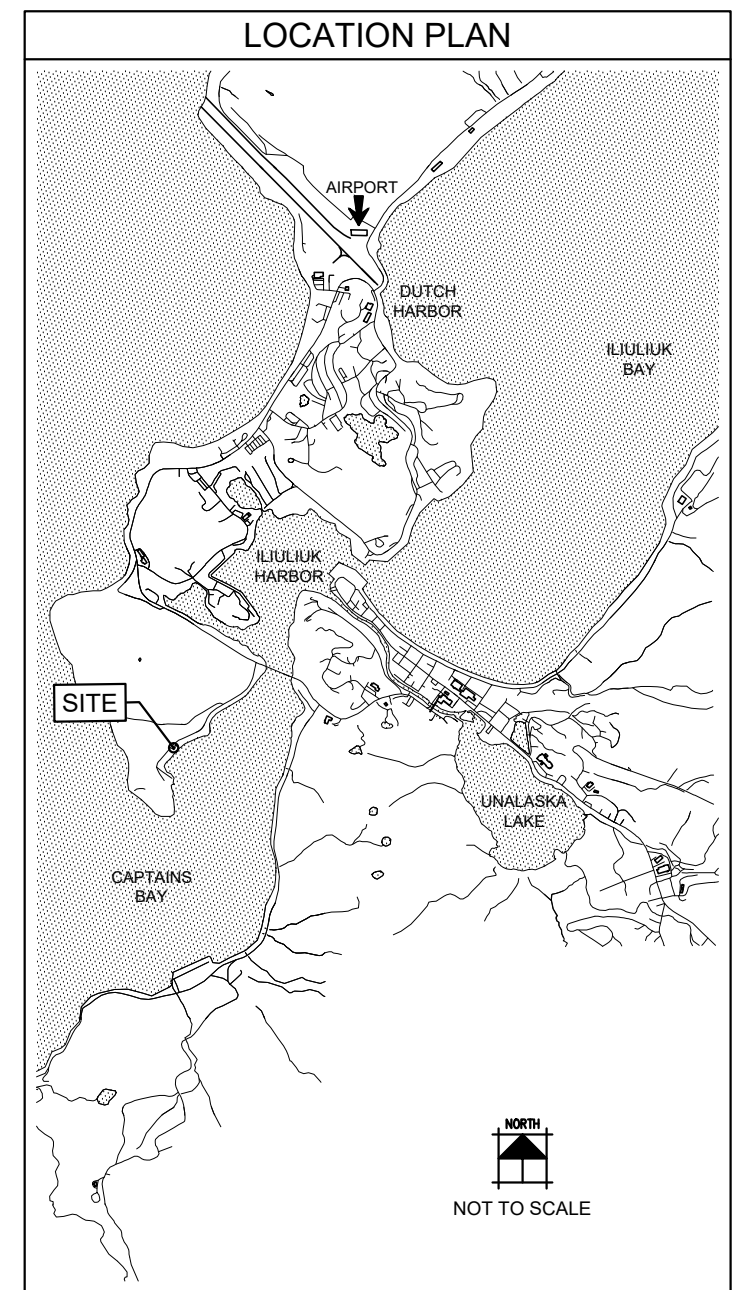
LEGEND	
	METAL ROOF Area: 2,000 SF

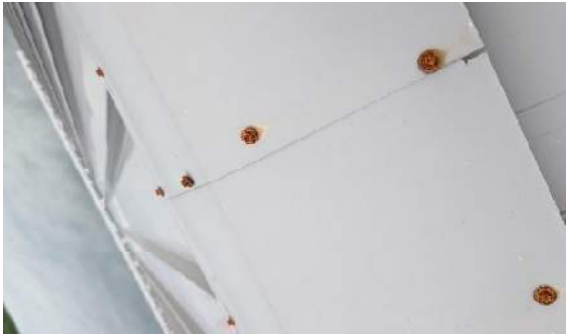
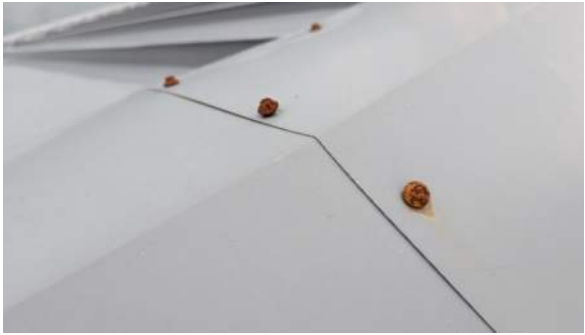
<p><i>Photo #1: Rusted gasketed hex head fasteners.</i></p>	<p><i>Photo #2: Some gasketed hex head fasteners are loose or have cracked gaskets.</i></p>

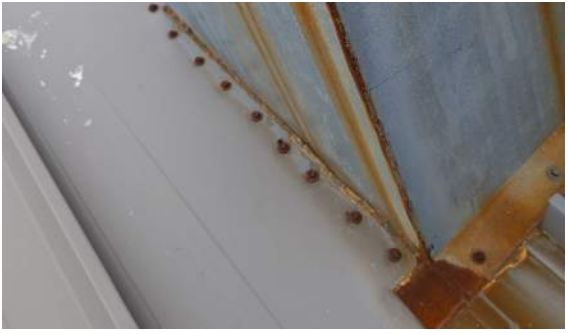
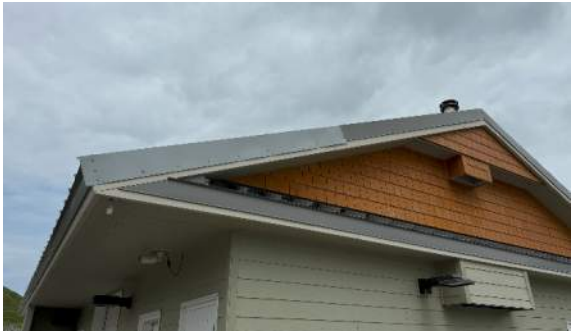
<p><i>Photo #3: Sealant around chimney hood is cracking and pulling away from flashing.</i></p>	<p><i>Photo #4: Rake flashing replacement due to wind event.</i></p>

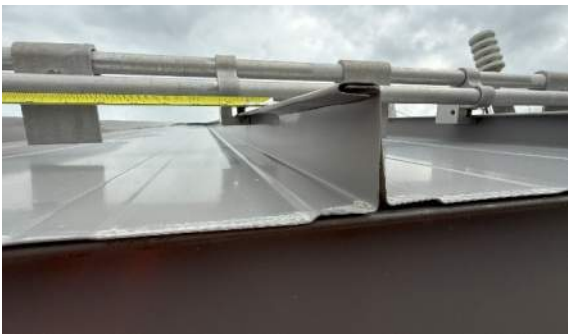
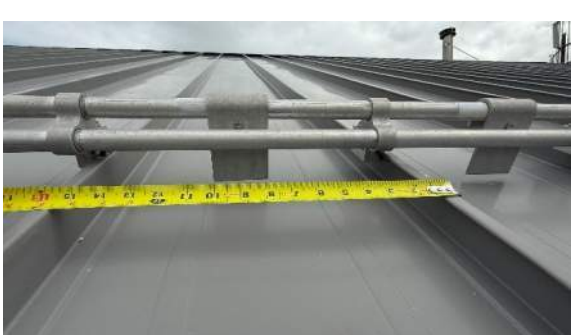
<p><i>Photo #5: Snowguard at roof eave.</i></p>	<p><i>Photo #6: Snowguard measurement.</i></p>

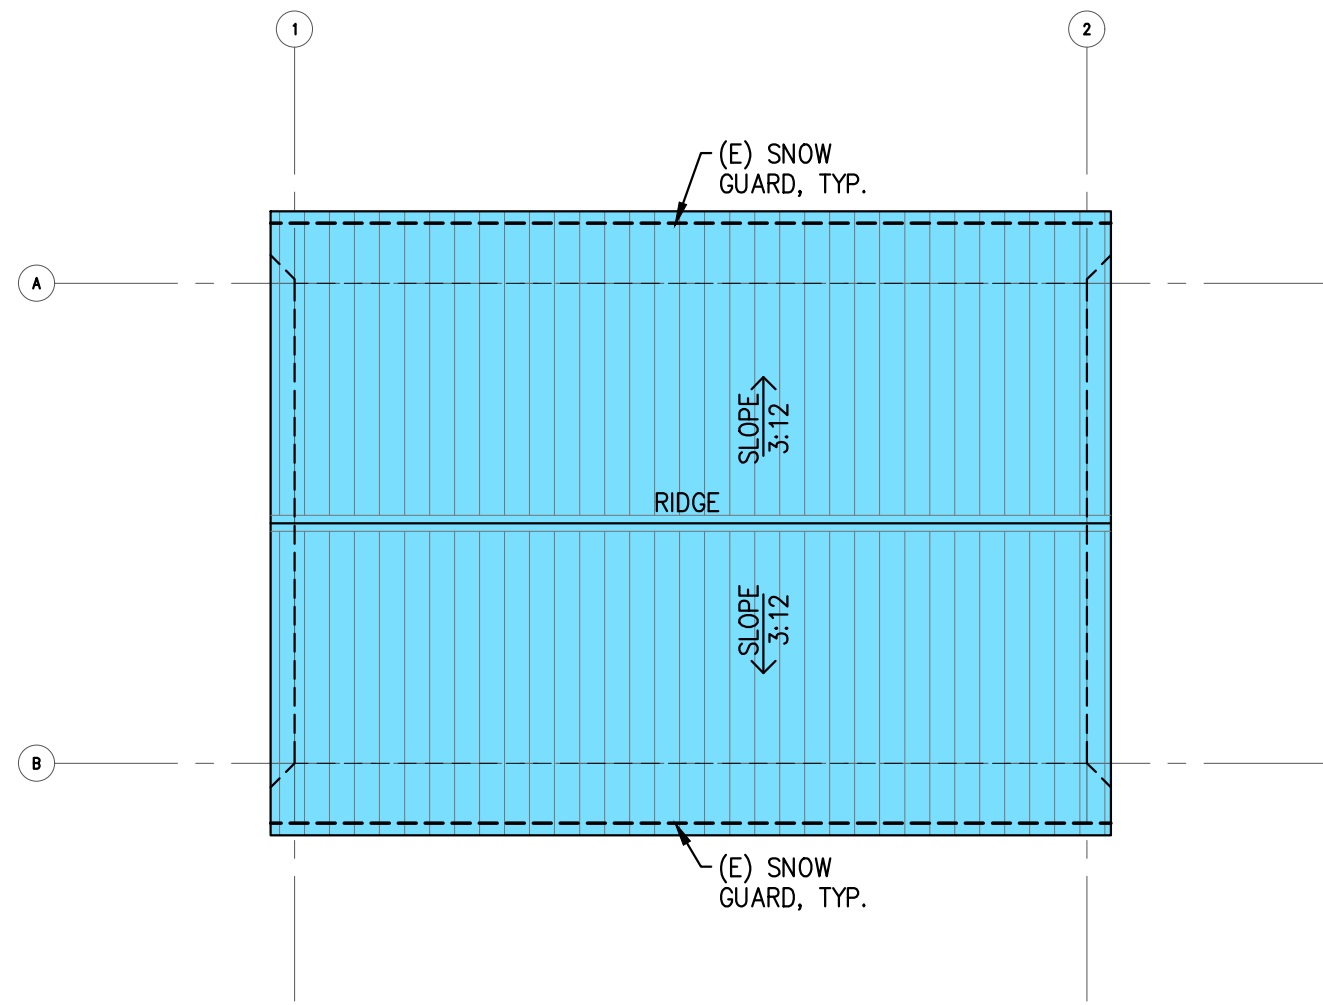
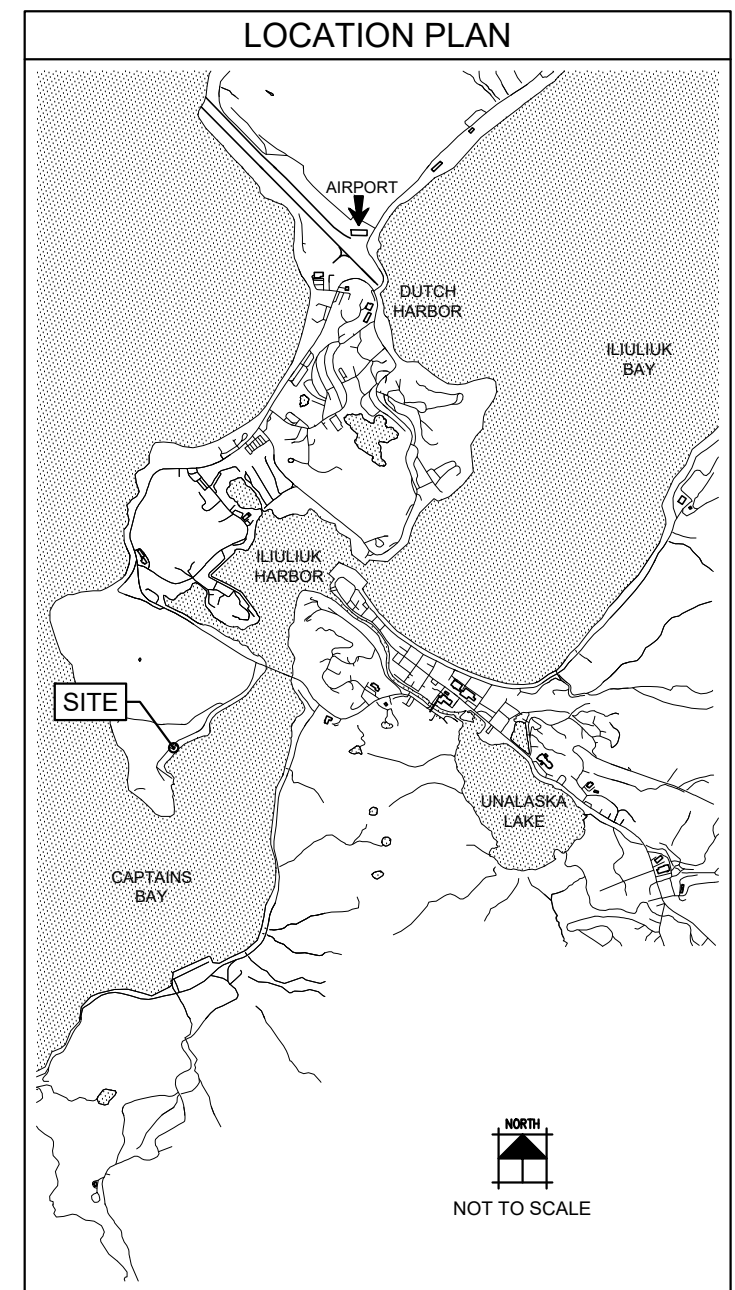
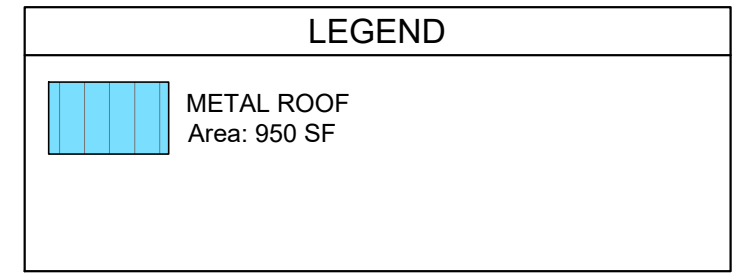
September 22, 2025 - 2:28 PM - BECKY - O:\GOVERNMENT\UNALASKA\3_DRAWINGS\00_AR SHEETS - REPORT\AR-20_CEM BOAT HARBOR WASTE OIL BLDG.DWG

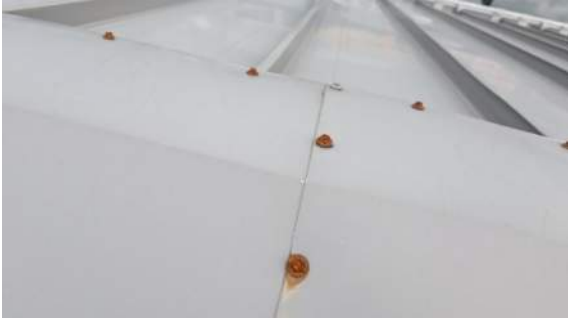
Photo #1: Rusted gasketed hex head fasteners.

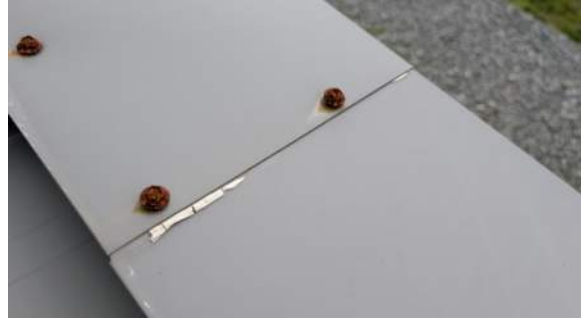
Photo #2: Sealant between lapped flashing is cracked and falling away.

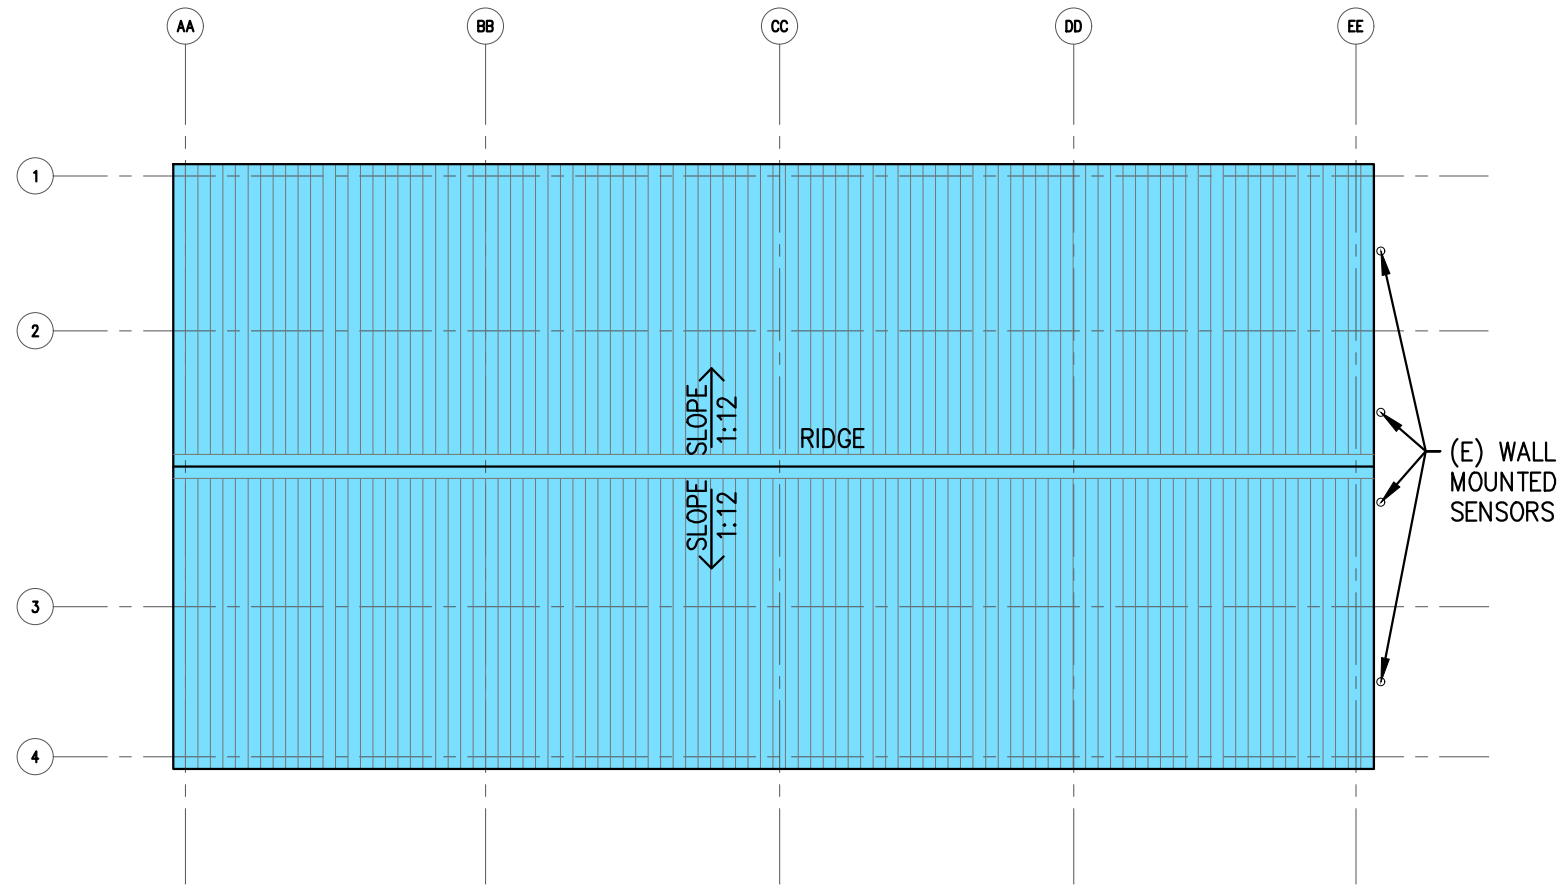
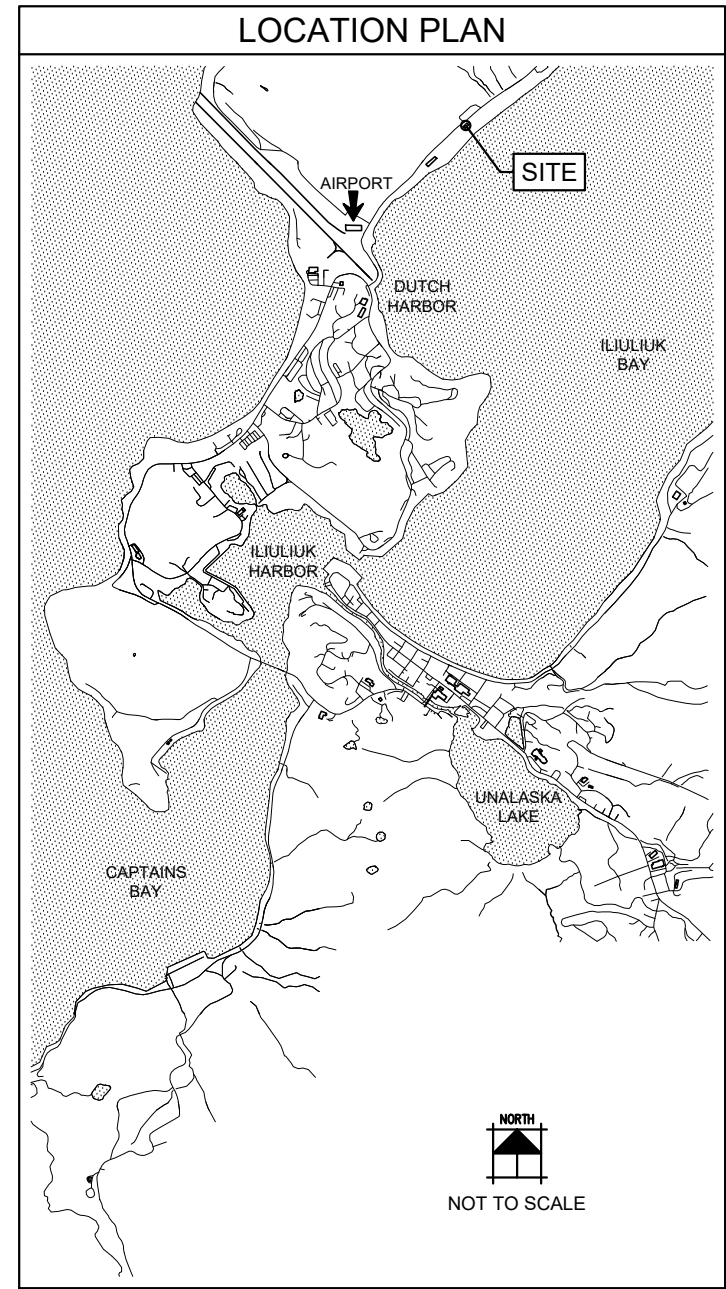
September 22, 2025 - 2:29 PM - BECKY - O:\GOVERNMENT\UNALASKA\3_DRAWINGS\00_AR_SHEETS - REPORT\AR-21_UNALASKA MARINE CENTER WAREHOUSE.DWG
