ATTACHMENT A

AGREEMENT FOR CONSULTING AND RELATED SERVICES

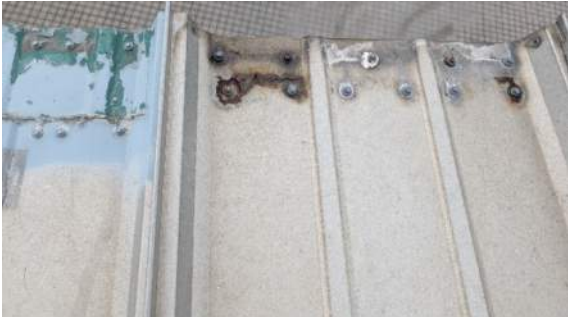
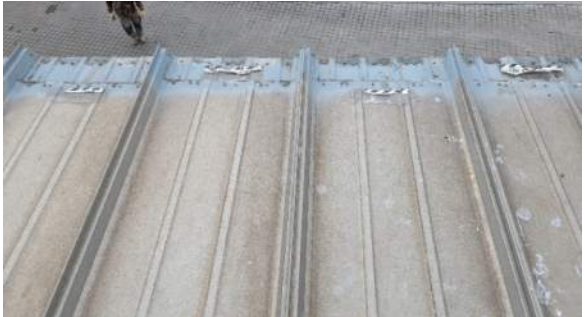
<p><i>Photo #1: Roof at eave is rusted through at fasteners, multiple locations.</i></p> <p><i>Photo #2: Roof has been repaired in multiple locations with non-matching roof material.</i></p>

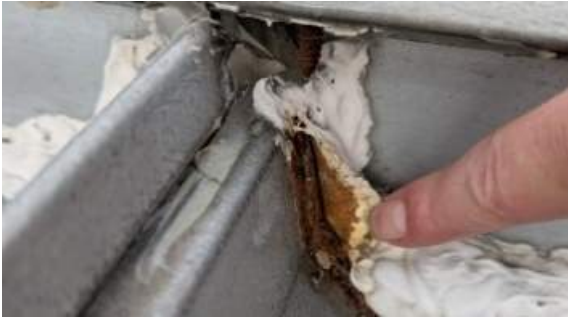
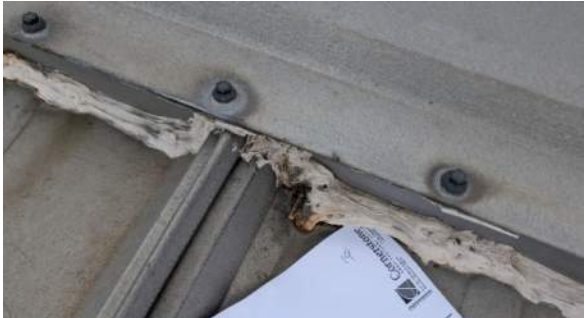
<p><i>Photo #3: Sealant at ridge closer is no longer adhering at multiple locations.</i></p> <p><i>Photo #4: Multiple holes in metal roof have been patched with sealant.</i></p>

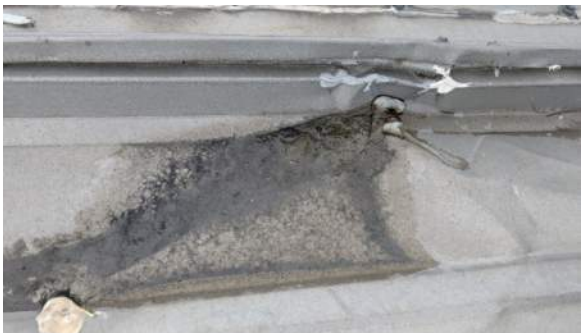
<p><i>Photo #5: Damaged area of roof from wind damage being held down with sandbags and other materials.</i></p> <p><i>Photo #6: Multiple holes in metal roof have been patched with sealant.</i></p>

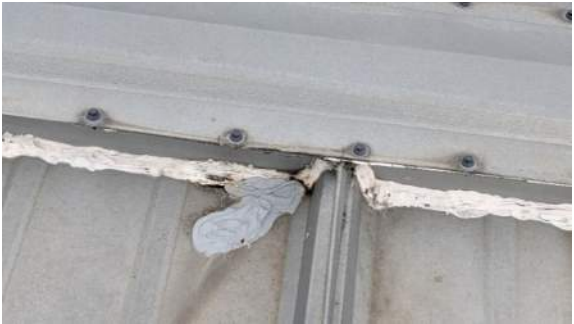
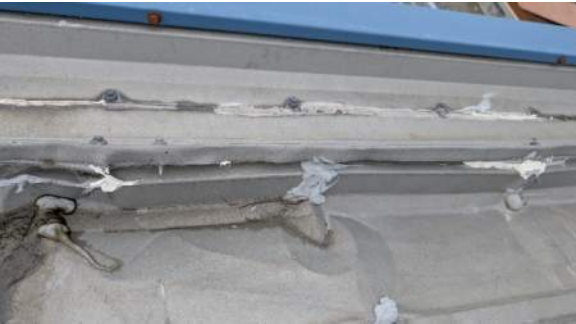
<i>Photo #7: Patched Hole</i>	<i>Photo #8: Patched Holes</i>

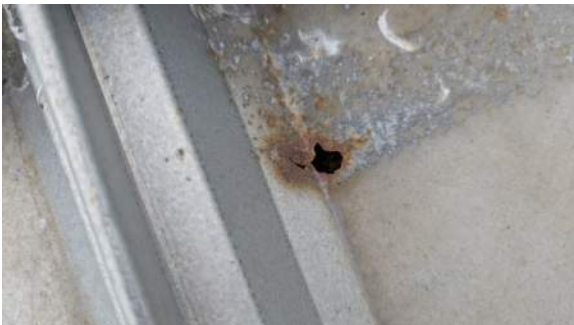
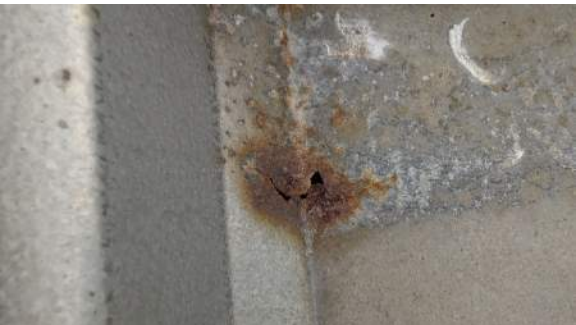
<i>Photo #9: Corroded hole in metal roof</i>	<i>Photo #10: Corroded hole in metal roof</i>

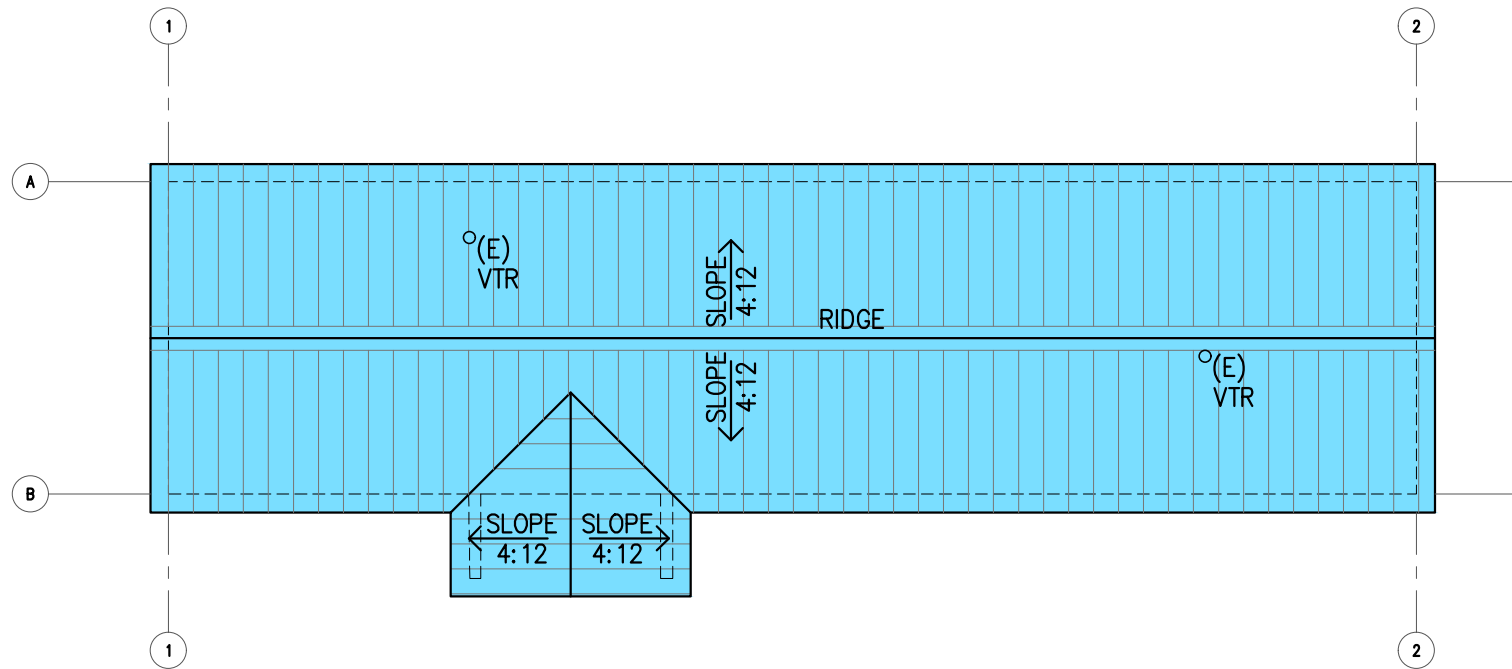
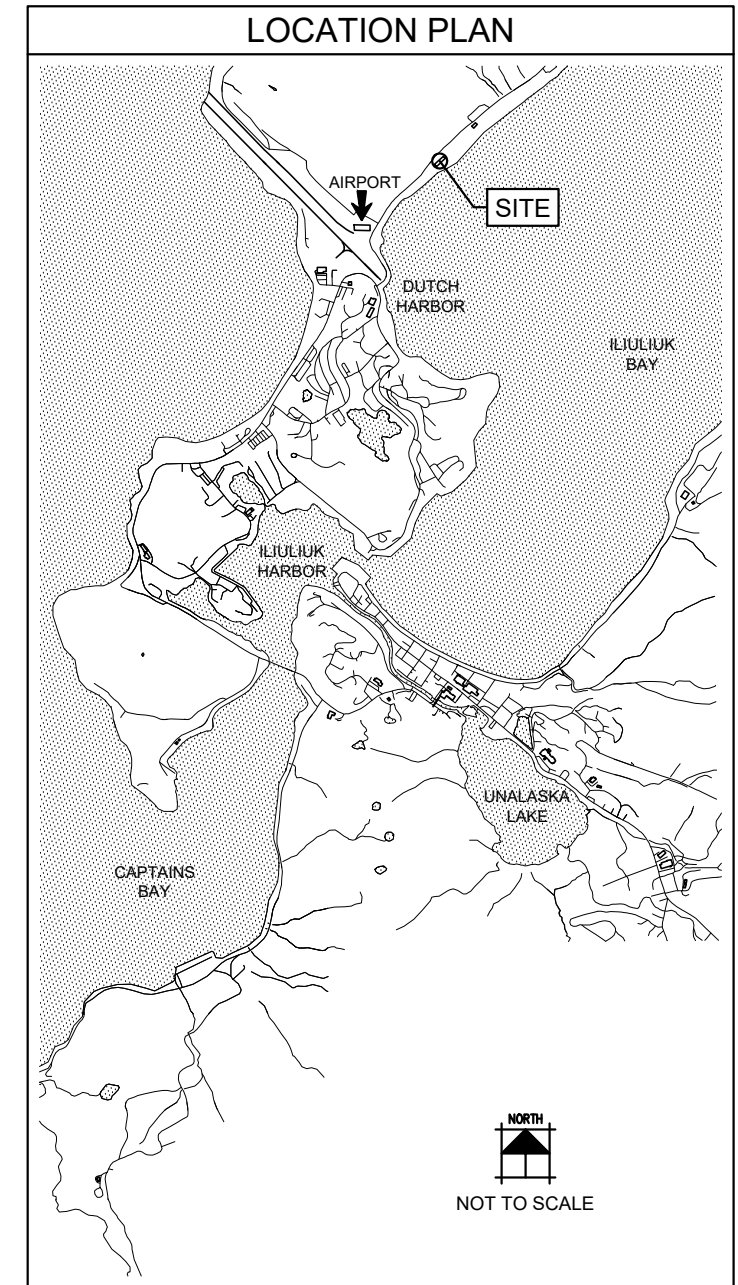
LEGEND	
	METAL ROOF Area: 900 SF

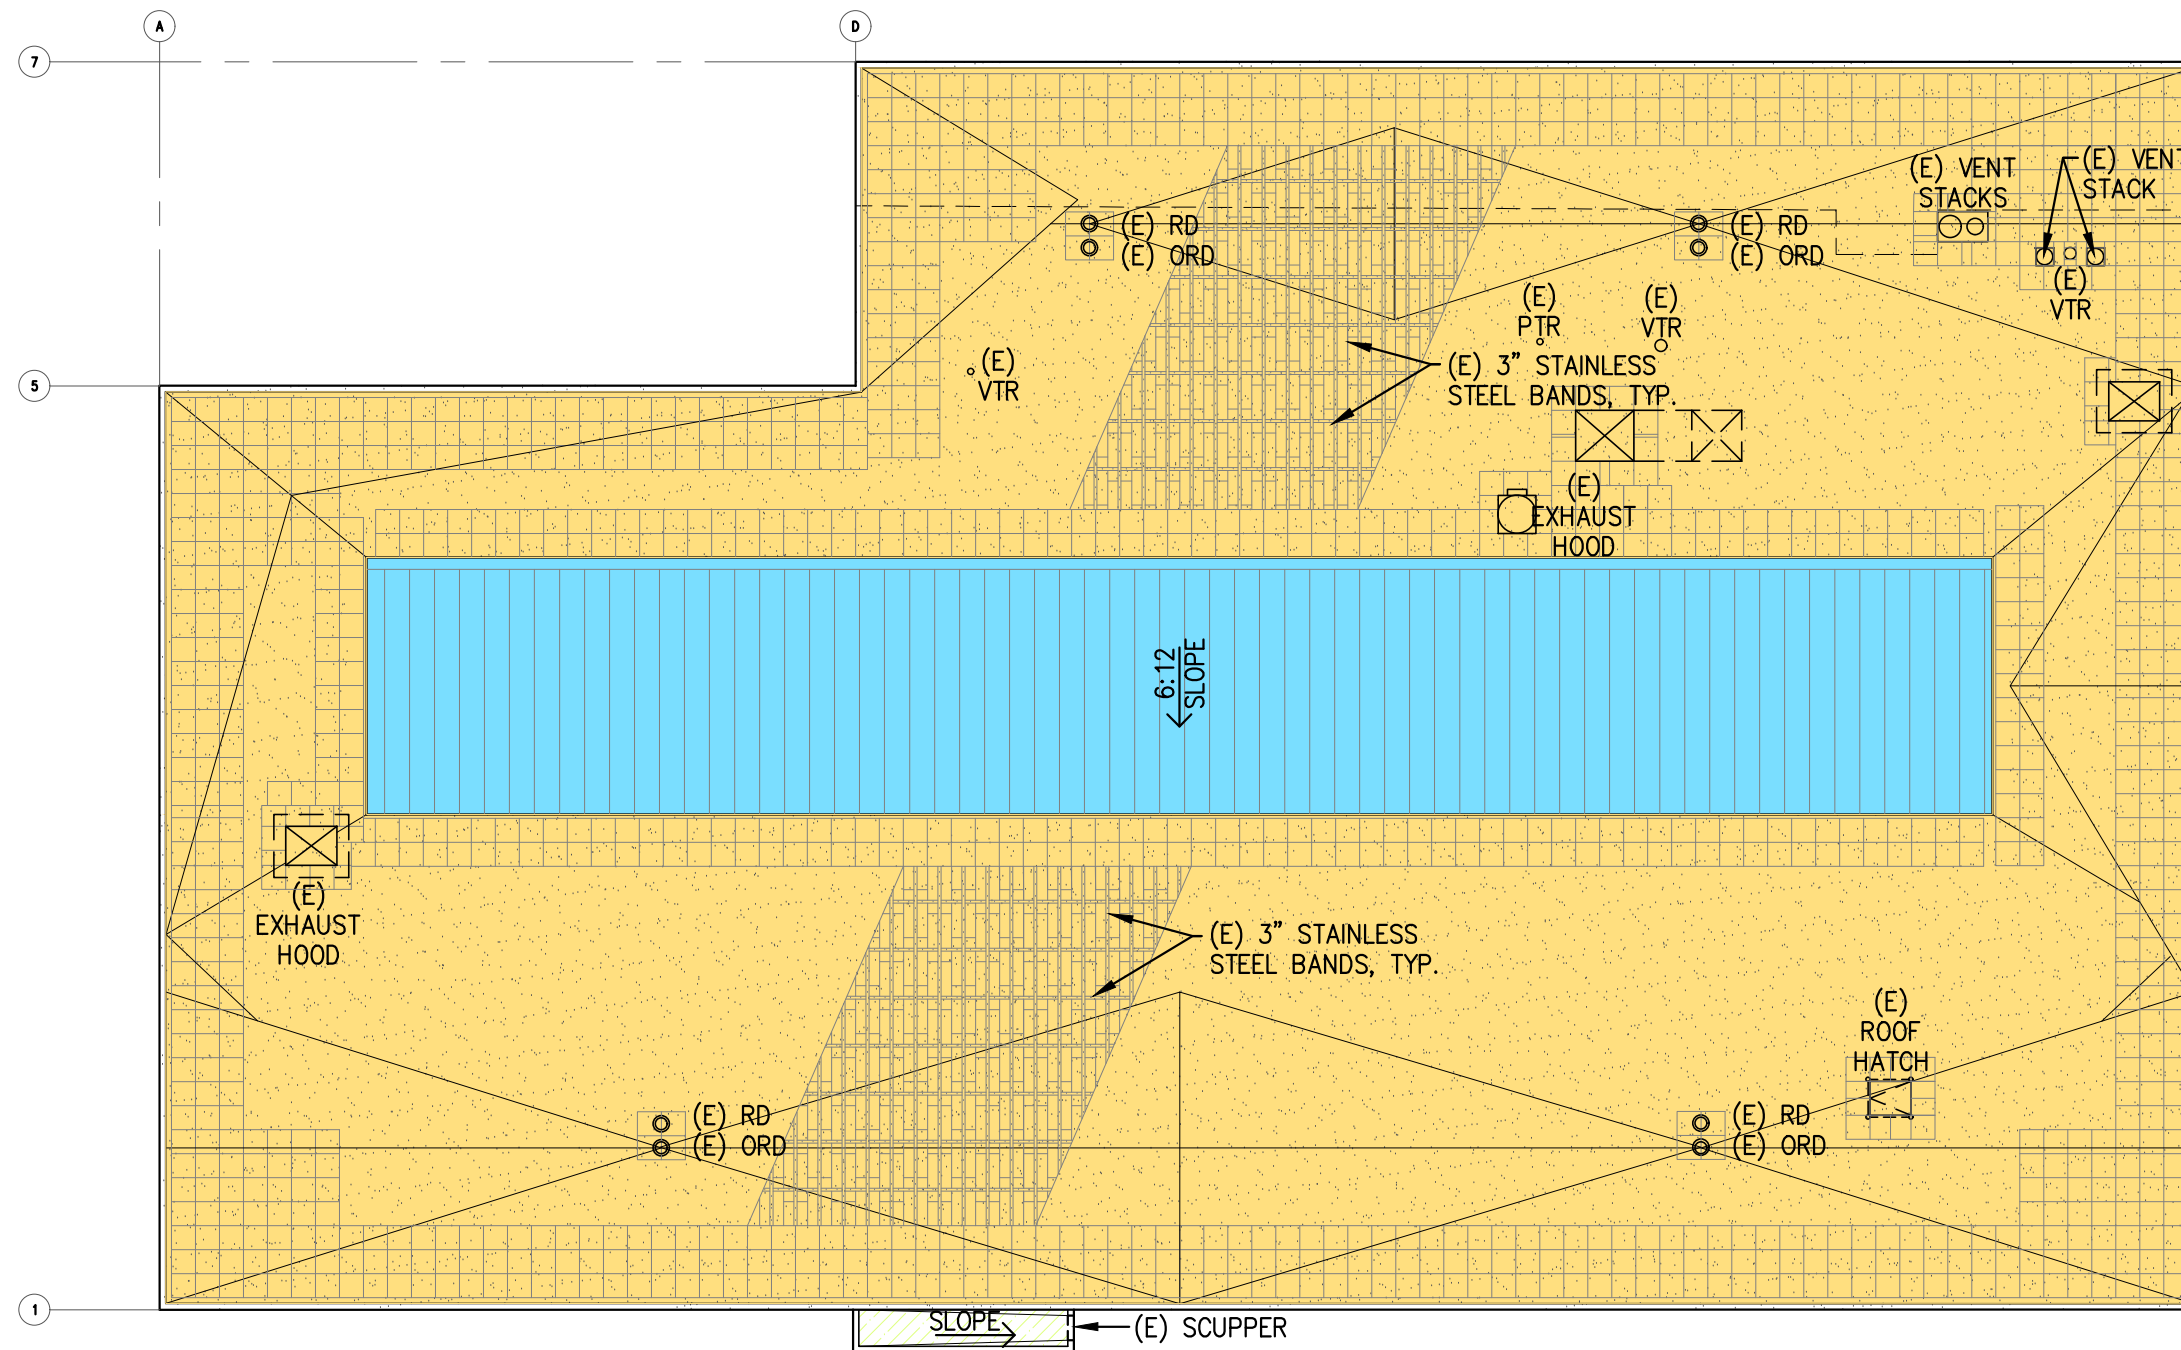
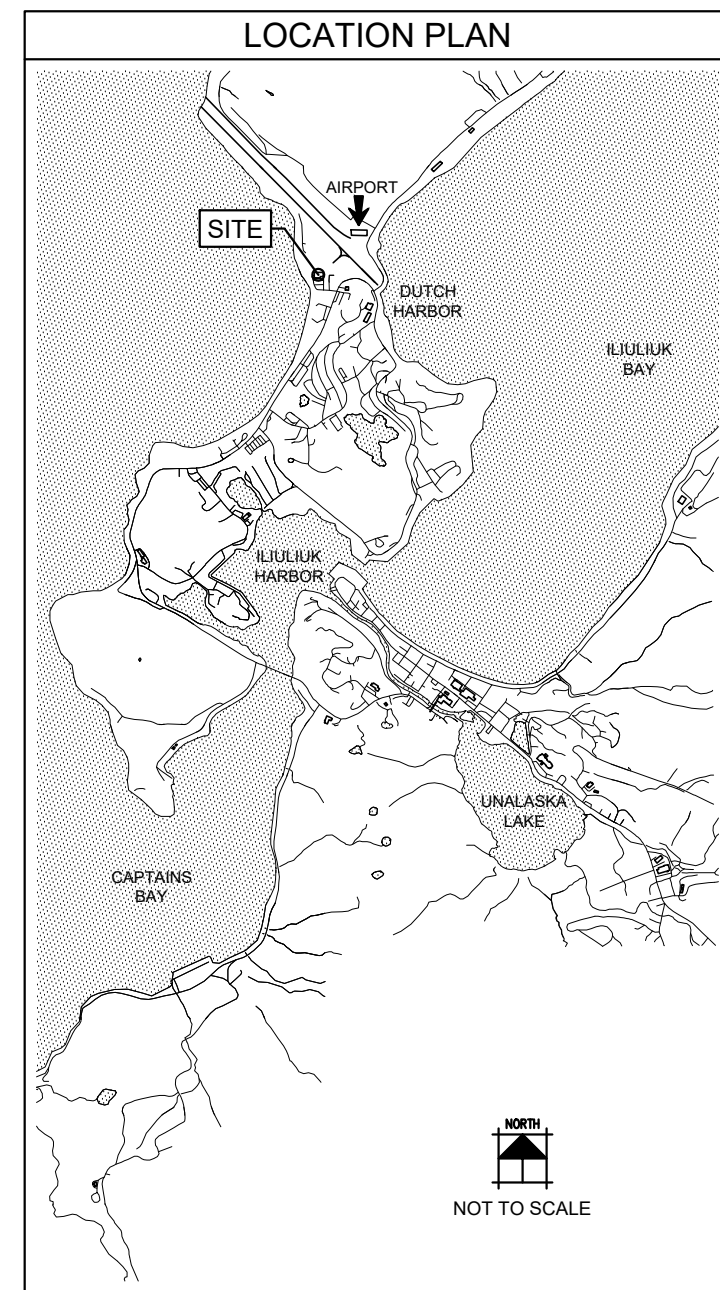
LEGEND	
	METAL ROOF Area: 2,900 SF
	INVERTED ROOF MEMBER ASSEMBLY Area: 13,500 SF
	PAVERS OVER INVERTED ROOF MEMBER ASSEMBLY
	EPDM ROOF Area: 1,500 SF

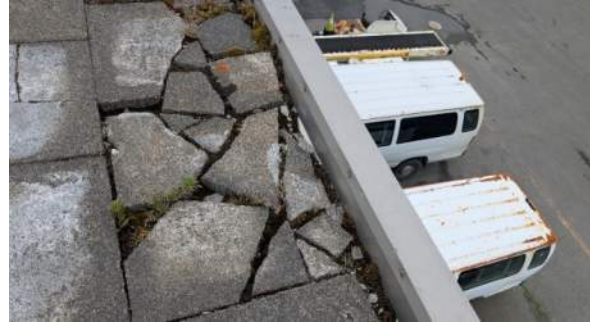
Photo #2: Broken pavers in multiple locations across entire roof.

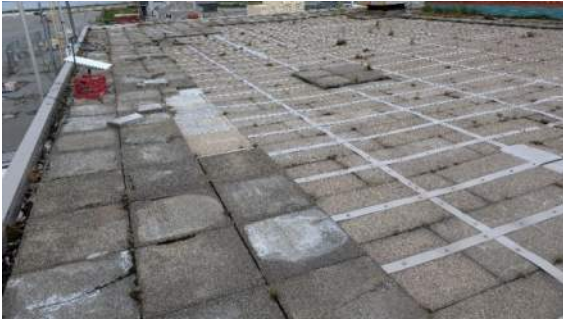
Photo #3: Moss and grass growing between pavers.

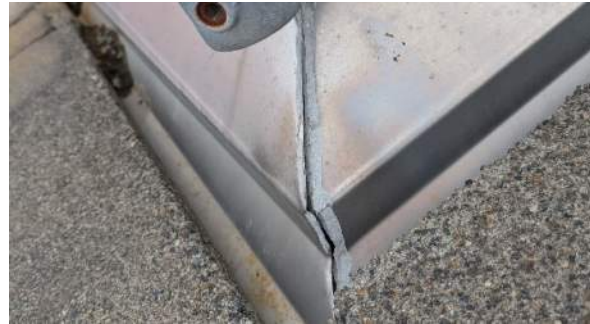
Photo #6: Broken sealant.

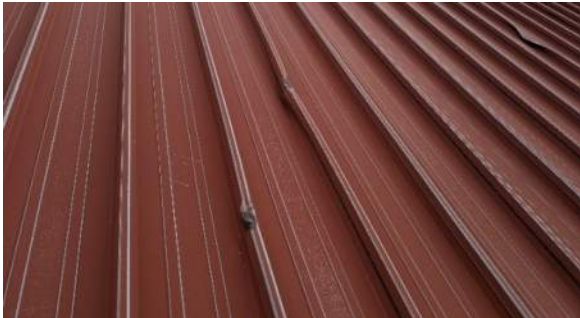
<p><i>Photo #19: Damaged roof ridges.</i></p>	<p><i>Photo #20: Damaged roof ridges, continued.</i></p>

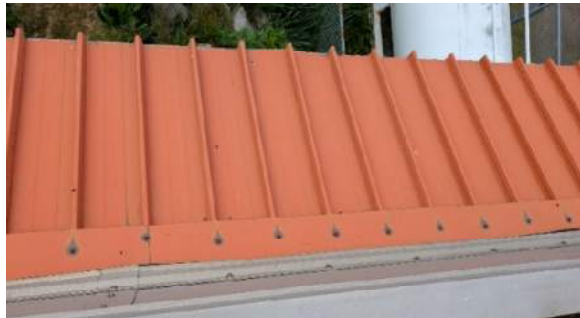
<p><i>Photo #21: Rust forming around fasteners at clerestory eave.</i></p>	<p><i>Photo #22: Rust forming around fasteners at awning.</i></p>

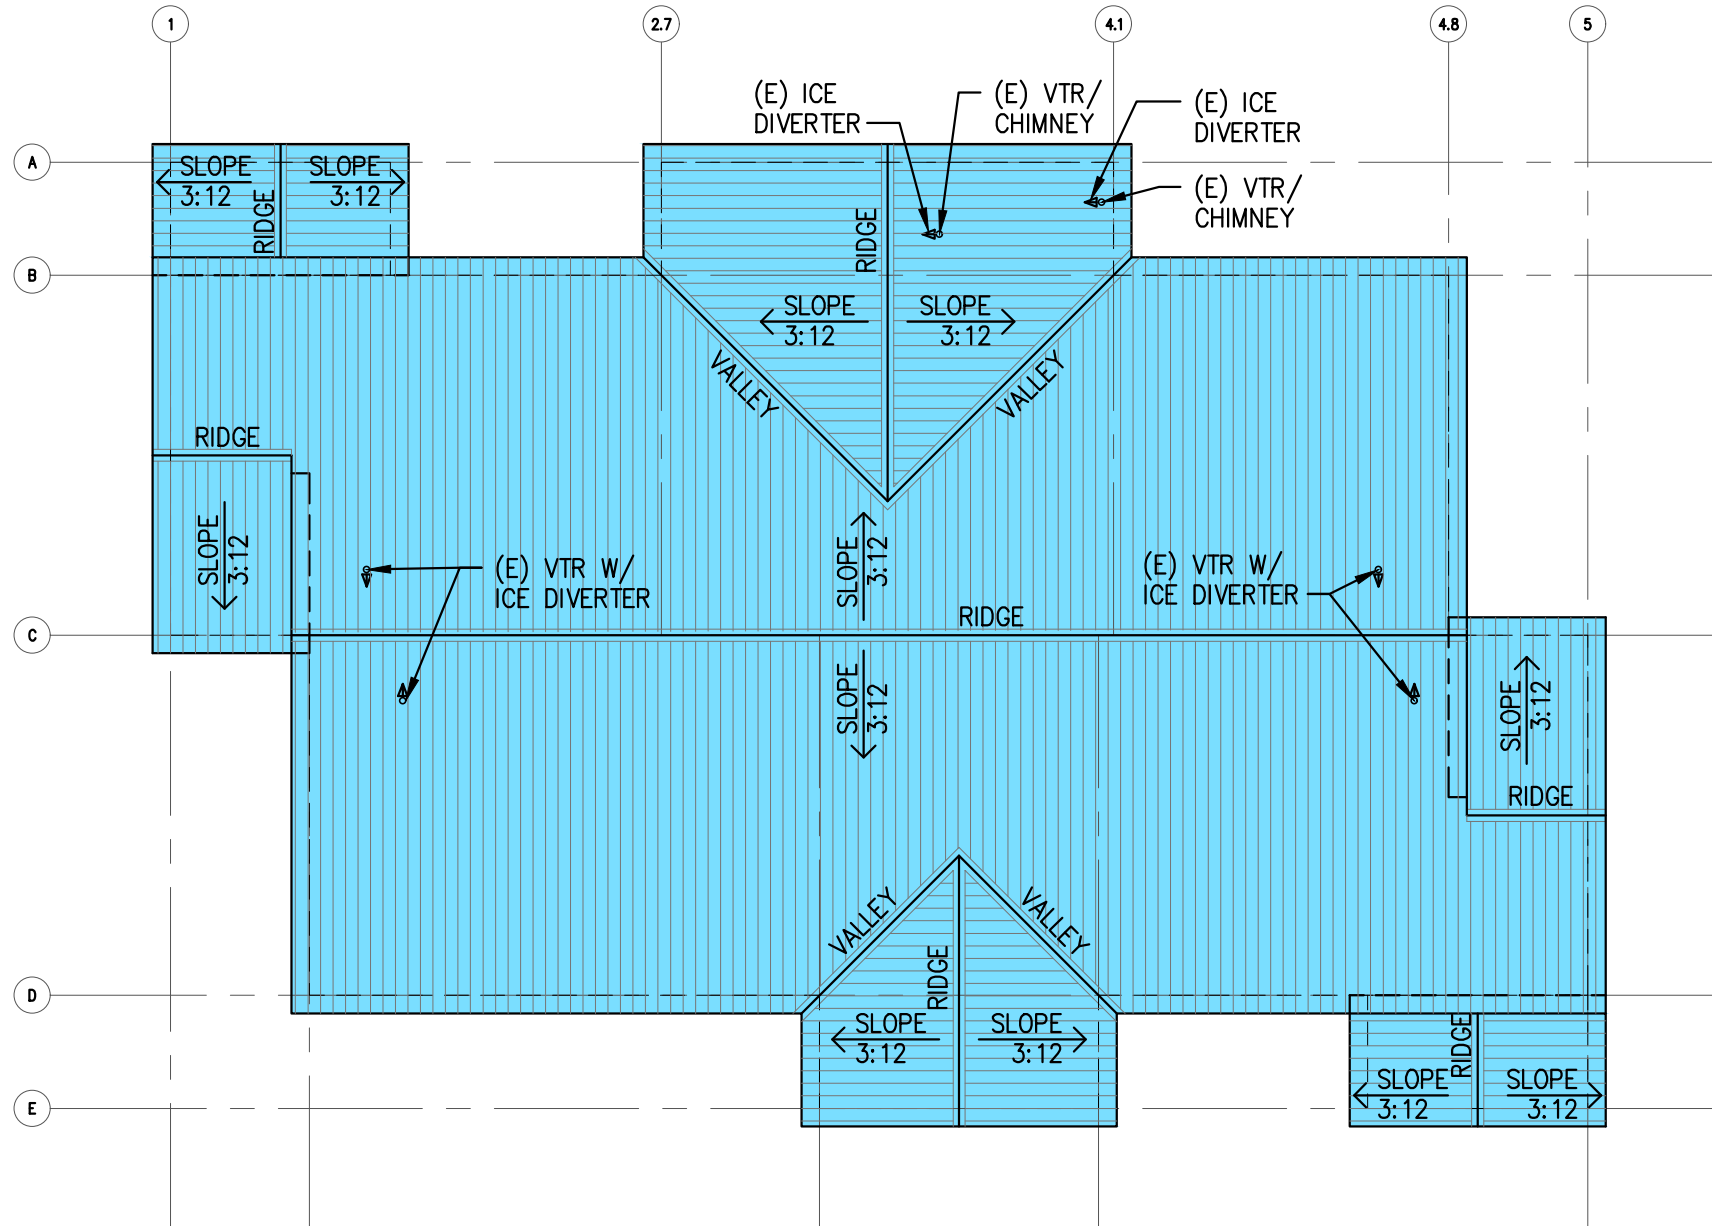
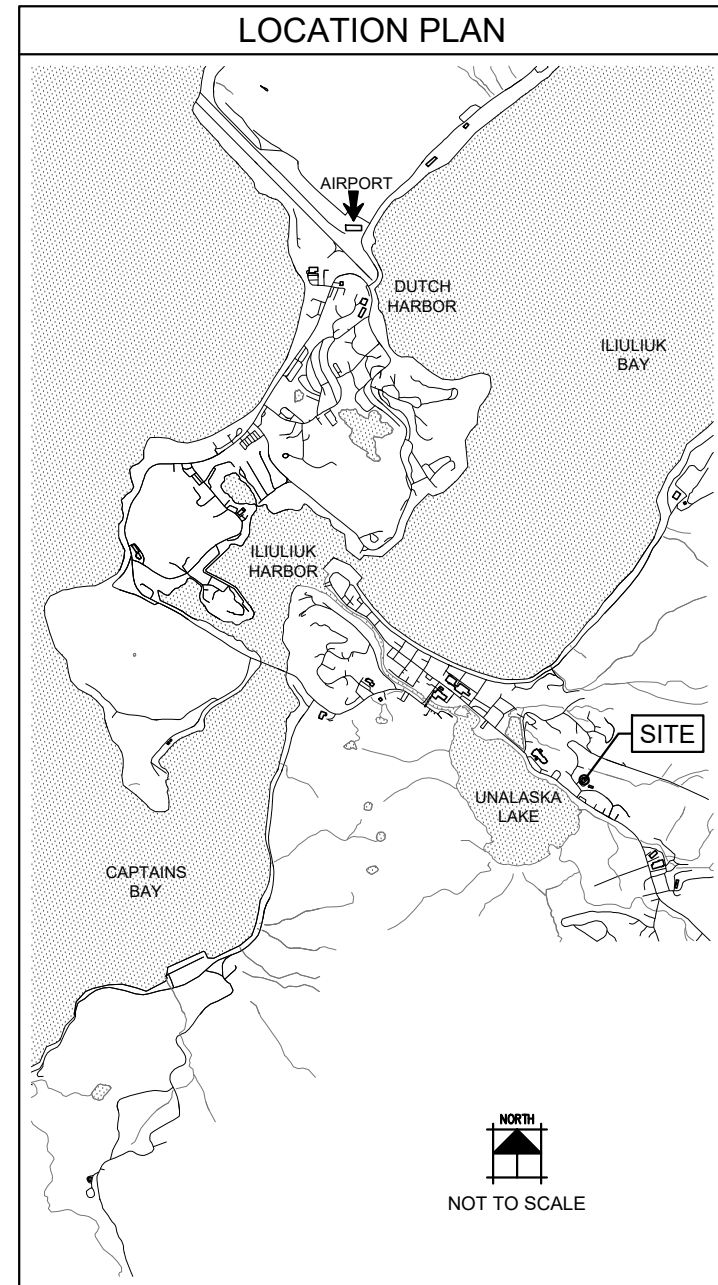
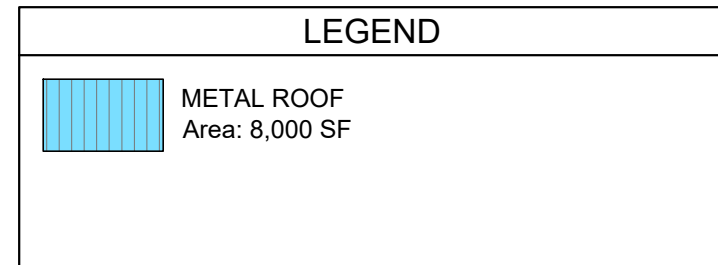
September 23, 2025 - 12:51 PM - BECKY - O:\GOVERNMENT\UNALASKA\3_DRAWINGS\00_AR SHEETS - REPORT\AR-24_8-PLEX HOUSING.DWG

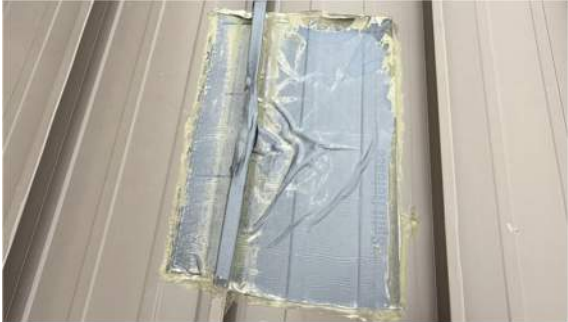
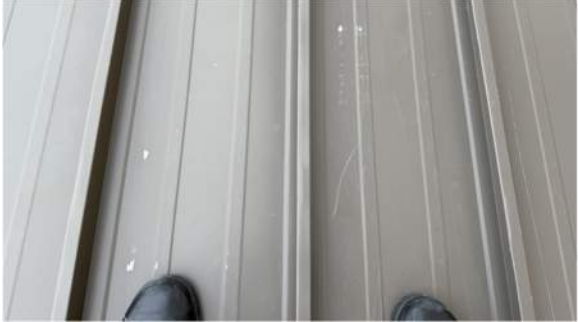
<p><i>Photo #1: Patch over damaged roof panel.</i></p>	<p><i>Photo #2: Paint layer on roof has started to peel off.</i></p>

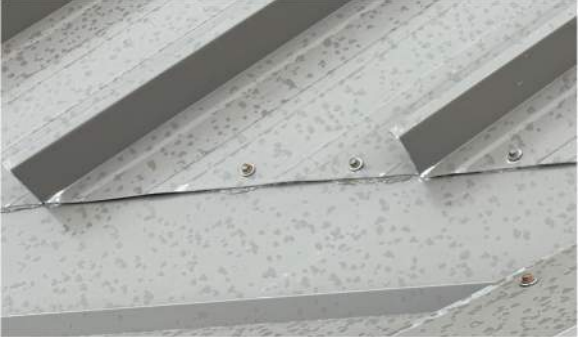
<p><i>Photo #3: Roof cut or torn at this location.</i></p>	<p><i>Photo #4: Sealant is old and cracking at valley flashing.</i></p>

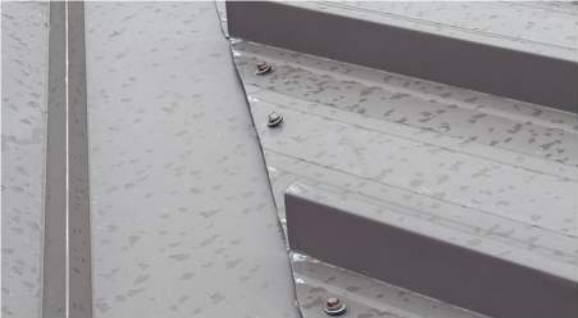
<p><i>Photo #5: Sealant is old and cracked. Sealant has separated from roof.</i></p>	<p><i>Photo #6: Gasketed hex head fasteners are not seated properly. Holes not sealed.</i></p>

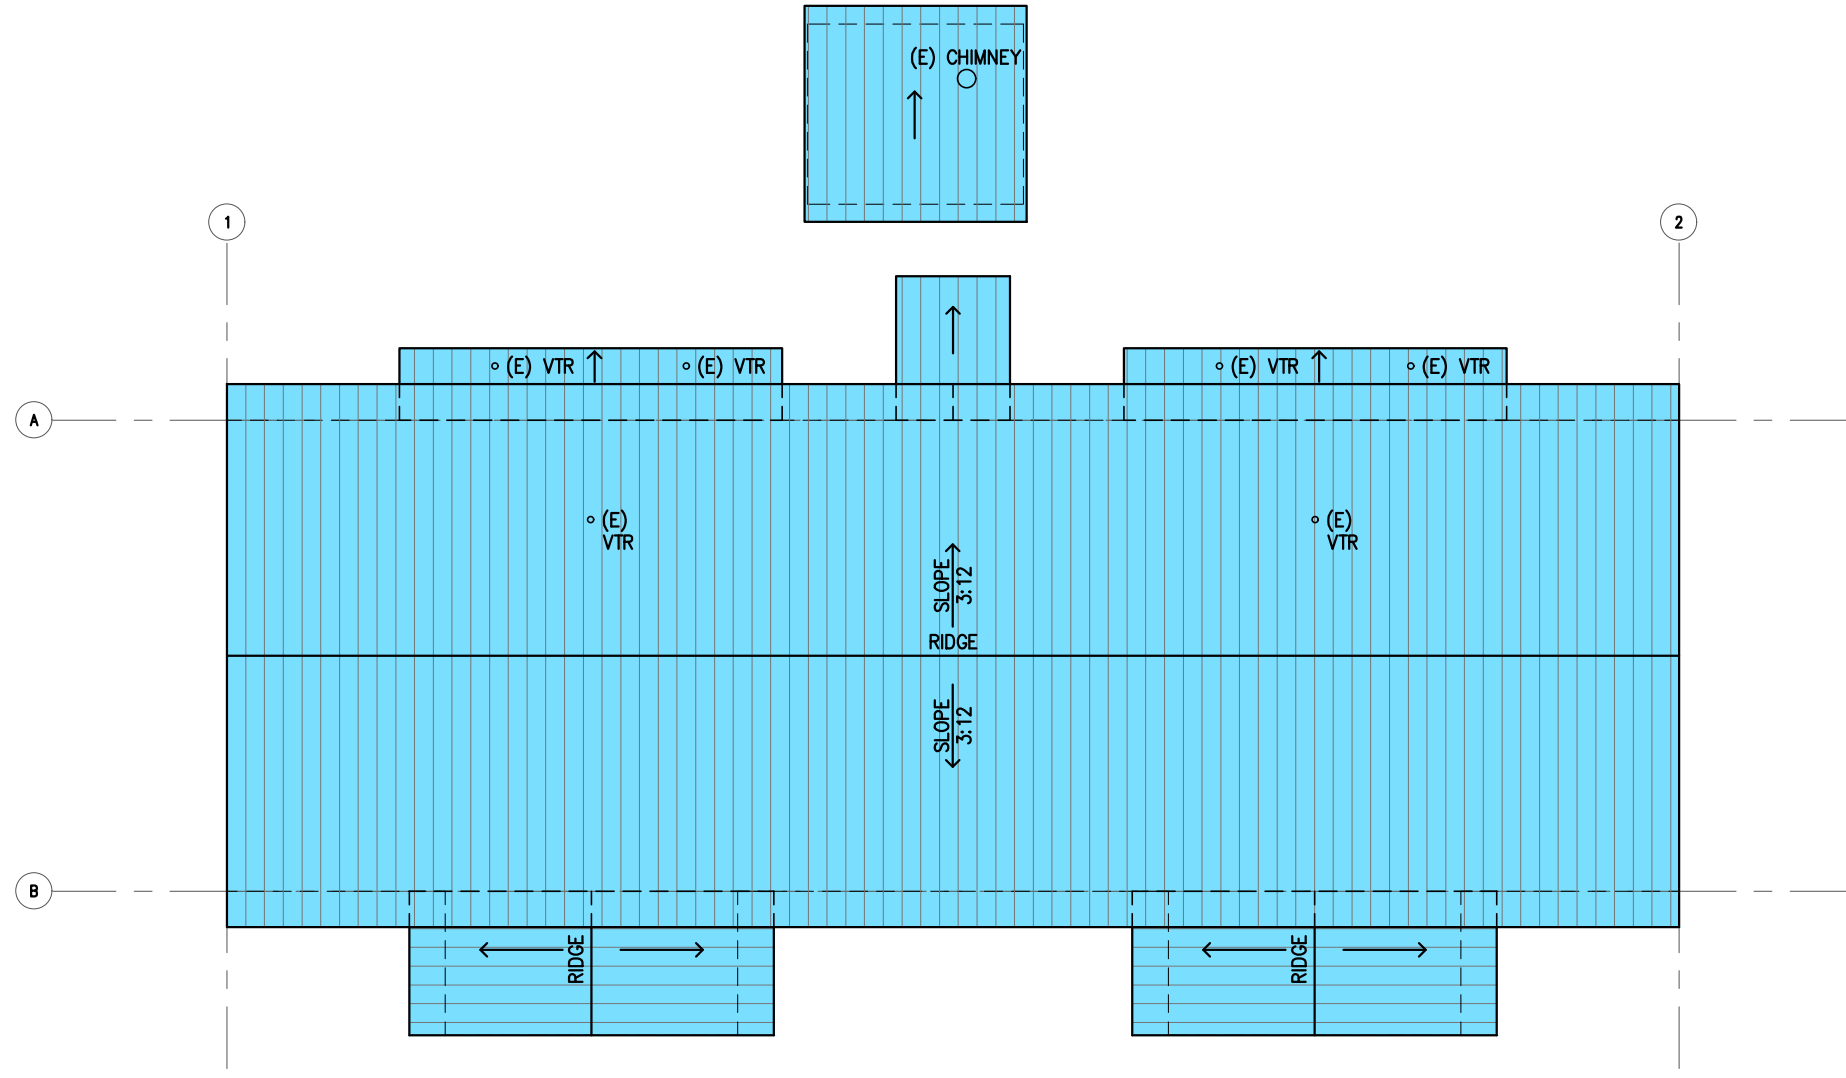
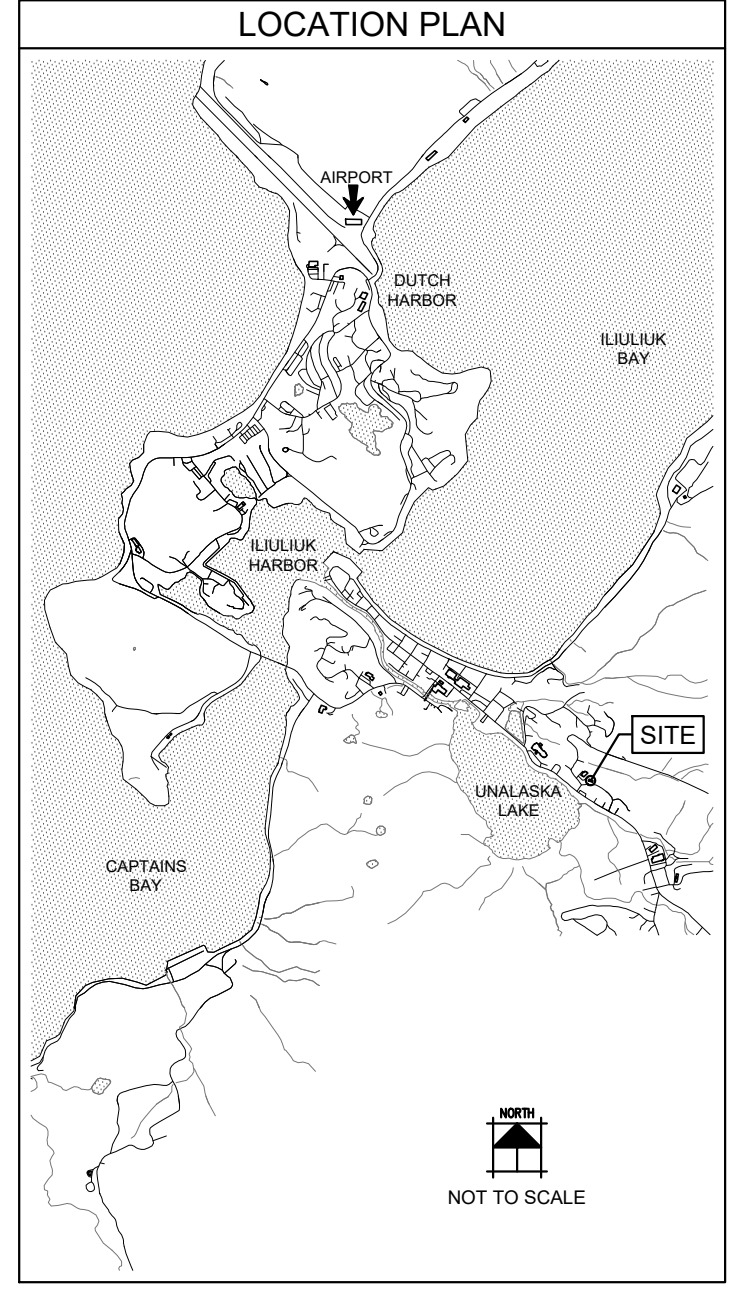
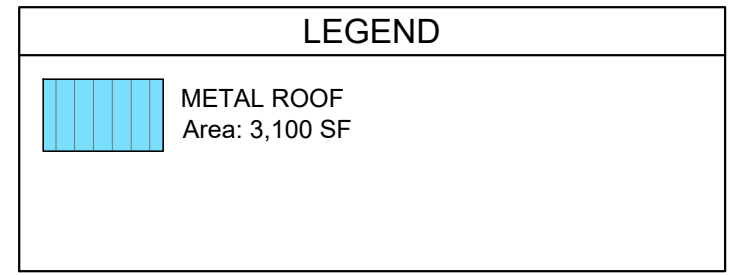
BUILDING ADDRESS
 63 Loop Road
 Unalaska, AK 99685

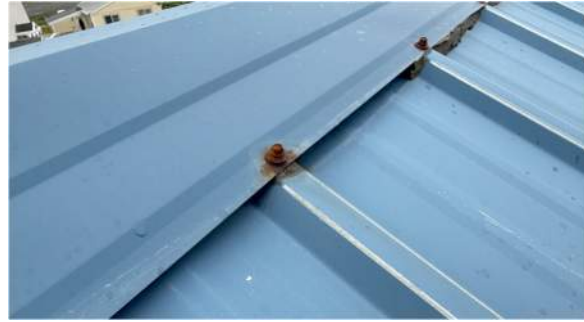
Photo #2: Ridge closer is missing. Fasteners are heavily rusted. Flashing rusting beneath.

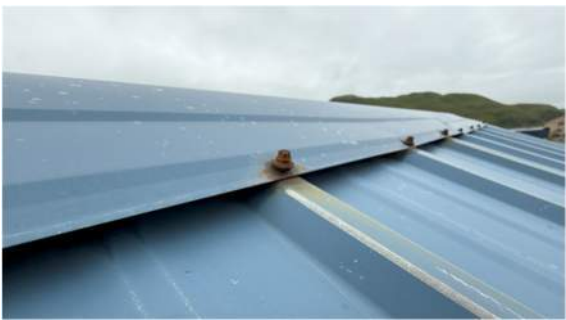
Photo #3: Ridge closer is missing. Fasteners are heavily rusted. Flashing rusting beneath. Gaskets are missing or deteriorating.

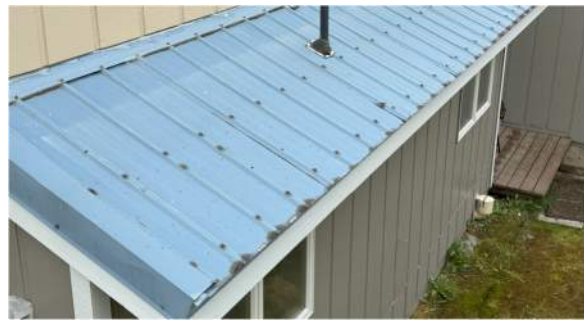
Photo #4: Ridge closer is missing. Fasteners are heavily rusted. Flashing rusting beneath. Gaskets are missing or deteriorating. Spots on the eave are starting to form rust.

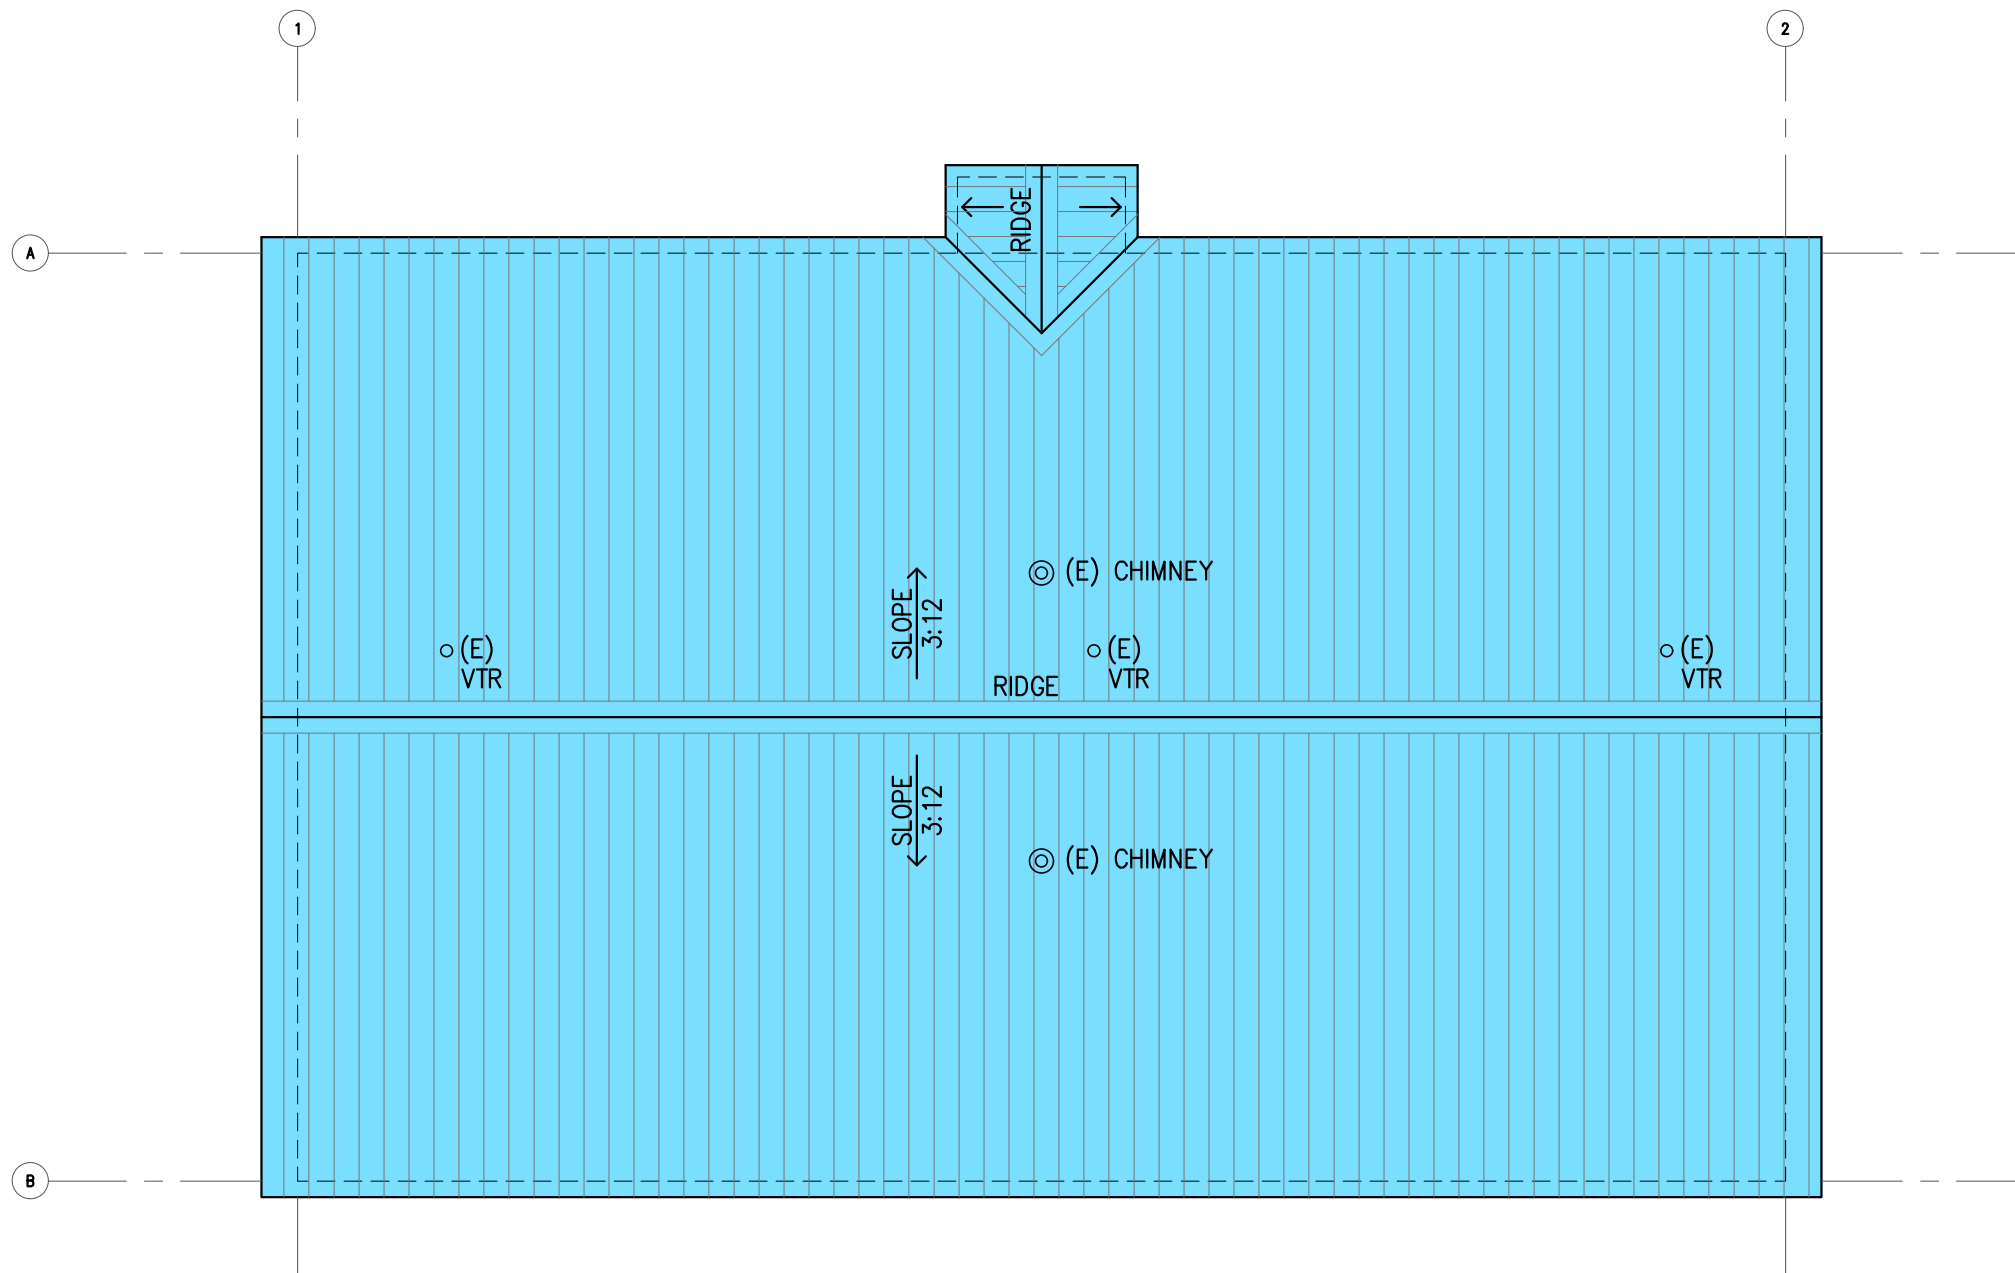
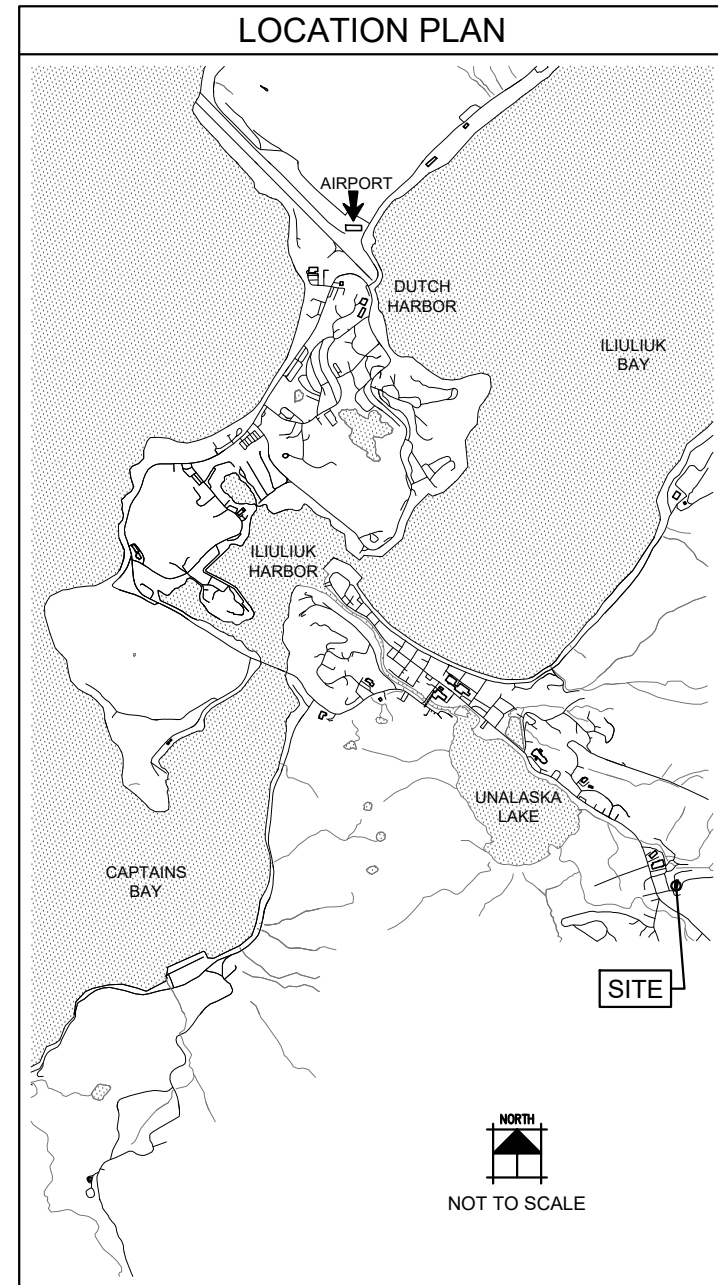
September 22, 2025 - 2:42 PM - BECKY - 0:\GOVERNMENT\UNALASKA\3_DRAWINGS\00_AR SHEETS - REPORT\AR-26_69&73 LEAR ROAD HOUSING.DWG

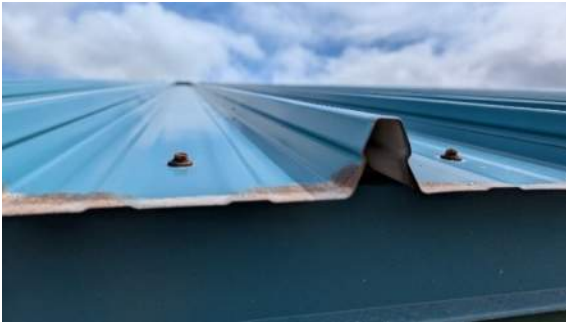
Photo #1: Roof eave is rusting. Fasteners are rusting.

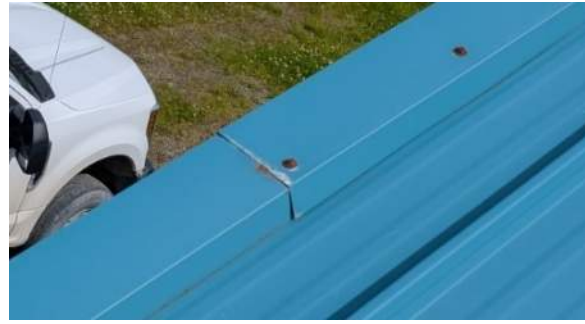
Photo #2: Rust forming where edge flashing overlaps.

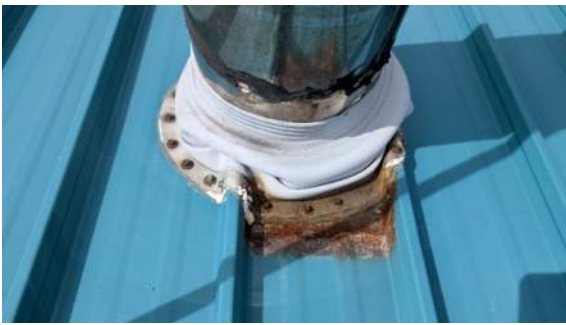
Photo #3: Heavy rust. Sealant is no longer providing any protection.

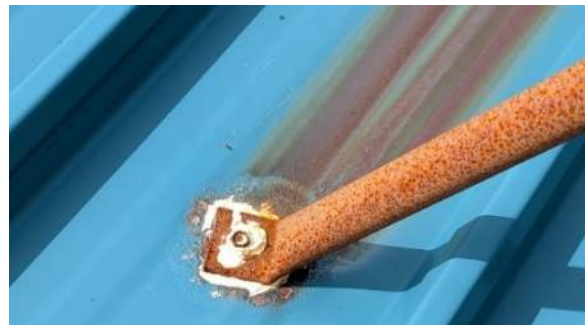
Photo #4: Rusty support has leached onto roof. Rust has formed beneath.

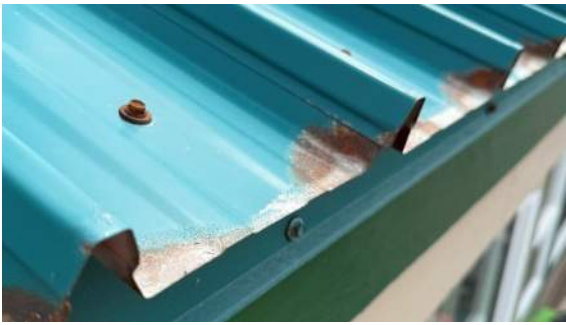
Photo #5: Rusty support has leached onto roof. Rust has formed beneath.

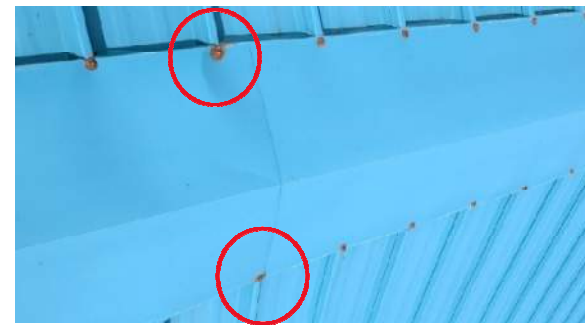
Photo #6: Dented ridge flashing. Rust forming under fastener. All ridge fasteners are rustin.

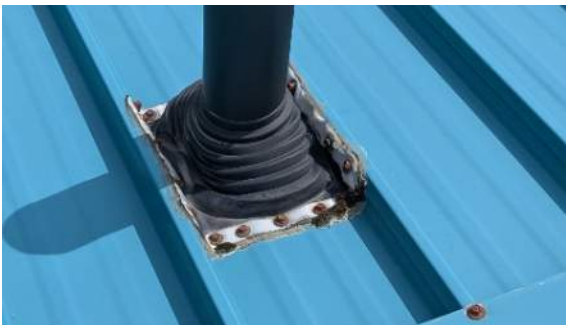
Photo #7: Moss growing on sealant.

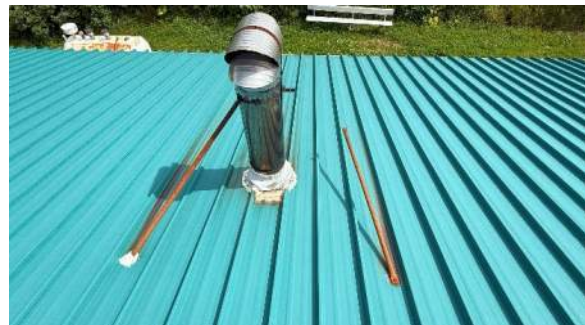
Photo #8: Broken and rusted chimney stay rods.
