ATTACHMENT A

AGREEMENT FOR CONSULTING AND RELATED SERVICES

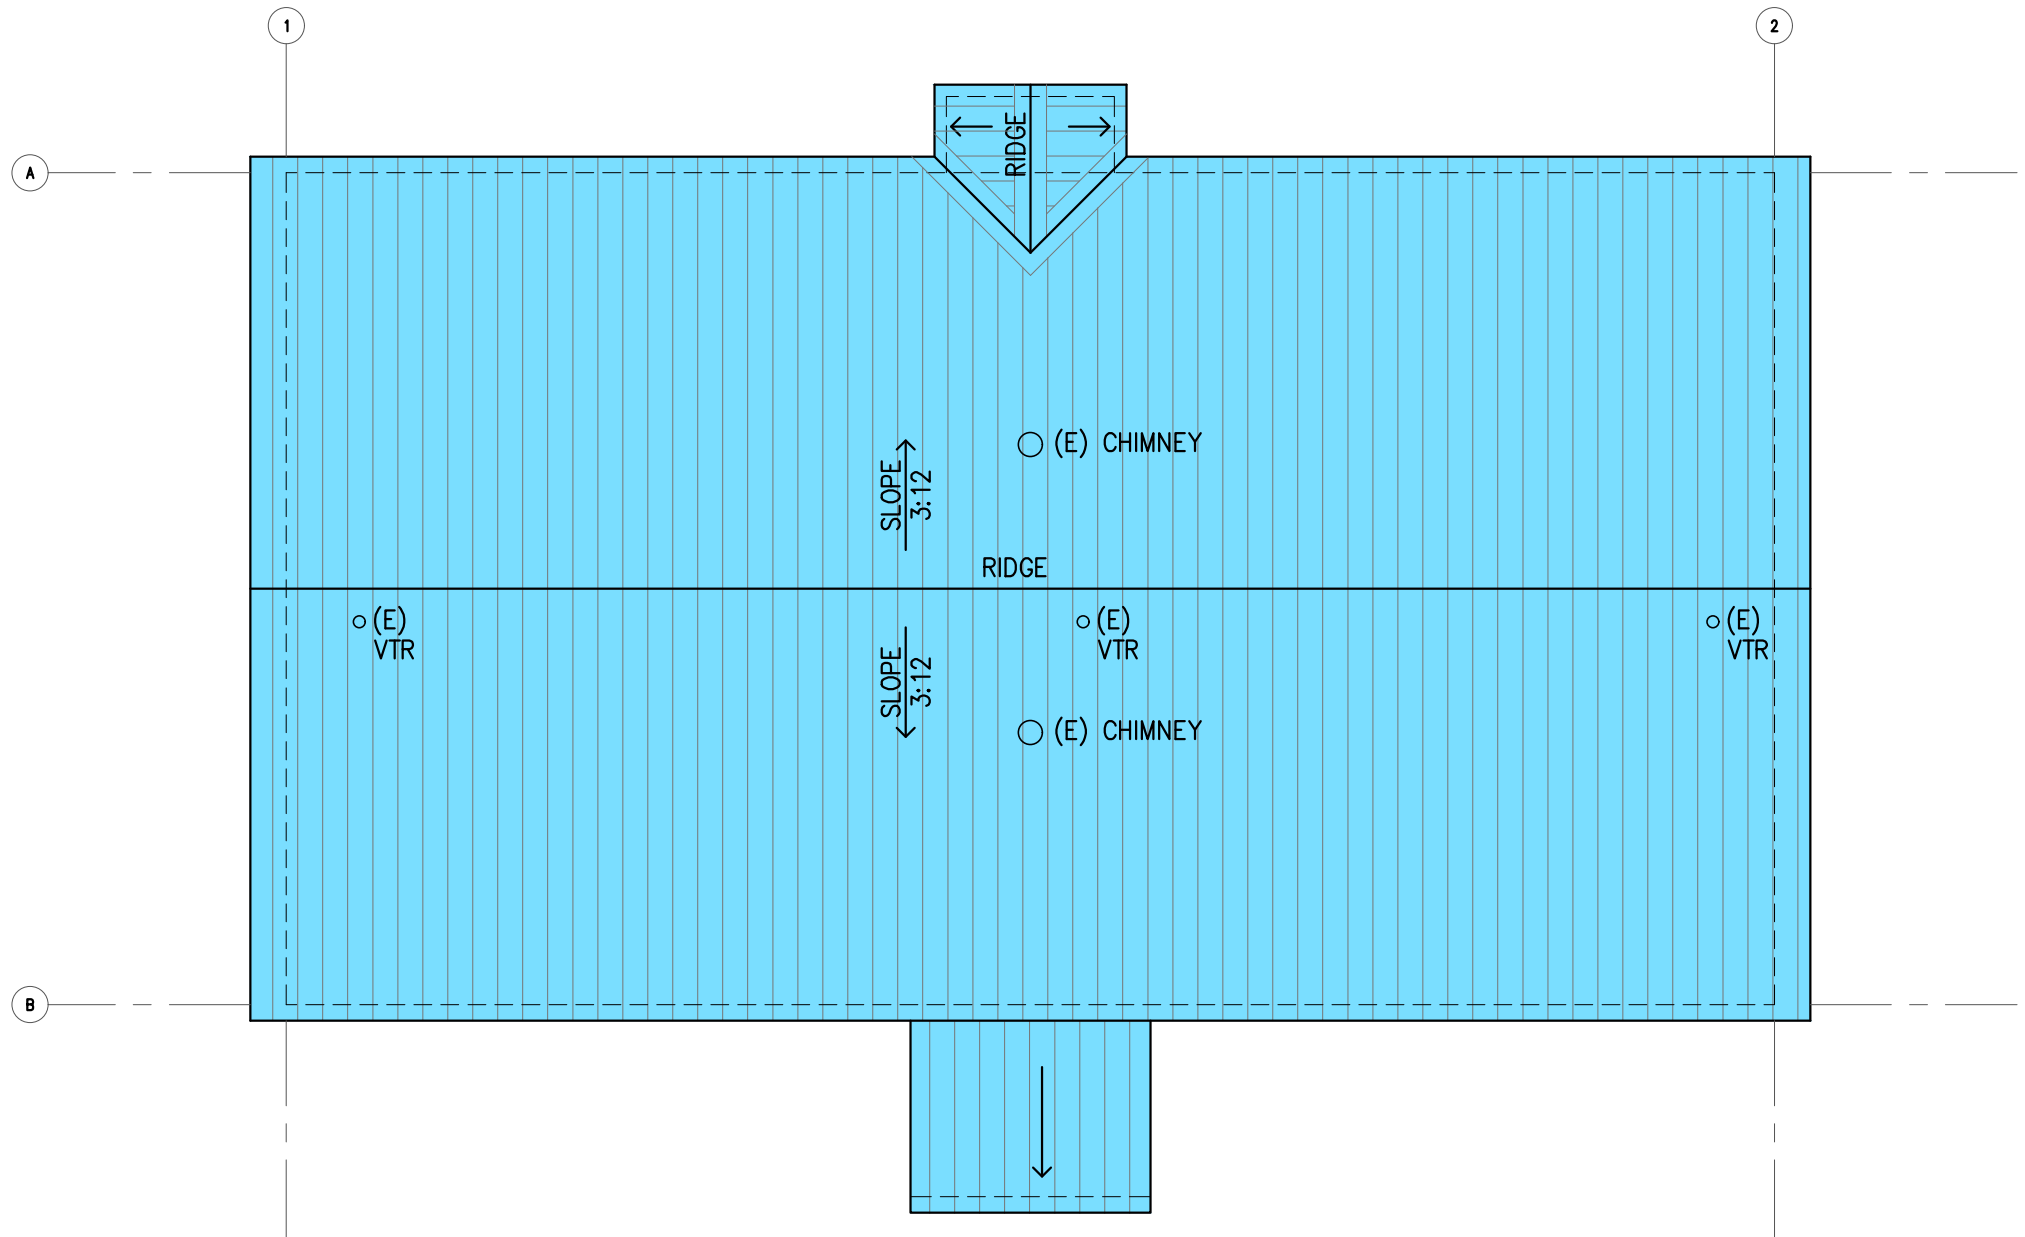
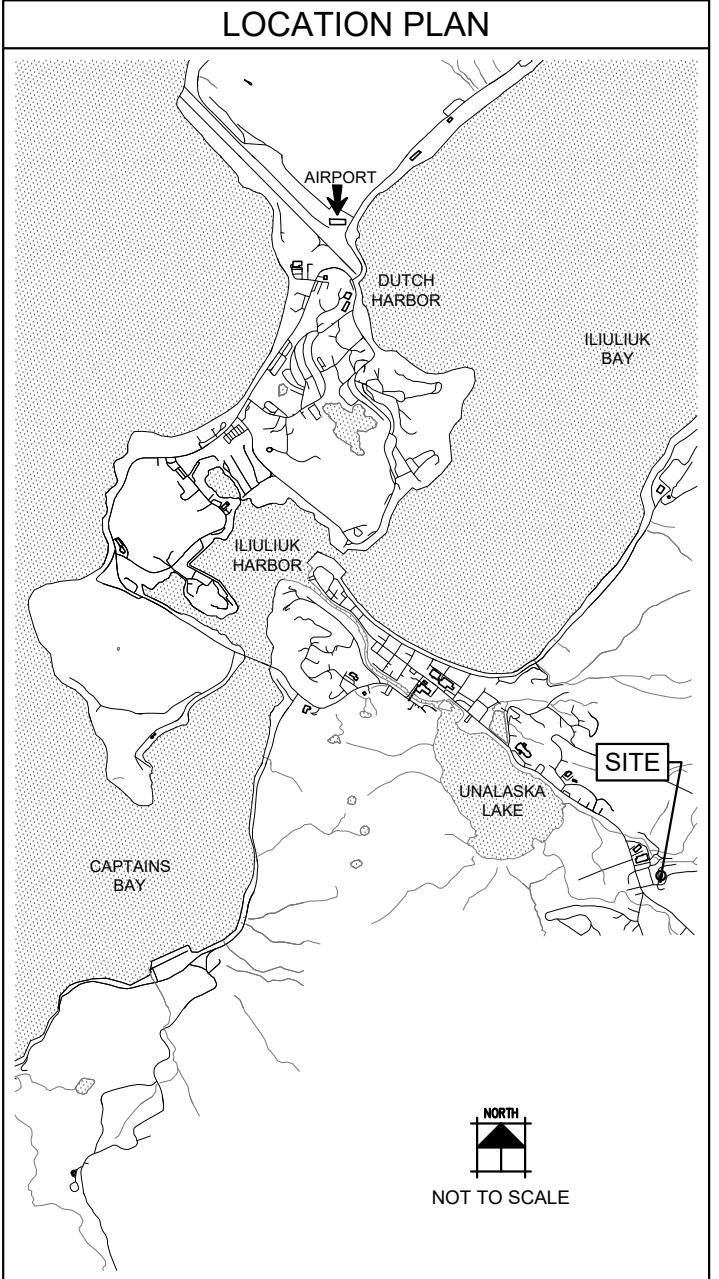
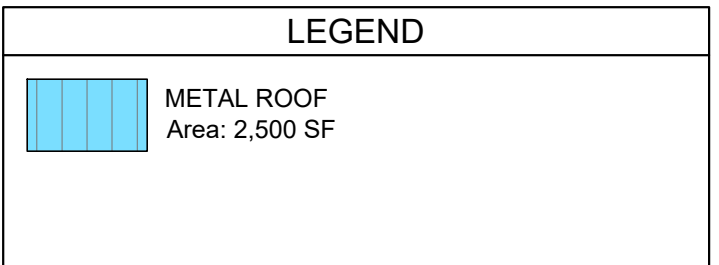
September 22, 2025 - 2:43 PM - BECKY - C:\GOVERNMENT\UNALASKA\3_DRAWINGS\00_AR_SHEETS - REPORT\AR-27_81&85 LEAR ROAD HOUSING.DWG

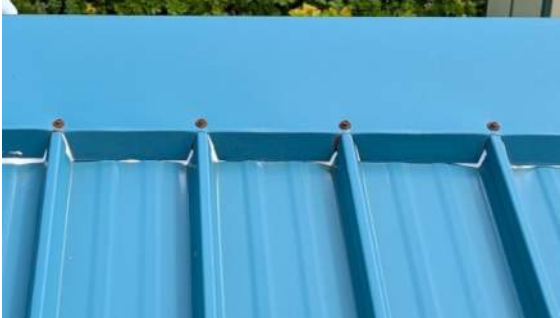
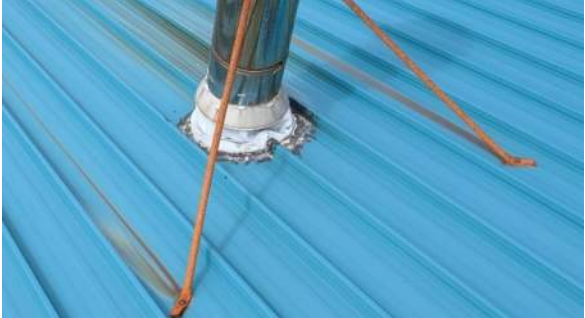
<p><i>Photo #1: Ridge caps are rusting at ribs.</i></p> <p><i>Photo #2: Supports are rusting and leaching onto roof. Roof is rusting beneath.</i></p>

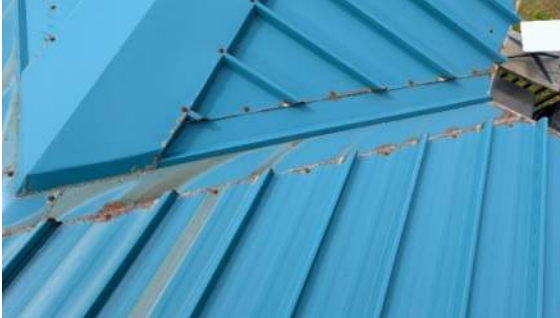
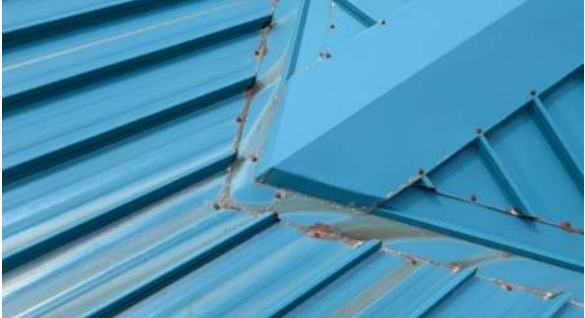
<p><i>Photo #3: Roof edge along valley is rusting along with valley flashing and fasteners.</i></p> <p><i>Photo #4: Roof edge along valley is rusting along with valley flashing and fasteners, continued.</i></p>

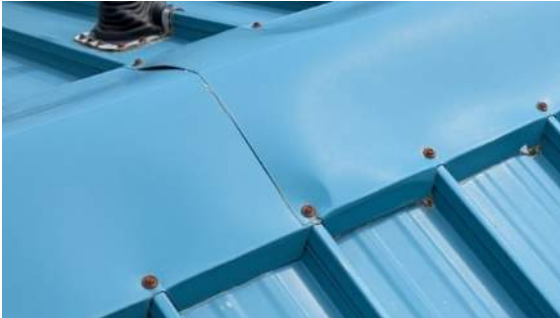
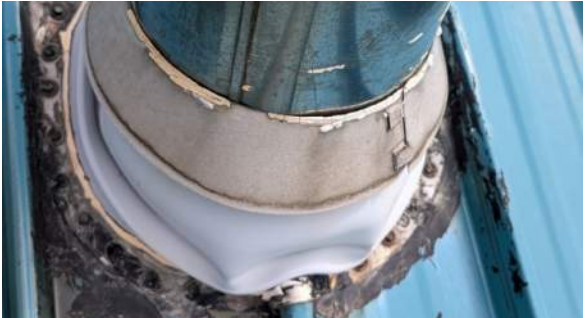
<p><i>Photo #5: Ridge cap is warped and not sealed.</i></p> <p><i>Photo #6: Sealant along chimney has failed providing gaps.</i></p>

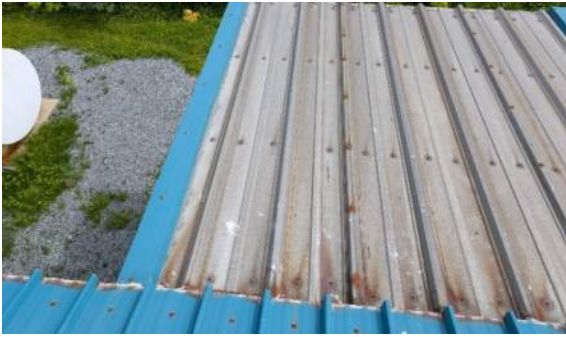
Photo #7: Roof and fasteners are rusting. Rust along main roof edge.

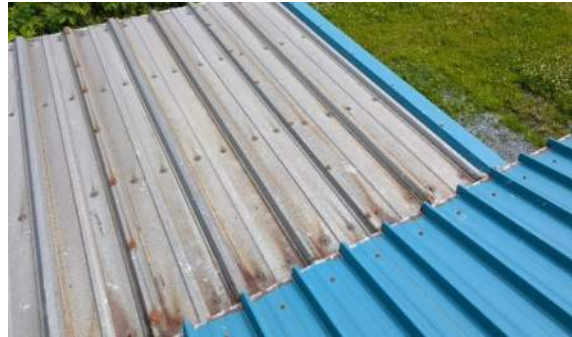
Photo #8: Roof and fasteners are rusting. Rust along main roof edge, continued.

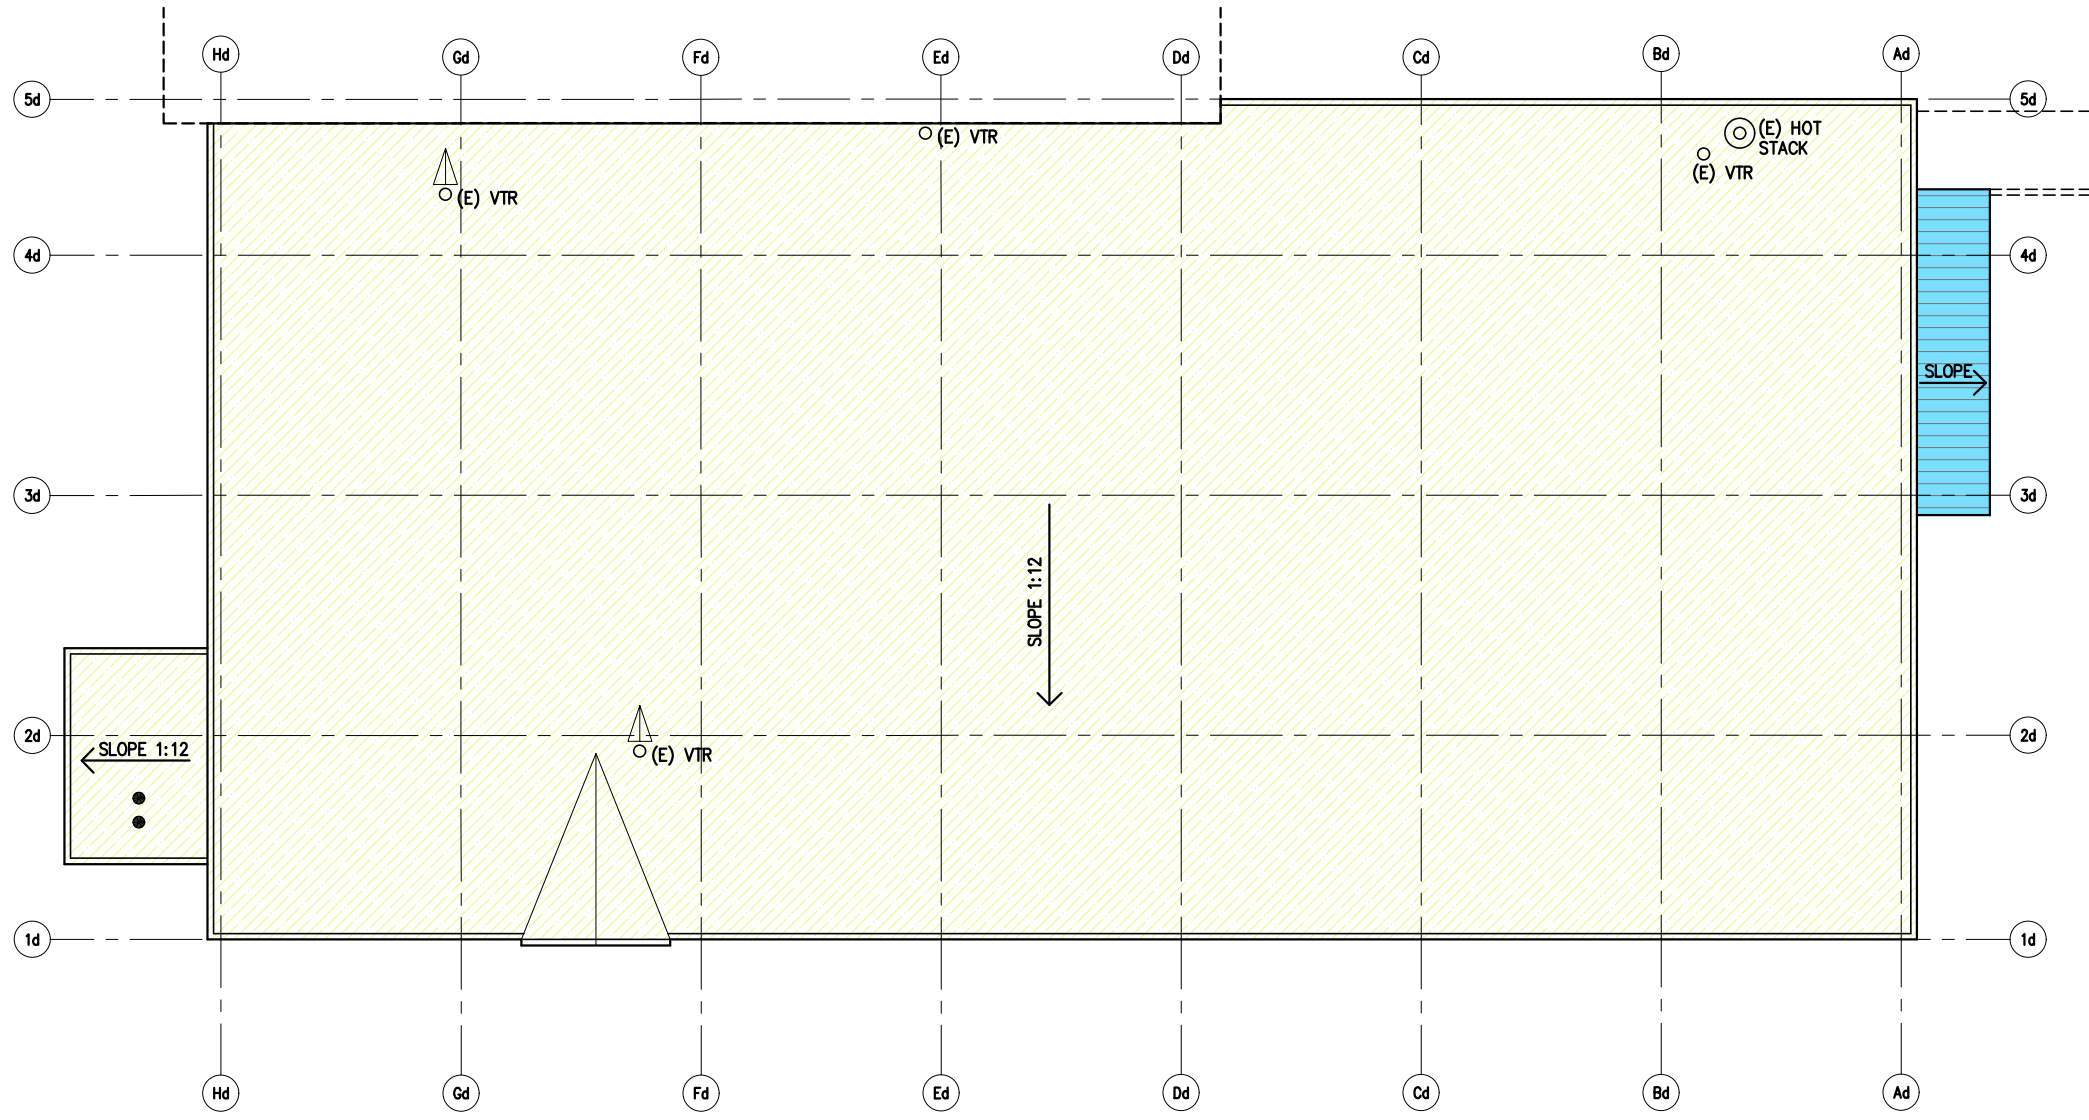
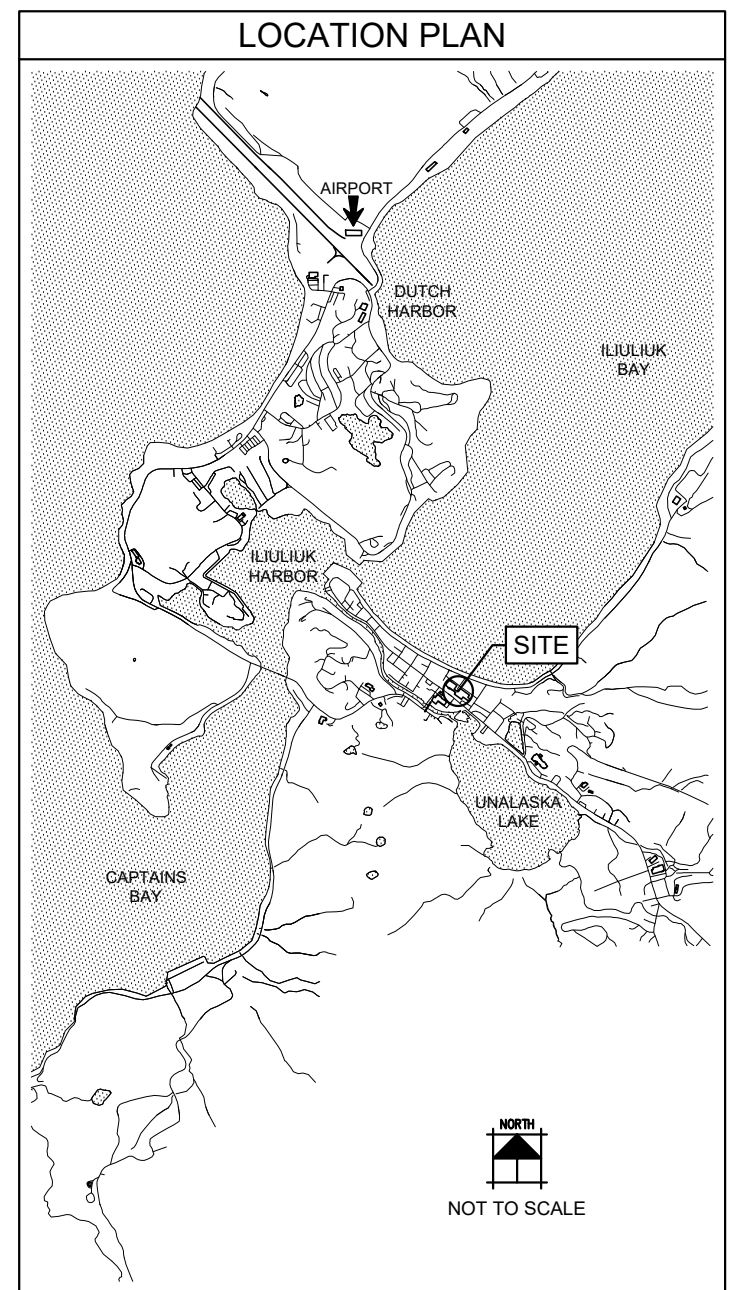
LEGEND	
	EPDM ROOF Area: 9,800 SF
	METAL ROOF Area: 200 SF
